Executive Summary

Introduction

In preparation for a Spring 2002 bond issue, the Santa Monica Community College District retained 3D/International to assist the District in assessing and documenting the facility repair, rehabilitation, modernization and new construction requirements for its main campus and satellite facilities.

Existing Facilities Assessment

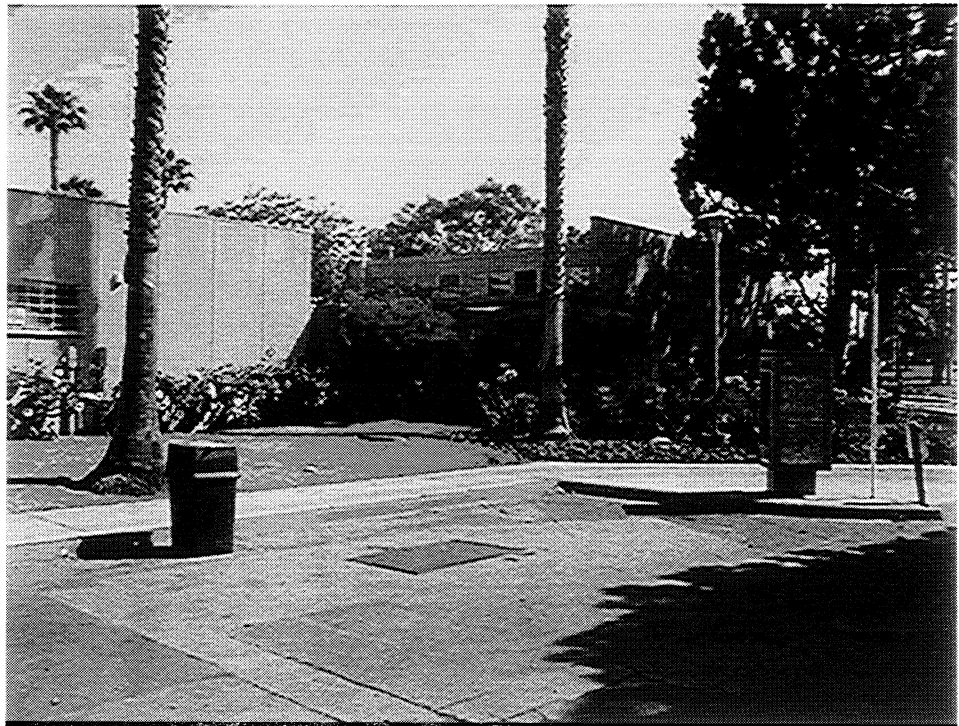
Administration, Northeast Quadrant

The complex rests on spread footings that are showing no signs of damage or settlement. The building's structural systems consist of wood frame construction with metal lath and cement plaster exterior skin.

The roof was last replaced in 1976 with a "monoform" system and is experiencing numerous leaks.
