HAZARDOUS MATERIALS ASSESSMENT

Ellis Environmental Management, Inc.,
Hazardous Materials Assessment,
2019 14th Street,
City of Santa Monica, CA 90405
March 2017.

**2019 14th Street
Santa Monica CA 90405**

**Sampling Date: March 2017
Project No: 17-044**

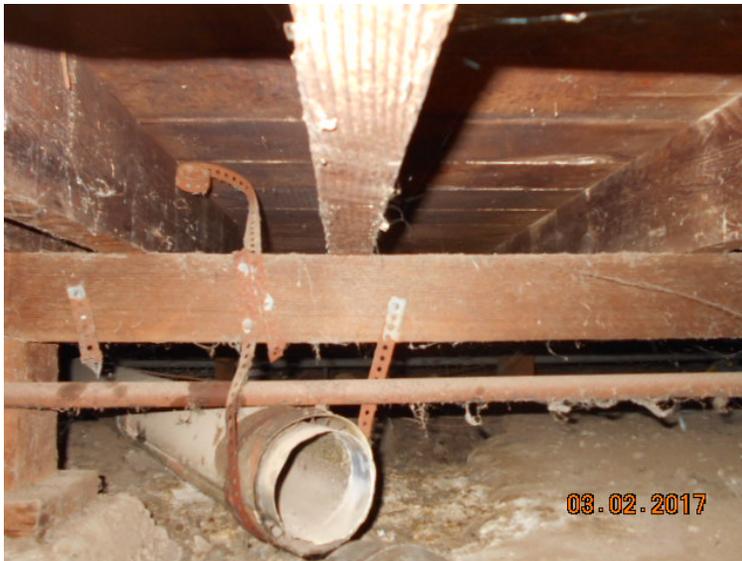
- AC (“Transite”) vent pipe (assumed, not shown), attic above kitchen stove. Viewed but inaccessible for sampling. App. 8 l.f. Undamaged, non-friable.
- Abandoned, insulated furnace duct, sub-floor crawlspace. Viewed but inaccessible for sampling. Est. 40 l.f. Damaged, friable.

Abandoned duct in sub-floor crawl space

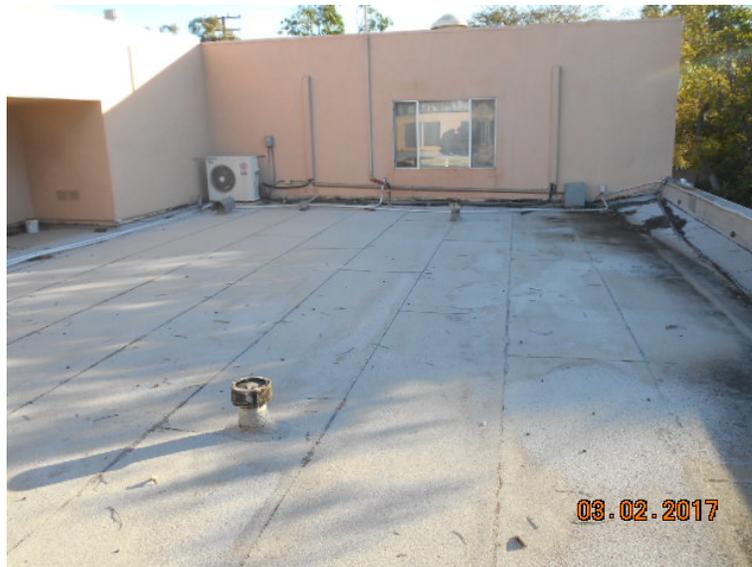
- Roof penetration mastic and sealants. Good condition, non-friable. Est. 130 s.f. including edge sealants.

Roof penetration mastics and sealants. No asbestos in main roofing field or in decorative roof shingles.

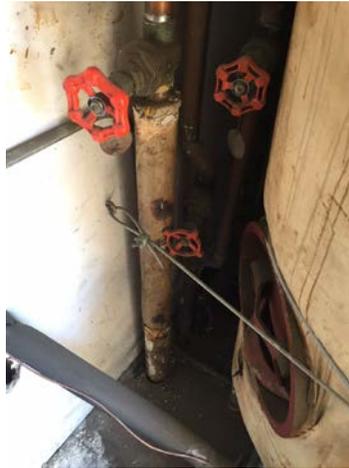
- Heater room pipe insulation. 4 l.f. exposed in heater room, assume an additional 60 l.f. in sub ceiling below, leading to women's locker room. Condition = friable, damaged.

Heater room pipe insulation

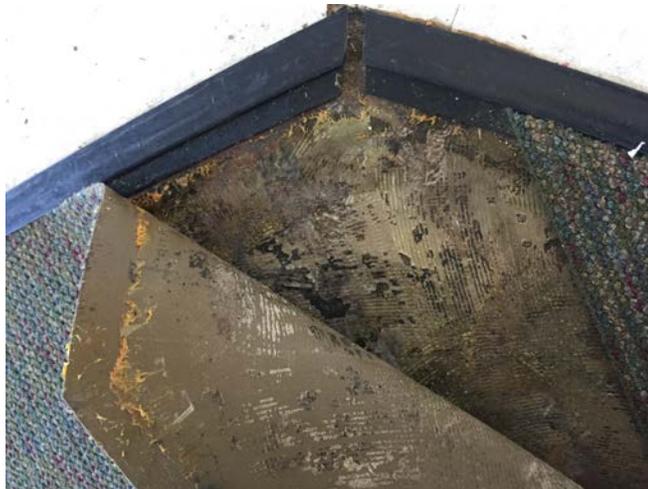
- Mastic under carpet. App. 625 s.f. Non-friable, good condition. See below.

Asbestos mastic under carpet

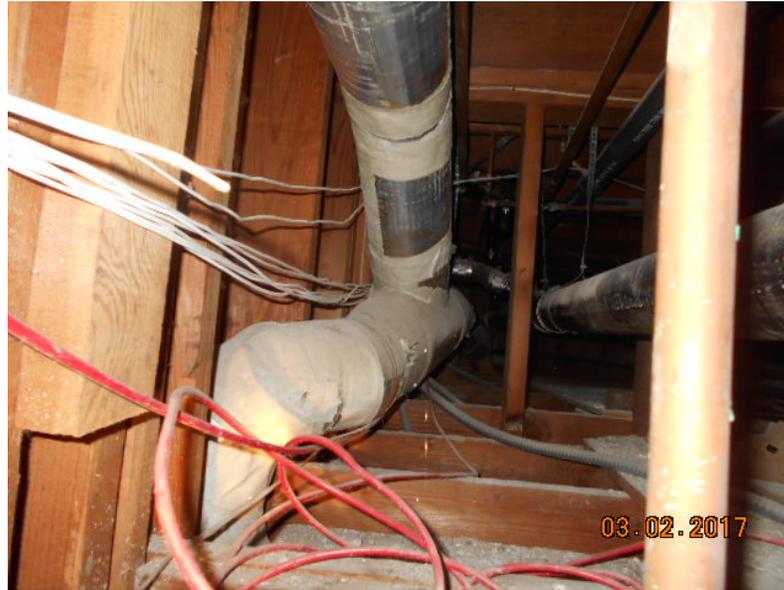
- Attic duct insulation. Friable. No apparent damage, but largely inaccessible. 150 l.f. estimated.

Duct insulation and paper

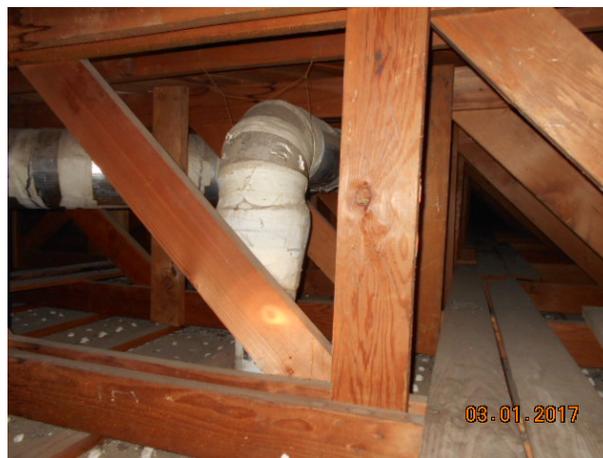
- Duct insulation (Fl. 2 crawlspace). No apparent damage, but largely inaccessible. 40 l.f. estimated.

Duct insulation, Shelter Home attic space

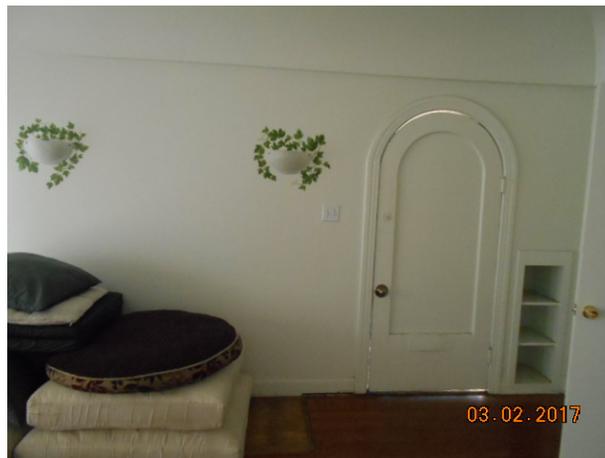
- Underlying paint on original interior plaster walls, door and window frames. Good condition. App. 1400 s.f.

Interior perimeter walls

- Lead Paint, all areas. Any damaged (peeling and flaking) paint should be stabilized by a licensed abatement contractor prior to demolition / renovation. Separate damaged lead paint and place in labeled drums for profiling. Remove remaining stabilized components in whole sections. Profile representative generated waste prior to transport or disposal.
- Exterior decorative brick – YWCA Recreation Building. Remove decorative exterior brick from within a lead-regulated area using trained workers. Store and profile this waste separately from other generated construction waste.
- Interior ceramic tile – YWCA Recreation Building. Remove interior beige ceramic tile under containment, using trained workers. Store and profile waste separately from other generated construction waste.

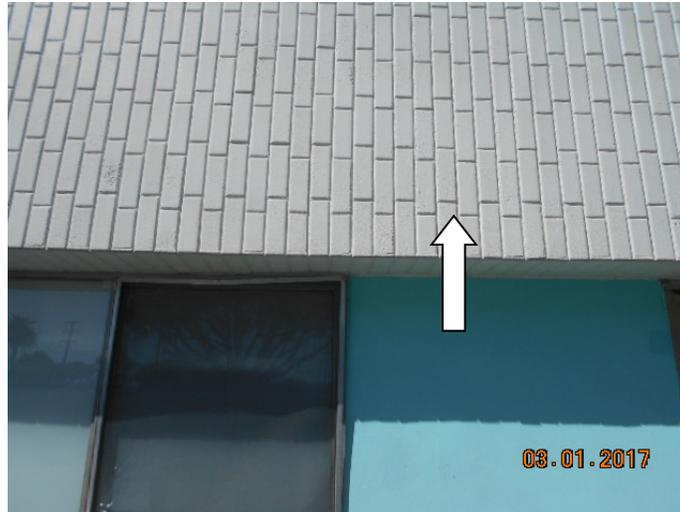
- Exterior decorative brick, all colors. Undamaged. Estimate 1,500 s.f.

Exterior decorative brick – lead-containing

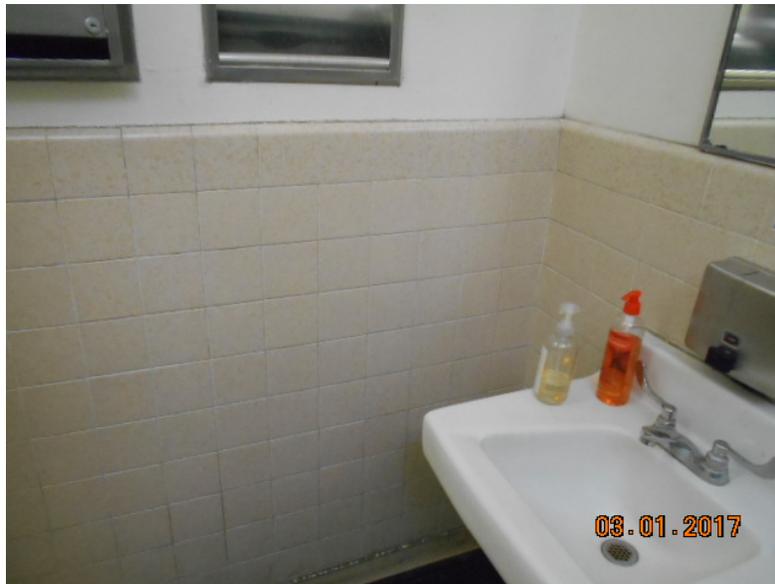
- Interior beige ceramic tile, restroom areas, good condition, app. 700 s.f.

Interior ceramic lead tile

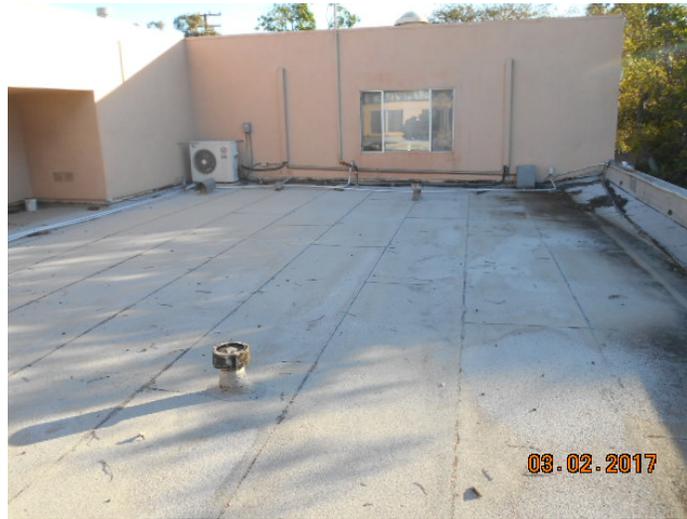
- Exterior beige paint, roof enclosure only

Paint on exterior stucco, roof enclosure only

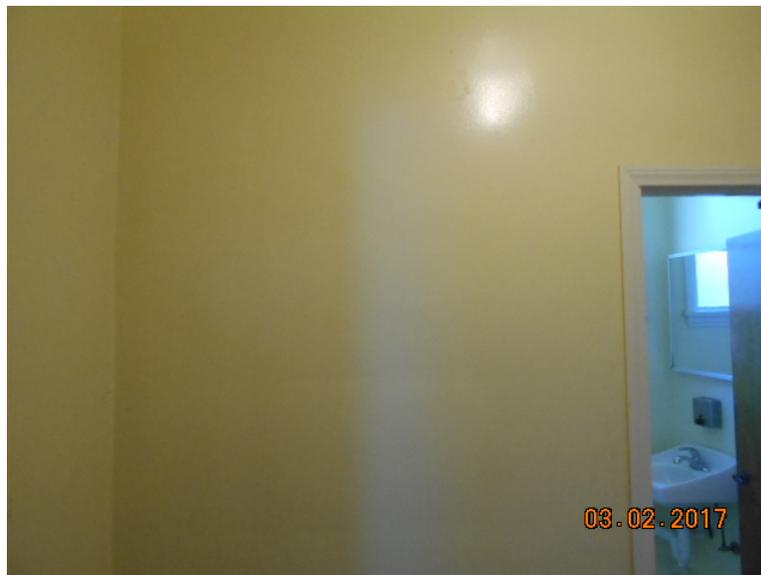
- Yellow paint, men's restroom and entry. Undamaged. 700 s.f.

Yellow paint, men's restroom entry

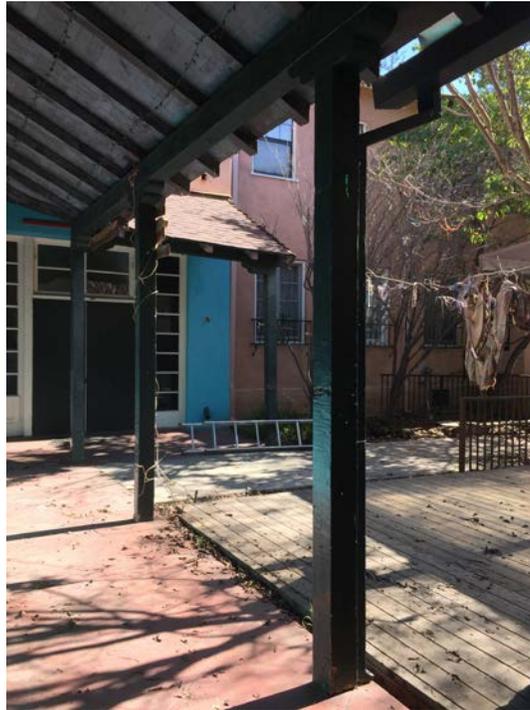
- Dark green exterior paint, posts and entry door. Good condition. Quantity unknown.

Auditorium exterior painted posts

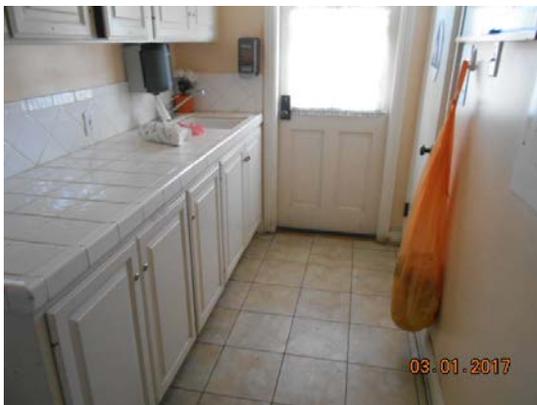
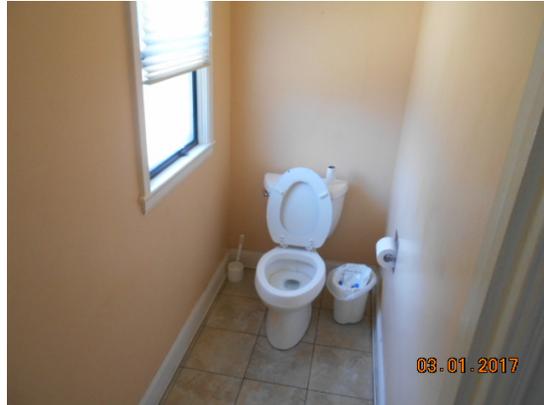
- Beige paint on rear entry walls, baseboards and ceilings, app. 400 s.f., undamaged.

Beige paint on rear entry walls

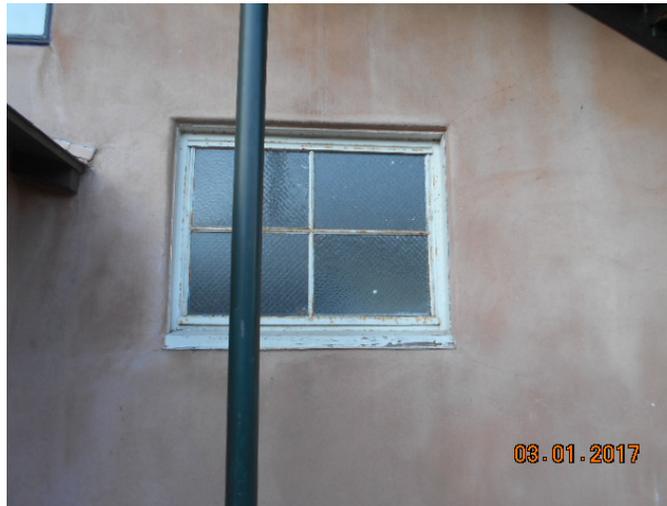
- White paint on original exterior windows. Significant damage. 3 each.

Exterior windows – original.

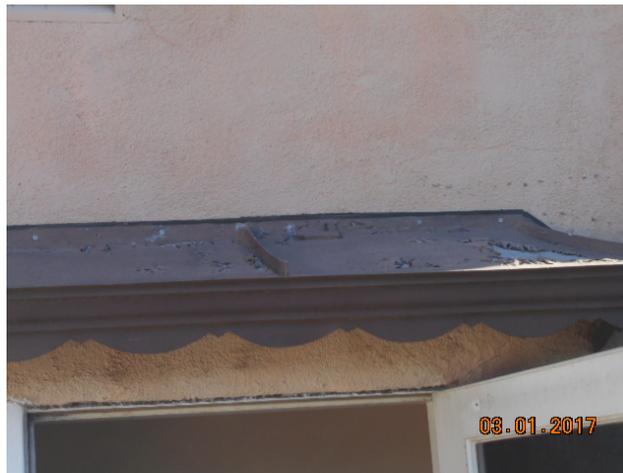
- Brown paint on metal awnings above exterior entries. 2 each. Significant damage.

Dark paint on metal awnings above doorways

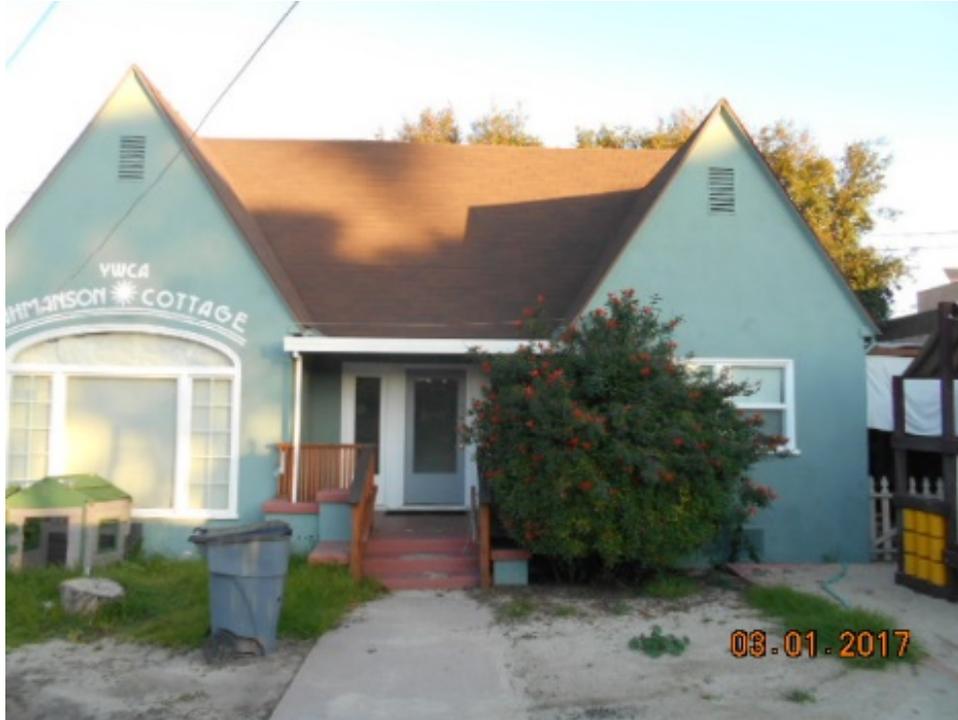
1. West Cottage Home. Front View Looking North. Asbestos in exterior stucco.

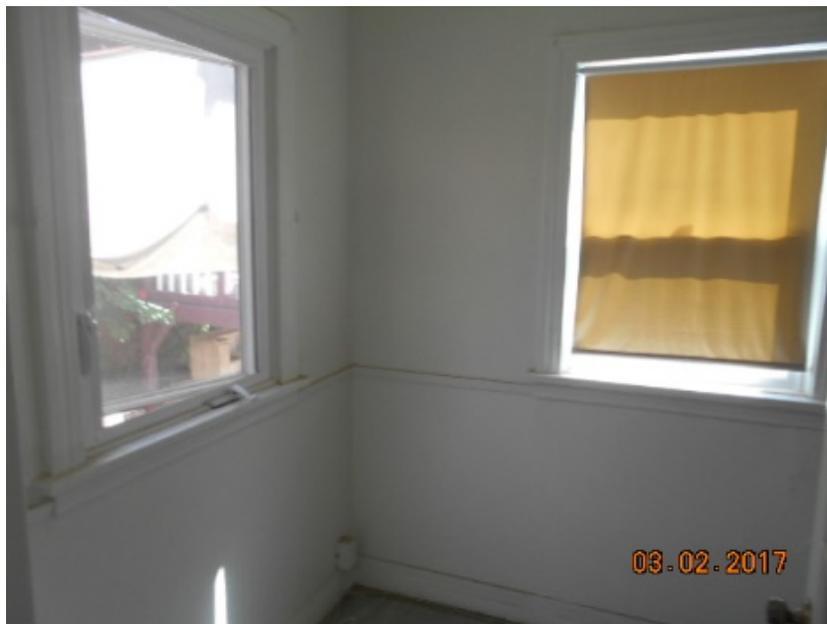
2. Typical bedroom. Interior perimeter walls, window frames and baseboard are covered with intact, undamaged, lead-containing paint.

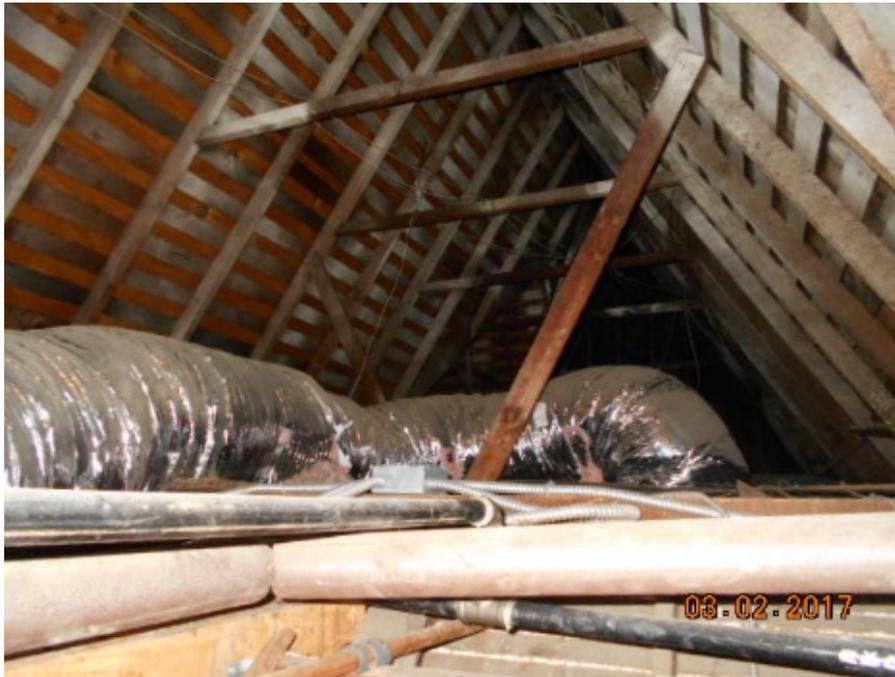
3. Attic space Not shown – kitchen transite vent pipe.

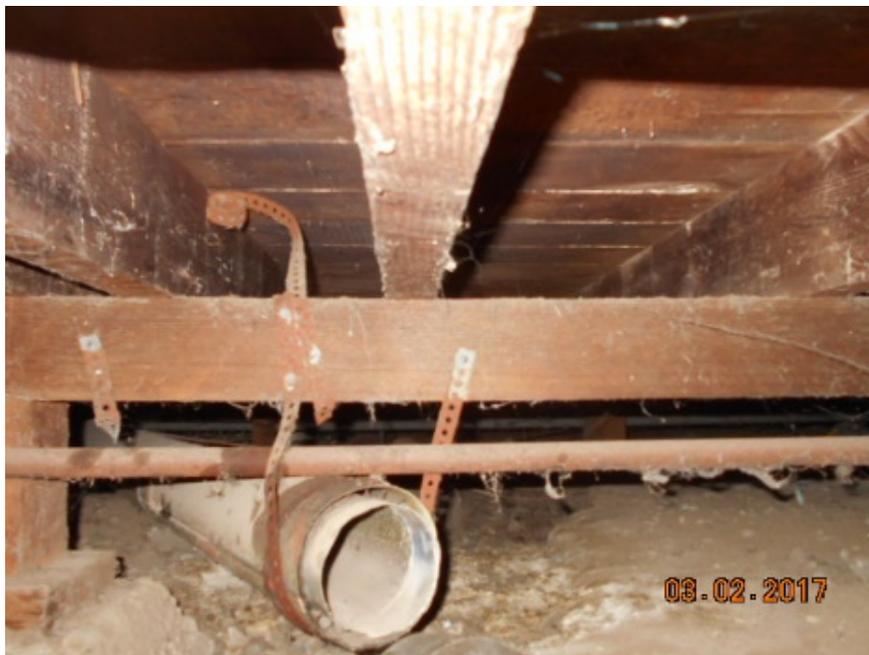
4. Sub-floor air duct pipe. Assumed asbestos wrapping.

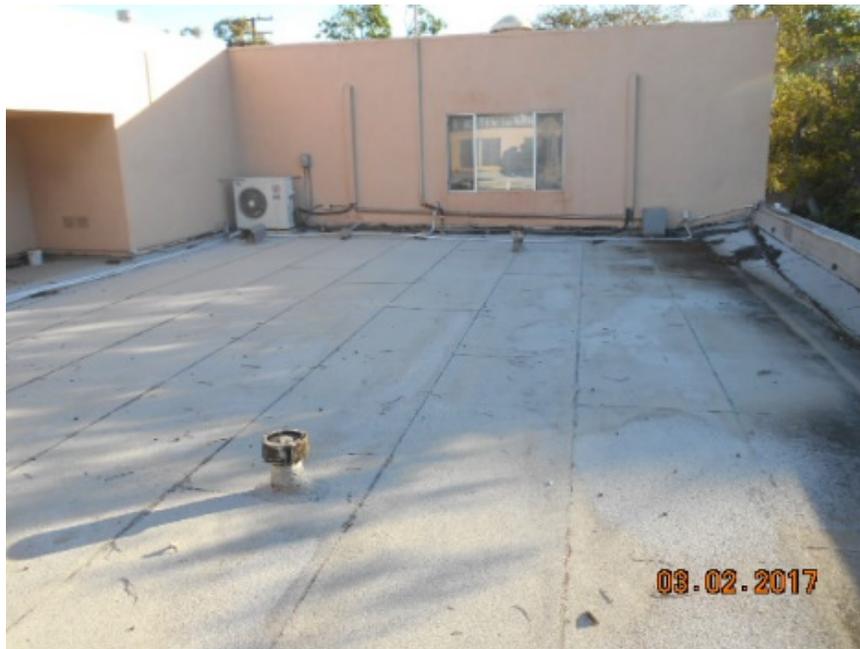
Roof penetration mastics and sealants – asbestos. Lead is present in paint on roof structure stucco.

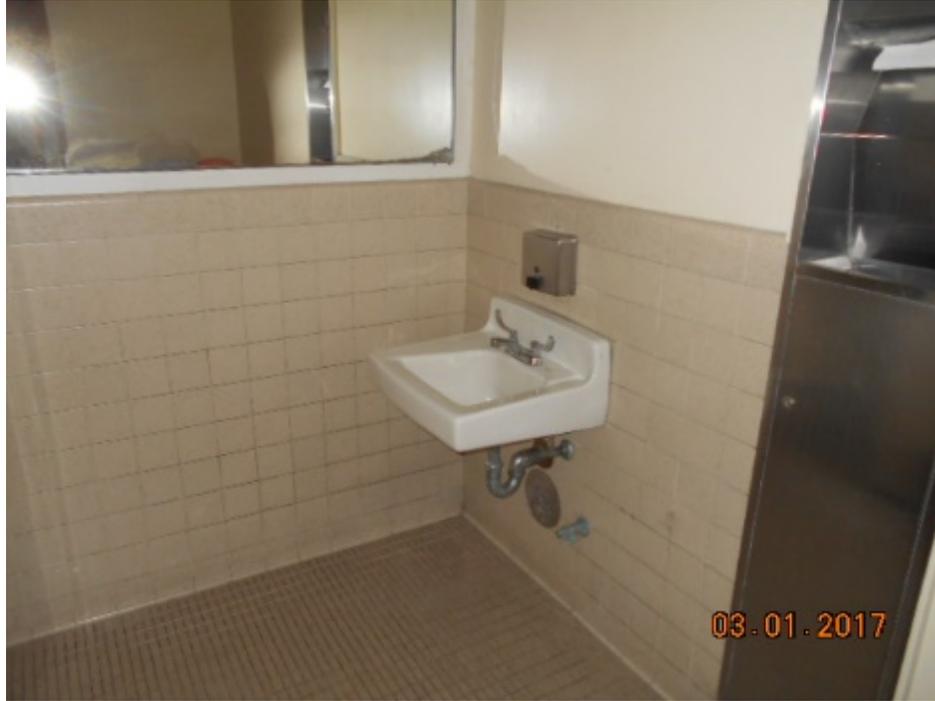
Lead Ceramic Tile

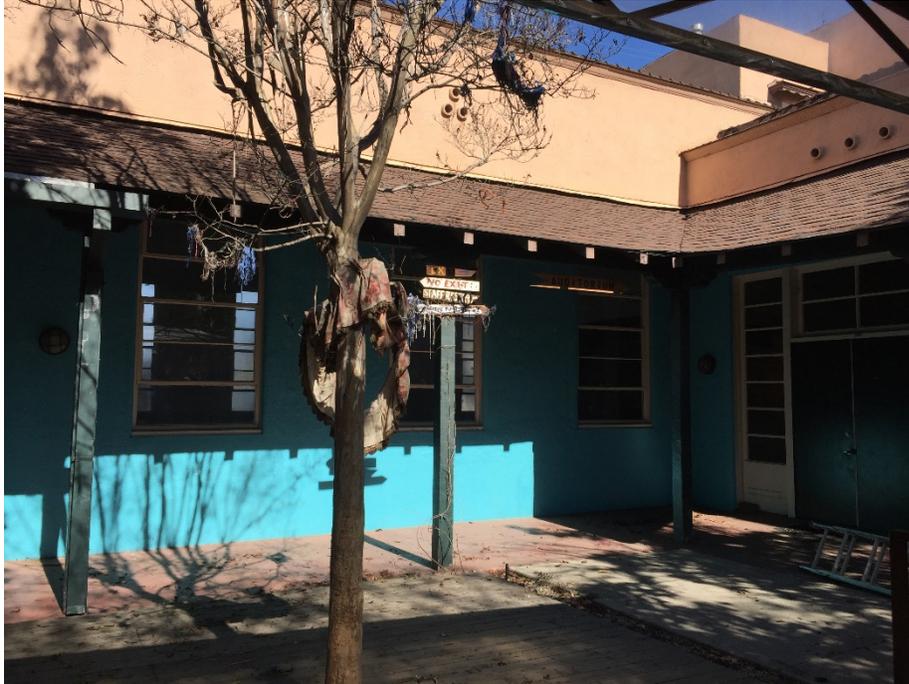
South Exterior Wall. Lead in green paint on posts and double door (only).

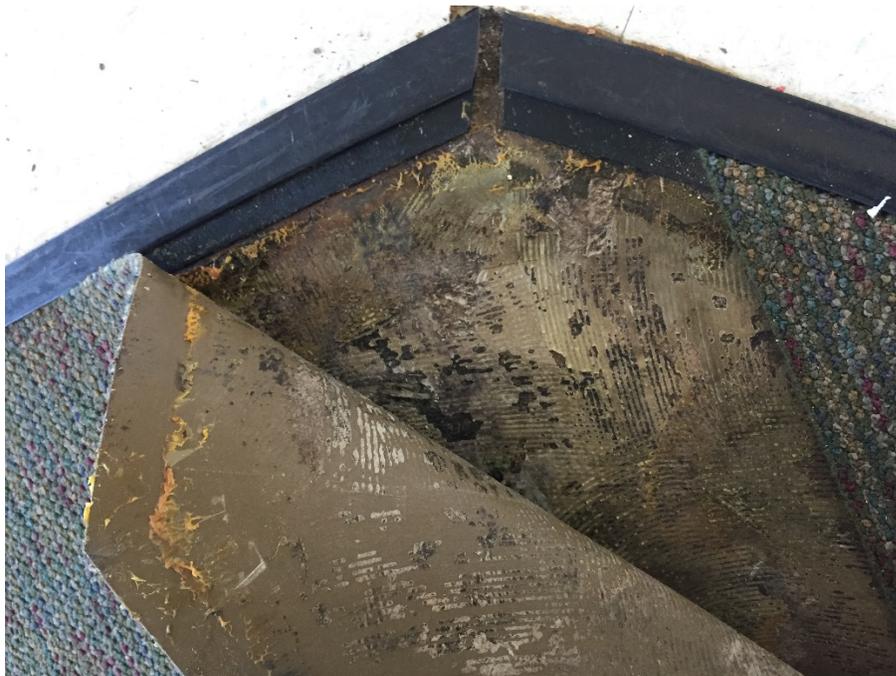
Asbestos Mastic Under Carpet

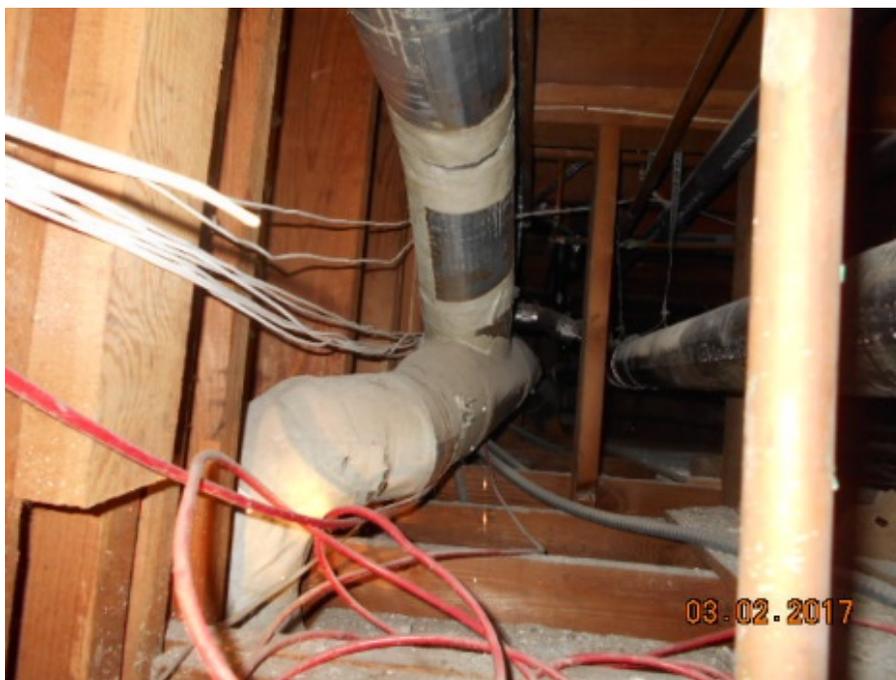
Asbestos Duct Wrapping – Attic

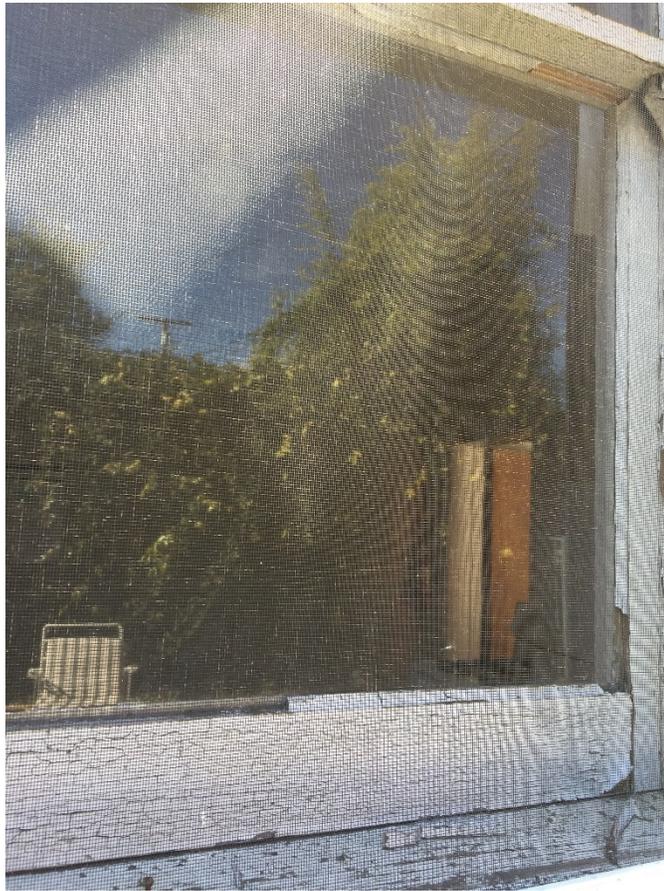
Original white paint on exterior windows and frames is lead-based.

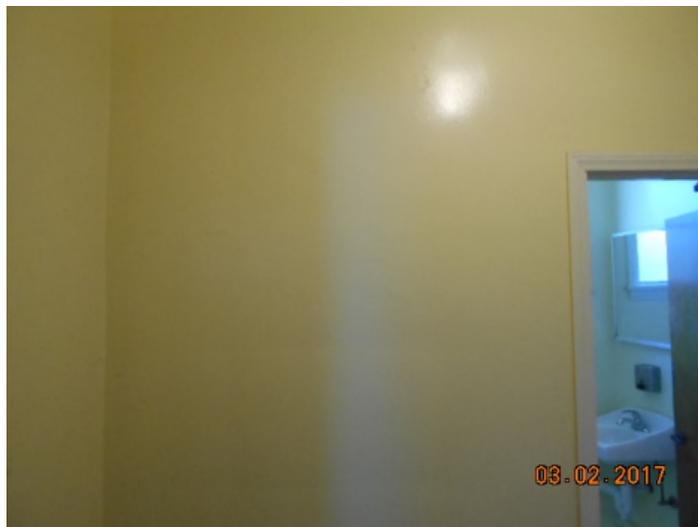
Lead-based, yellow paint at restroom entry area.

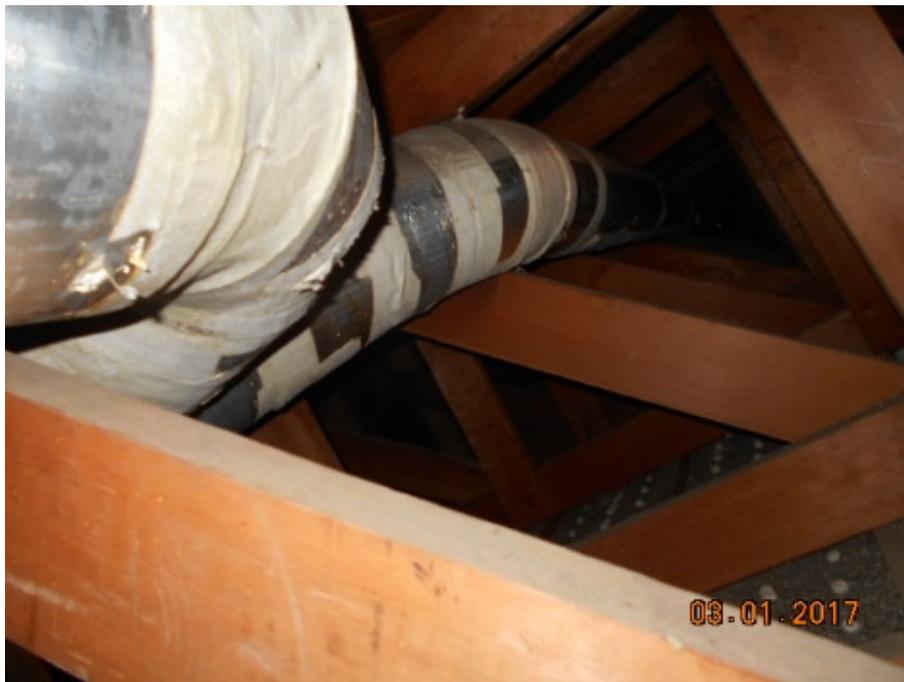
Duct Insulation, Floor 2 crawlspace. Asbestos

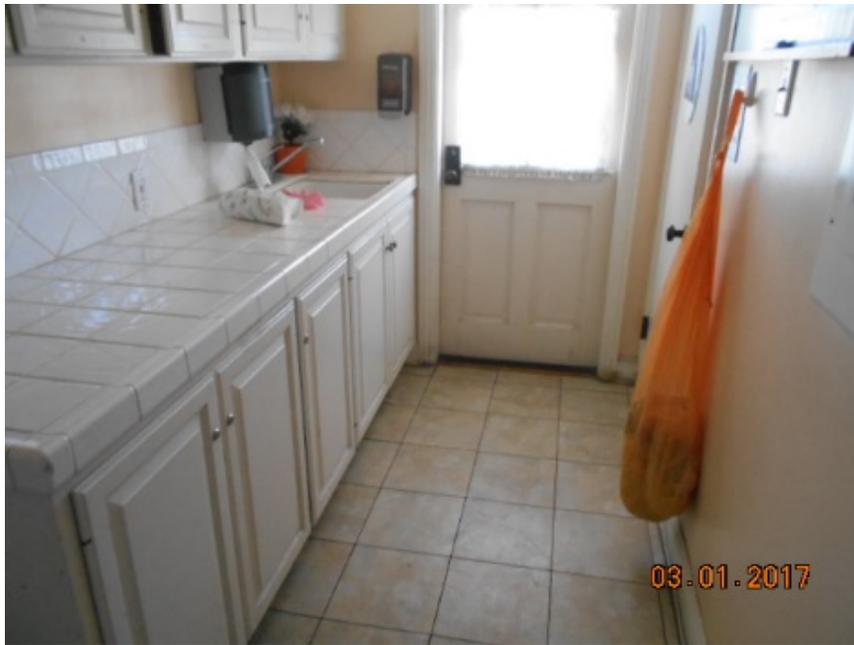
Lead beige paint, rear (east) entry area.

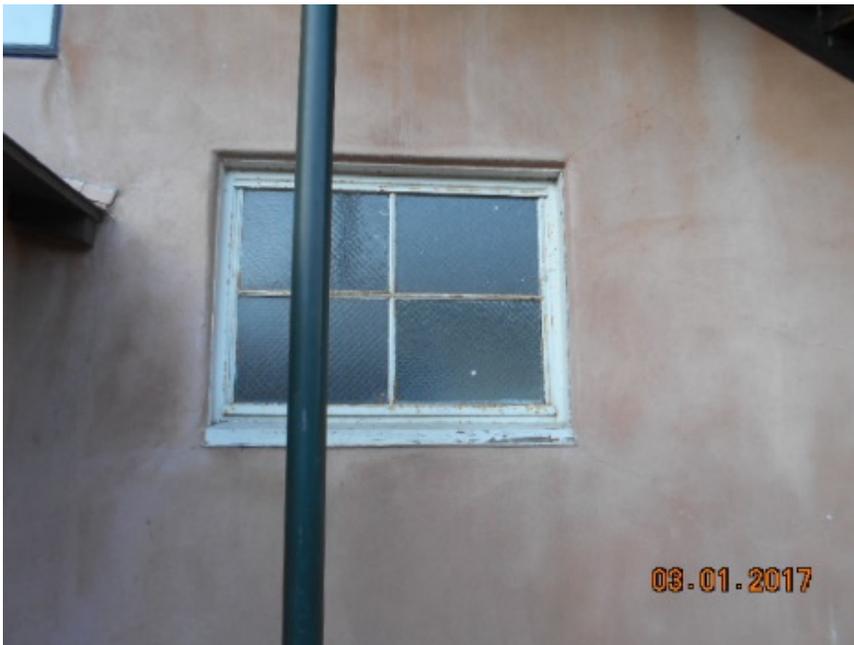
Lead-based white paint on original exterior windows.

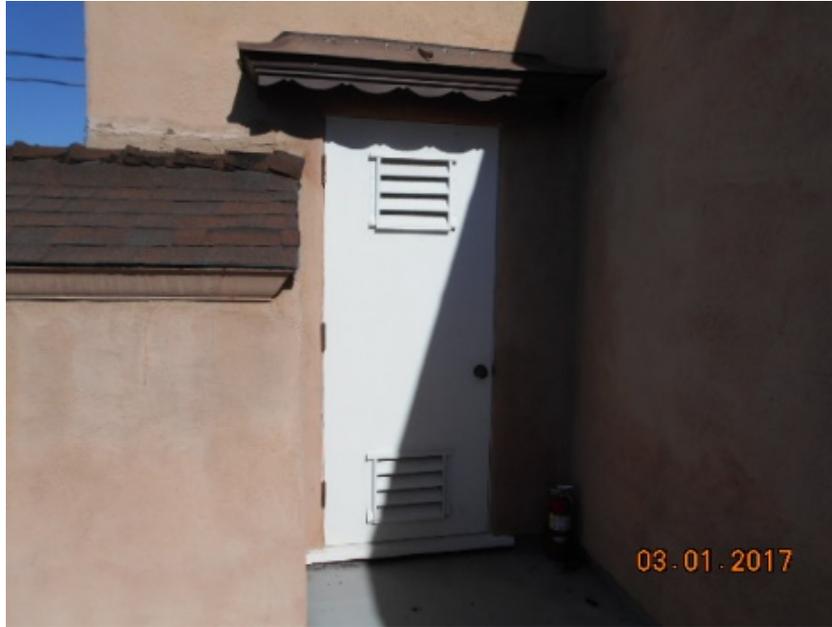
Brown lead paint on metal awnings.

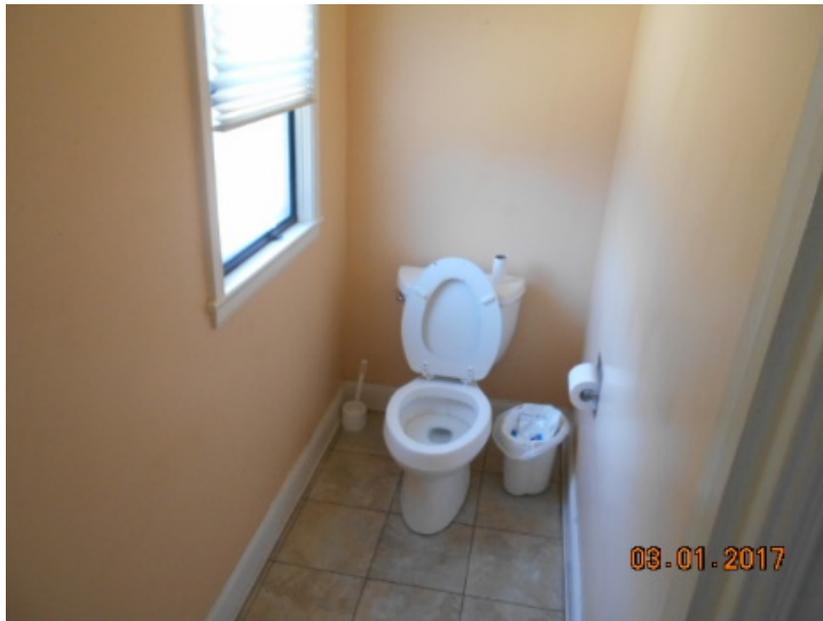
Lead-based paint, rear (east) restroom.
