# SANTA MONICA COLLEGE

## 2040 CAMPUS MASTER PLAN

### FACILITIES CONDITIONS ASSESSMENT

*CREATED JUNE 2020; SUBMITTED JUNE 2024*

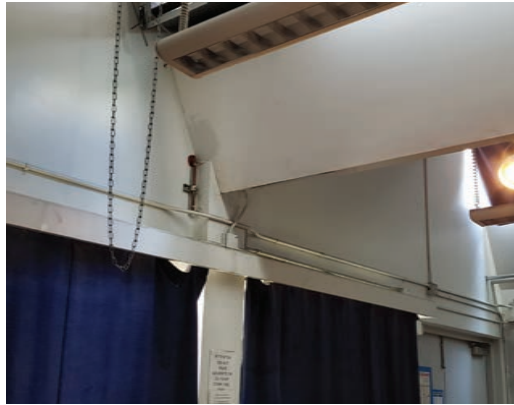
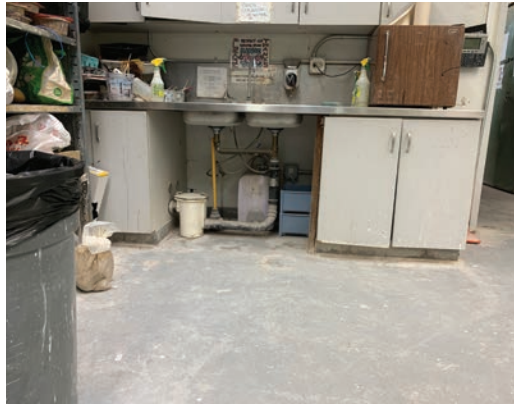
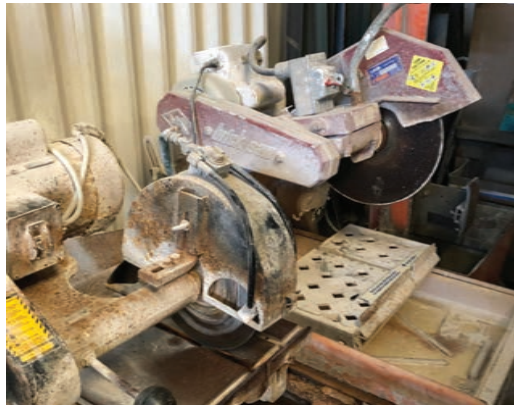
SYSTEM	COMMENTS (CONDITION)	SHORT-TERM RECOMMENDATIONS
<b>ARCHITECTURE/ INTERIORS</b>	<p>Exterior walls are Cast-in-place concrete. Metal doors with panic hardware. Metal and aluminum windows with double or single pane. At the kiln yard, there is significant leakage through the temporary roof structure. Portions of the roof are broken. Entry door for fork lift is too small and inadequate. Floor drains are clogged. Kilns are old and unsafe to use. Air compressor condensates and blows water instead of air. No air circulation at Kiln yard. No student restroom in the building. Circuits are constantly tripping due to overload. Space is not conducive to student observation of instruction in the kiln and glass blowing areas.</p>	<p>Replace roof and potential substrate/substructure due to existing water intrusion; access and accessibility are deficient and all areas will need renovation to bring to current compliance; building services are deficient and must be replaced; restrooms need to be added to the facility; windows and exterior doors to be replaced for energy compliance; likely require exterior wall/roof insulation for energy compliance; potential to replace gutters for proper drainage</p>

<b>STRUCTURE</b>	<p>Structural Assessment noted here is data reported on Fusion, 2017. "The building rests on a slab on/below grade using spread footings at the exterior walls with a partial basement using cast in place concrete walls." Further assessment requires more in-depth investigation.</p>	
<b>MECHANICAL</b>	<p>The single-story buildings have only heating and ventilating systems, which are provided by space heaters installed in the individual classrooms. There are two existing boilers installed in 2012 in the basement mechanical room. However, the gravity flue vent has excessive numbers of elbows in violation of mechanical code and it needs to be corrected. The existing air conditioning system were installed in 2015 and they are in good operating condition. The existing process area dealing with wood dust, ceramics dust and glass, etc. have no dust collection systems intended to evacuate dust from the space. The ceramic shop has no doors separating from the staircase and combustion openings in the boiler room. The staircase and the boiler room is covered with thick layer of dust. This presents environmental hazard and need to be corrected. People working near kilns complained about poor temperature control associated with hot temperature radiating from equipment. There is also no venting system provided for the kilns from what we observed during site visit.</p>	<p>Provide new dust collection system and local exhaust in front of the kilns. Repair or replace kilns emitting excessive amount of heat creating discomfort for people working near them. Modify flue vent as required to bring it in compliance with the code. As an option provide fan assist at the top of the flue vent. Replace outdated HVAC controls. Provide door in the ceramic shop in order to prevent dust spread to other building areas.</p>

SYSTEM	COMMENTS (CONDITION)	SHORT-TERM RECOMMENDATIONS
<b>PLUMBING</b>	<p>This building has multiple plumbing issues. There are two (2) large floor drains on each side of the ceramics / glass area that have been disconnected and filled in. These drains are essential for cleanup as the floors are washed weekly and water should discharge to these drains. Without these drains, cleanup is far more difficult for the staff and students. The chisels, compressed air reels, and sand blaster machines all cannot function properly as water is quickly introduced into the compressed air system. Filters have been added in multiple places, but they cannot keep up with the amount of water entering the system; water is continuously present in the system. The ceramics sink is fitted with an Eemax storage water heater below the sink along with a clay trap. The sink functions, but it should be replaced with a newer model with a new clay trap. The paint room sinks are well covered in paint as expected, but they function properly with Eemax water heaters.</p>	<p>Replace clogged floor drains. Replace worn out but functional sinks and clay trap. Fix or repair air compressor from accumulating water. Due to the age and longterm use, sinks at paint room should also be replaced.</p>

<b>ELECTRICAL</b>	<p>Electrical distribution equipment was replaced in 1998, They were observed to be in fair condition. This building was served from a 150 KVA transformer, 4160 to 120/208 volt, 3 ø, 4W. Main distribution panel was observed to be 600 amps. Lighting in this building were observed to be fluorescent type. There was no observable lighting control found in this building during the visit. We recommend upgrading the light fixtures to more efficient LED type and providing a new lighting control system compliant with the California Title 24 energy code and other applicable codes, for this building.</p>	<p>It was observed that this building still utilizes Cat3 &amp; Cat5 cabling for information technology. It was also found that this building still have 10/100 Mbps switches. We recommend to provide new Cat6A cabling and to provide new 1Gbps or 10Gbps switches.</p>
<b>FIRE SPRINKLERS/ FIRE ALARM</b>	<p>This building was observed to have smoke/heat detectors but don't have Emergency Voice/Alarm Communication System (EV/ACS).</p>

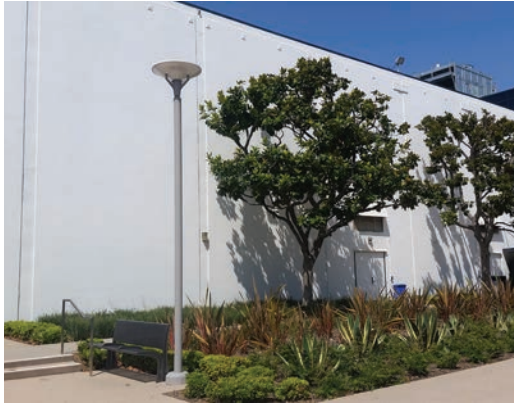
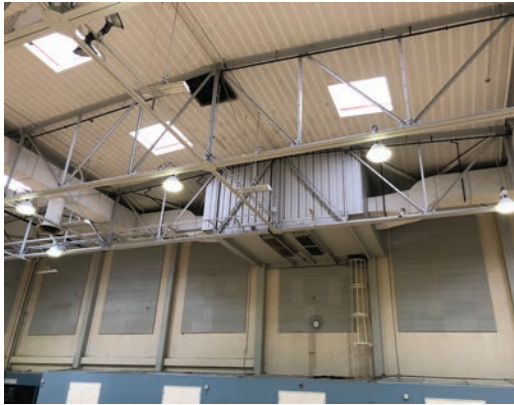
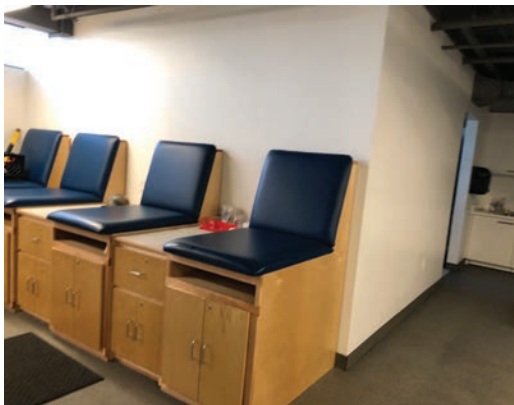
SYSTEM	COMMENTS (CONDITION)	SHORT-TERM RECOMMENDATIONS
<b>ARCHITECTURE/ INTERIORS</b>	<p>The walls of the gymnasium are cast concrete. Roofing system is rolled asphalt. Exterior doors are metal with panic hardware. Walls at the gymnasium space are covered partially with acoustical panels. Floors, walls, and retractable seating is generally in good condition. The large gymnasium space had good lighting with skylights throughout. Hallway walls were in good shape. Building in general did not show any indication of damage.</p>	
<b>STRUCTURE</b>	<p>Structural Assessment noted here is data reported on Fusion, 2017. "The building rests on a concrete slab on and below grade using cast in place concrete spread footings and walls. The main structure is cast concrete using metal truss and metal frame and pan deck."</p>	
<b>MECHANICAL</b>	<p>The building is consisted of a gymnasium, offices for the gym staff, Shower/locker facility and classrooms. The building areas are heated and ventilated only and there is no air conditioning provided to maintain comfort level in the rooms during the summer time. The gymnasium ventilation air is exhausted by roof mounted exhaust fans. Ventilation air in the rest of the occupied spaces is exhausted by wall mounted fans. All HVAC systems and equipment have exceeded useful service life and should be replaced with air conditioning systems. Additionally, since all HVAC equipment is of a constant volume type, the energy waste is high due to the absence of air modulation. Air flow reduction during the time of part load conditions can reduce the energy consumption by about 30 to 40%. Chilled water for the building should be provided by a newly built central plant. The building is connected to the BMS, but the building controls are limited to the monitoring of the HVAC systems.</p>	<p>Replace the existing HVAC heating ventilating units with new equipped with cooling and heating coils. Provide fans with variable frequency drives to modulate supply air CFM. Provide chilled water system connected to the central plant. Modify the HVAC controls to accommodate the change in the equipment functions. Provide environmental ducts cleaning.</p>

SYSTEM	COMMENTS (CONDITION)	SHORT-TERM RECOMMENDATIONS
<b>PLUMBING</b>	<p>The drinking fountains in the gym space are of mixed ages and types. One group is very old and should be replaced while the other set is rather new, but needs maintenance repairs. It is suggested that both be replaced. The locker rooms and restroom areas are newer and in good operating condition with automatic sensor-type flushometers and faucets; all fixtures have minimal cosmetic wear. No suggestions for upgrades are suggested in these areas.</p>	<p>Only replace drinking fountains at this time.</p>
<b>ELECTRICAL</b>	<p>Electrical distribution equipment was observed to be per original construction. They were observed to be in fair condition. This building was served from a 500 KVA transformer, 4160 to 120/208 volt, 3 ø, 4W. Main distribution panel was observed to be 1400 amps. Lighting in this building were observed to be high bay hid type. Lighting control for this building were also from original built-out using lighting contractors and time clocks. We recommend installing new lighting controls compliant with the California Title 24 energy code and other applicable codes, for this building.</p>

<b>FIRE SPRINKLERS/ FIRE ALARM</b>	<p>There was no smoke detector nor heat detector found in these building. Only fire alarm horns and strobe were found within this building. There was no Emergency Voice/Alarm Communication System (EV/ACS) found in this building. We are recommending for a fire alarm upgrade for this building.</p>

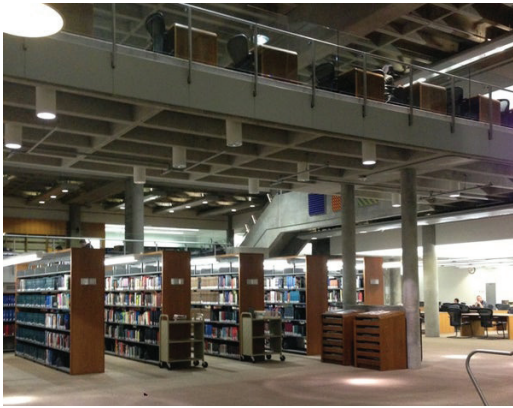
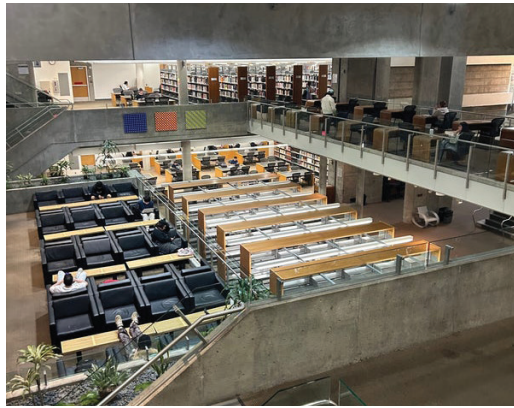
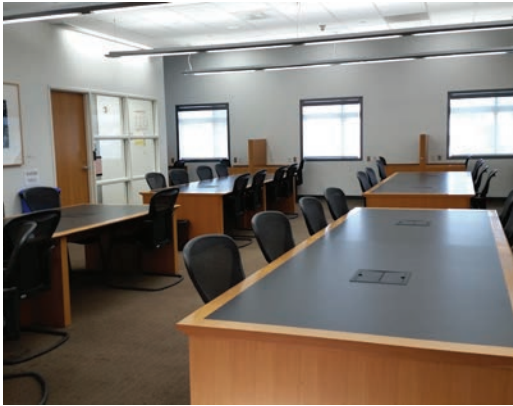
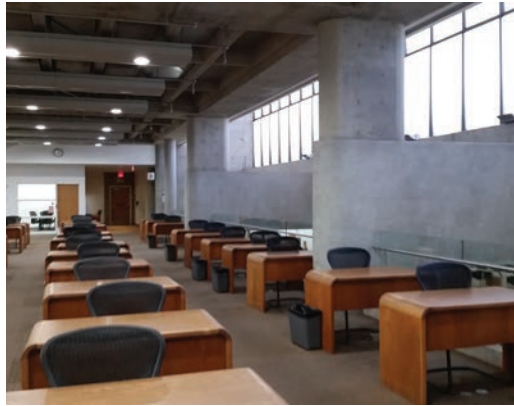
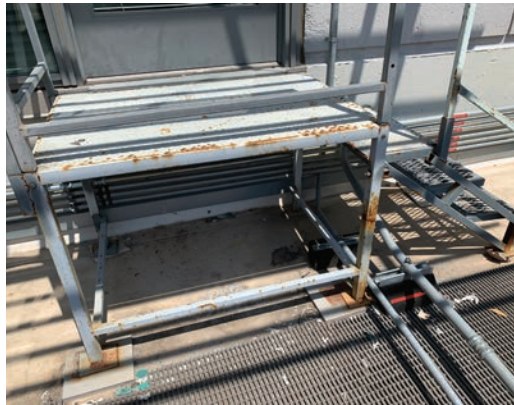
SYSTEM	COMMENTS (CONDITION)	SHORT-TERM RECOMMENDATIONS
<b>ARCHITECTURE/ INTERIORS</b>	<p>The library building is cast concrete. Main entrance doors are aluminum framed store front. Windows are fixed dual pane. Interior walls are mostly concrete and some painted gypsum. Interior doors are metal and wood in metal and wood frames. Study rooms Ceilings are painted gypsum with acoustic tiles in study areas, otherwise exposed concrete in the main open areas. Majority of floor finish is carpet which is old and needs maintenance. Carpet in areas near stair landings was loose and could result in tripping hazard. Roof is in generally good condition. Solar panels need cleaning. Overall acoustic and temperature is adequate. Lighting is poor in open study areas. Metal penthouse wall siding has areas of peeling paint. Steel canopy structure at the entrance is rusted. In general the building and finishes are in good condition.</p>	<p>Some maintenance and upkeep of finishes; sand and paint canopy, mechanical penthouse walls, and other metal structures to arrest and inhibit rust; clean carpeting; repair areas of loose or damaged carpeting; some exterior ductwork may need to be painted to address rusting.</p>

<b>STRUCTURE</b>	<p>Structural Assessment noted here is data reported on Fusion, 2017.          “The building rests on a concrete slab on and below grade with spread footings at exterior walls. The main structure is cast concrete with metal framing and pan deck.”</p>	
<b>MECHANICAL</b>	<p>Library and Media center is approximately 40 years old and within the last ten years it went through a number of remodeling. The building is served by two large VAV custom built air handling units located on the building roof and delivering supply air to the individual comfort zones via VAV boxes with terminal reheat. The units are approximately 10 years old they are in good operating condition, but the units’ exterior shows signs of rust. The building has large thermal mass, which helps with storing cooling during the night time. Two existing 90-ton chillers have been reconnected into the booster loop operation at the time of the library building connection to the new central plant. This allows the use of the chillers when the central plant is not running. The majority of VAV boxes are existing and may need to be retrofitted with new controls.</p>	<p>Provide environmental ducts cleaning. Retrofit the existing VAV boxes with new controls. Remove rust and repaint portions of the frames and unit housing.</p>

SYSTEM	COMMENTS (CONDITION)	SHORT-TERM RECOMMENDATIONS
<b>PLUMBING</b>	<p>The age and condition of the water closets differ from restroom to restroom within the library area. Most are in good condition with automatic sensor-type flushometers while some are older with discolored seats. The urinals are in good condition also with automatic sensor-type flushometers. Some restrooms have lavatory faucets that are manual while others have the automatic sensor-type. Despite the variances, the lavatories and faucets are all in good condition. Some restrooms are served by small electric AO Smith 19 gallon, 6,000 W water heaters, all of which are identical and new. The other section of the building hot water is served by a 2017 Bradford White 48 gallon, 55,000 BTU gas-fired storage type water heater. Only minor upgrades are recommended for the water closets.</p>	<p>Review water closet individually for replacement. No other work needed at this time.</p>

<b>ELECTRICAL</b>	<p>This building was remodeled around 2014. Electrical distribution equipment was observed to be replaced during that construction. They were observed to be in good condition. Electrical building service was found to be 3000 amps, 277/480 volt, 3 ø, 4W. Lighting in this building were observed to be fluorescent type. Lighting control for this building was observed to have combination of lighting control panel and motion sensors. We recommend upgrading the light fixtures to more efficient LED type and providing a new lighting control system compliant with the California Title 24 energy code (which would require additional lighting control devices such as dimmers, daylight harvesting sensors, etc.) and other applicable codes, for this building.</p>	
<b>FIRE SPRINKLERS/ FIRE ALARM</b>	<p>This building was observed to have smoke/heat detectors but don't have Emergency Voice/Alarm Communication System (EV/ACS).</p>

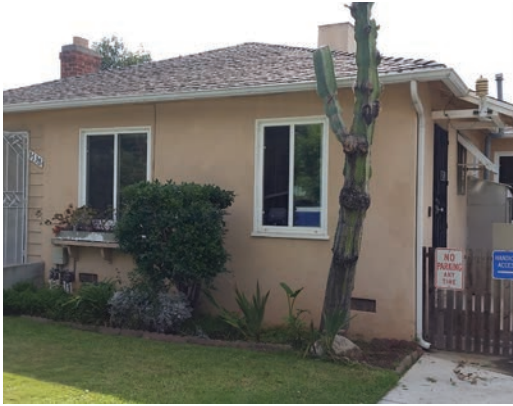
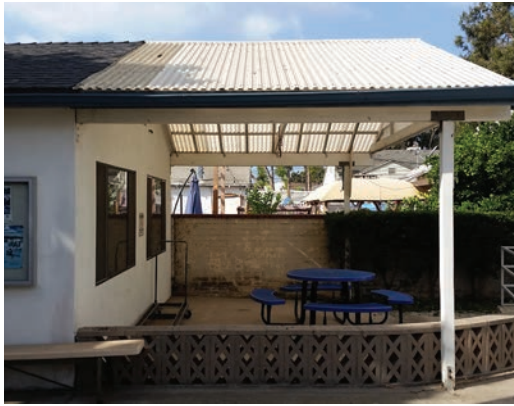
<b>MECHANICAL</b>	<p>Residential space converted for commercial use. The split 3-ton air conditioning system has exceeded useful service life and shall be replaced with the energy efficient equipment. Duct cleaning will help to improve the indoor air quality.</p>	<p>Revise the HVAC system to deliver the code required minimum amount of outside air during the occupied building hours. Provide building connection to the campus BMS for monitoring.</p>
<b>PLUMBING</b>	<p>The lavatories and water closets are in average condition. No regent repairs need.</p>	<p>If hot water is desired for the kitchen sink, provide insta hot water heater. No other work needed.</p>

SYSTEM	COMMENTS (CONDITION)	SHORT-TERM RECOMMENDATIONS
<b>ELECTRICAL</b>	<p>We observed this building or structure to be within residential zone. Electrical distribution equipment was observed to be per original construction. We found electrical service equipment to be in fair condition. Service for this building was observed to be 200 amps, 120/240 volt, 1 ø, 3W. Lighting in this building were observed to be fluorescent type. We observed absence of motion sensors for lighting control within rooms and hallways. We also observed the absence of fire life safety devices such as smoke detectors, and fire alarm pull stations. We recommend upgrading the light fixtures to more efficient LED type and providing a new lighting control system compliant with the California Title 24 energy code (which would require additional lighting control devices such as dimmers, daylight harvesting sensors. Etc.) and other applicable codes, for this building. We also recommending updating fire life safety system for compliance to latest code.</p>	<p>It was observed that this building still utilizes Cat3 &amp; Cat5 cabling for information technology. It was also found that this building still have 10/100 Mbps switches. We recommend to provide new Cat6A cabling and to provide new 1Gbps or10Gbps switches.</p>

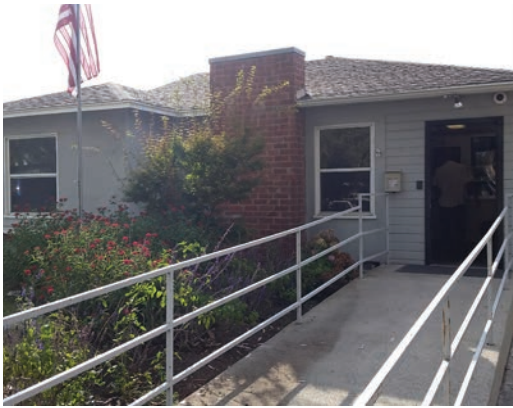
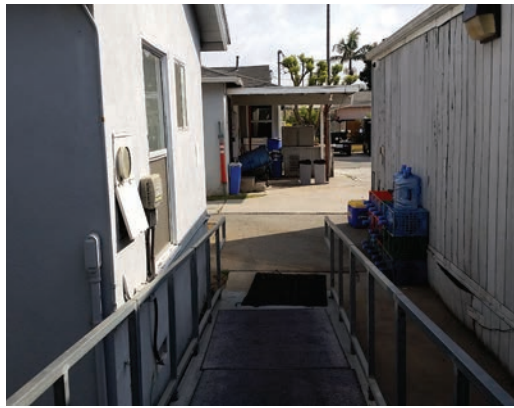
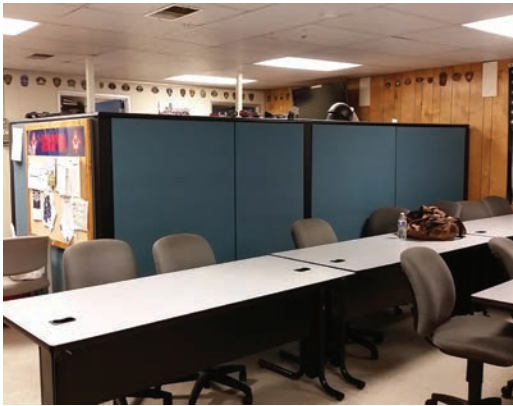
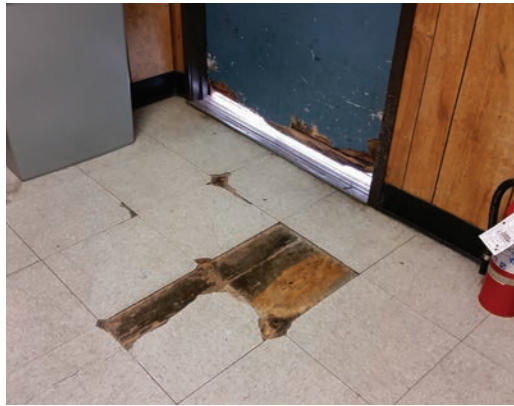
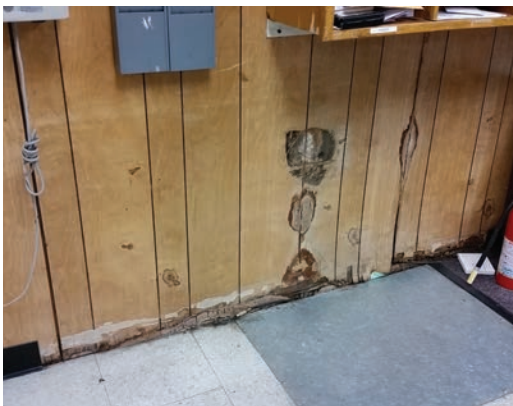
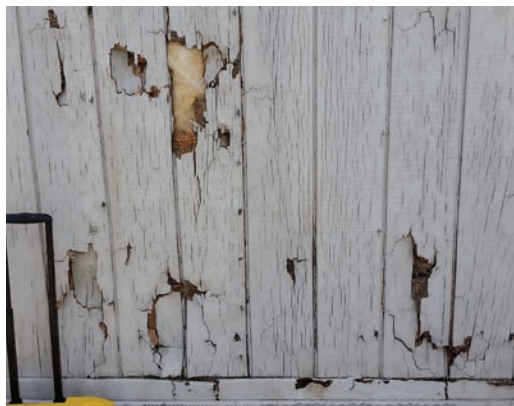
<b>MECHANICAL</b>	<p>Residential space converted for commercial use. The split 3-ton air conditioning system has exceeded useful service life and shall be replaced with the energy efficient equipment. Duct cleaning will help to improve the indoor air quality.</p>	<p>Revise the HVAC system to deliver the code required minimum amount of outside air during the occupied building hours. Provide building connection to the campus BMS for monitoring.</p>
<b>PLUMBING</b>

SYSTEM	COMMENTS (CONDITION)	SHORT-TERM RECOMMENDATIONS
<b>ELECTRICAL</b>	<p>We observed this building or structure to be within residential zone. Electrical distribution equipment was observed to be per original construction. We found electrical service equipment to be in fair condition. Service for this building was observed to be 200 amps, 120/240 volt, 1 ø, 3W. Lighting in this building were observed to be fluorescent type. We observed absence of motion sensors for lighting control within rooms and hallways. We also observed the absence of fire life safety devices such as smoke detectors, and fire alarm pull stations. We recommend upgrading the light fixtures to more efficient LED type and providing a new lighting control system compliant with the California Title 24 energy code (which would require additional lighting control devices such as dimmers, daylight harvesting sensors, etc.) and other applicable codes, for this building. We also recommending updating fire life safety system for compliance to latest code.</p>	<p>It was observed that this building still utilizes Cat3 &amp; Cat5 cabling for information technology. It was also found that this building still have 10/100 Mbps switches. We recommend to provide new Cat6A cabling and to provide new 1Gbps or10Gbps switches.</p>

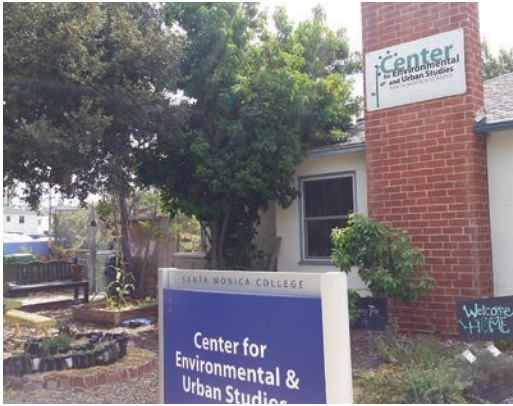
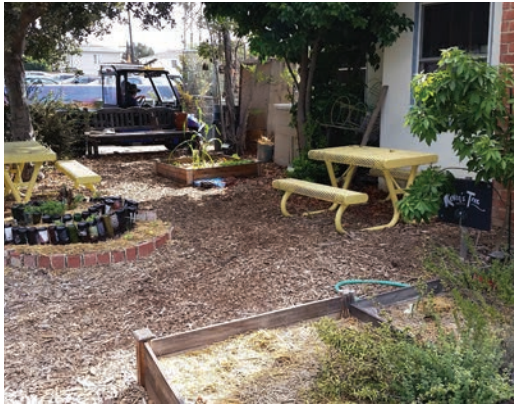
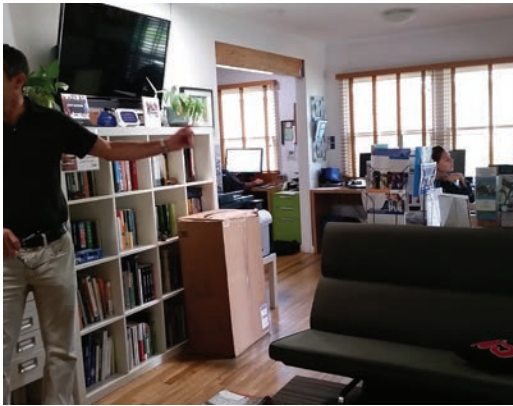
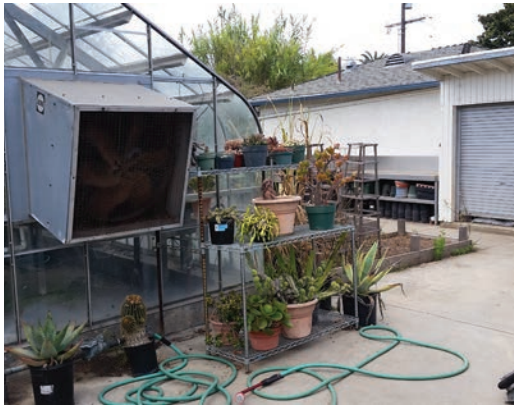
<b>PLUMBING</b>	<p>All fixtures are in great condition. No work need in this building</p>	<p>No work needed</p>

SYSTEM	COMMENTS (CONDITION)	SHORT-TERM RECOMMENDATIONS
<b>ELECTRICAL</b>	<p>We observed this building or structure to be within residential zone.</p> <p>We observed this building or structure had been recently remodeled approximately within 10 - 12 years. Electrical distribution equipment was observed to be per original construction. We found electrical service equipment to be in fair condition. Service for this building was observed to be 60 amps, 120/240 volt, 1 ø, 3W. Lighting in this building were observed recently updated with LED fixtures and 'SOLAR' Tubes to bring sunlight to interior spaces. We observed advance energy management controls for lighting and energy controls. We also observed the absence of fire life safety devices such as smoke detectors, and fire alarm pull stations. We are also recommending having minimum number of smoke detectors and pull station for code compliance.</p>
