**Facility Executive Summary**

**Facility:** Santa Monica Community College\Southeast Quadrant\Environmental Studies

Facility Cost Summary

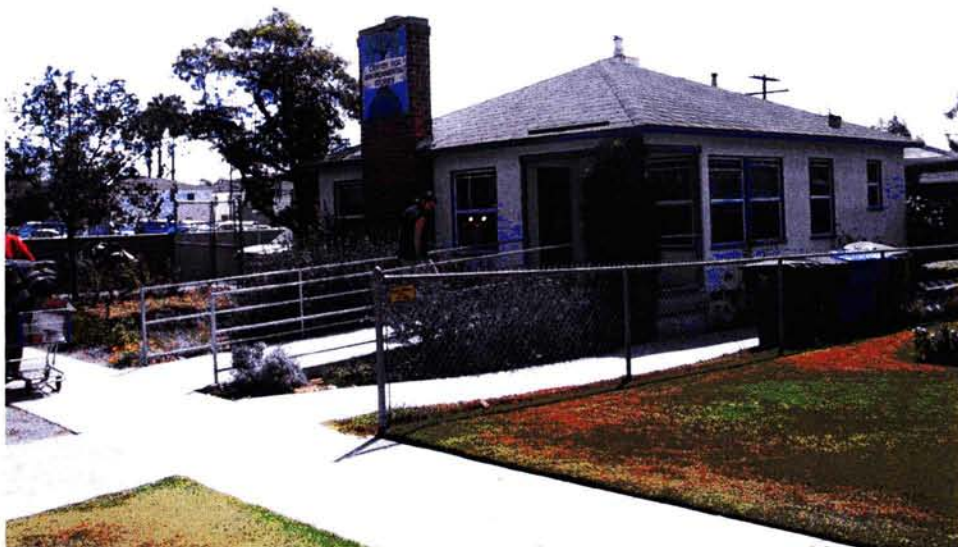
Environmental Studies, Southeast Quadrant

The building rests on continuous spread footings and a raised floor that are showing no signs of settlement. The building's structural system was constructed of wood joists, studs and rafters. The exterior skin is cement plaster and wood siding. The composition tile roof does not leak but it is beyond its useful life and should be replaced.

The building does not contain a fire alarm system and is not generally handicap accessible; the only accessible element is a ramp to the main entrance.

The electrical system is fed with a 100-amp sub feed from a 200-amp, 120/240 volt, single phase metered service mounted on the green house at the rear of the property. The sub panel is residential grade and feeds lighting and power circuits throughout the building. The original wiring is romex and should be upgraded and replaced.

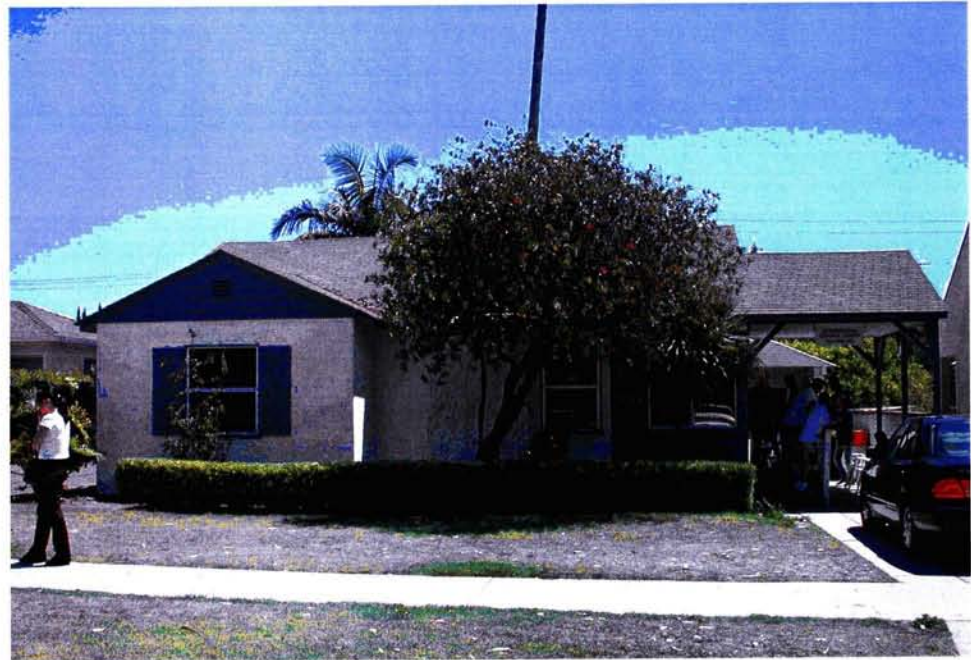
International Ed. Counseling

The building rests on continuous spread footings and a raised floor that are showing no signs of settlement. The building's structural system was constructed of wood joists, studs and rafters. The exterior skin is cement plaster and wood siding. The 3-tab asphalt shingle roof does not leak but it is beyond its useful life and should be replaced.

The building does not contain a fire alarm system and is not generally handicap accessible; the only accessible element is a ramp to the main entrance.

The electrical system is fed with a 100-amp sub feed from a 200-amp, 120/240 volt, single phase metered service mounted on the green house at the rear of the property. The sub panel is residential grade and feeds lighting and power circuits throughout the building. The original wiring is romex and should be upgraded and replaced.

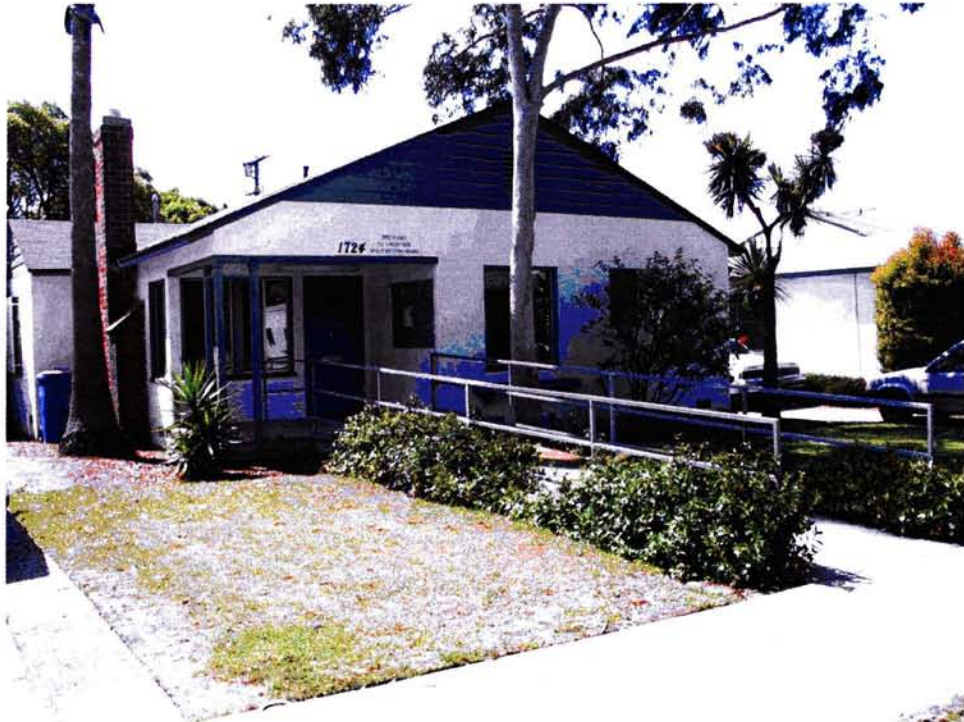
**Photo Description:** Institute Research, Southeast Quadrant

The building rests on continuous spread footings and a raised floor that are showing no signs of settlement. The building's structural system was constructed of wood joists, studs and rafters. The exterior skin is cement plaster and wood siding. The 3-tab asphalt shingle roof does not leak but it is beyond its useful life and should be replaced.

The building does not contain a fire alarm system and is not generally handicap accessible; the only accessible element is a ramp to the main entrance.

The electrical system is fed with a 100-amp sub feed from a 200-amp, 120/240 volt, single phase metered service mounted on the green house at the rear of the property. The sub panel is residential grade and feeds lighting and power circuits throughout the building. The original wiring is romex and should be upgraded and replaced.

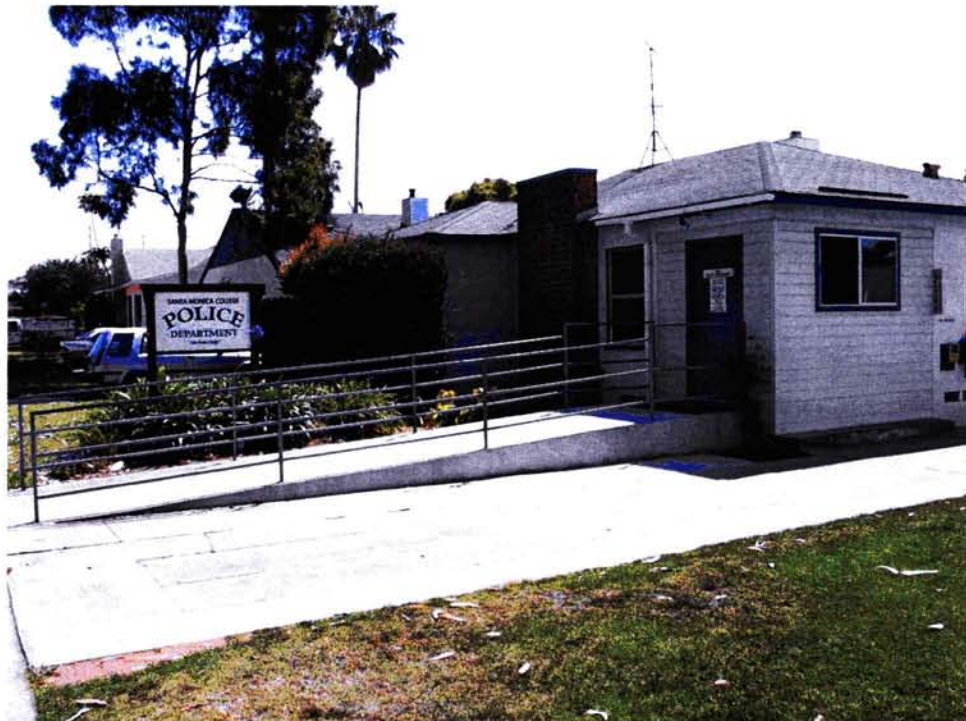
Campus Police, Southeast Quadrant

There is no sprinkler system and compliance with handicap requirements is minimal.

These systems are typical of fifty-year-old homes and need to be updated.

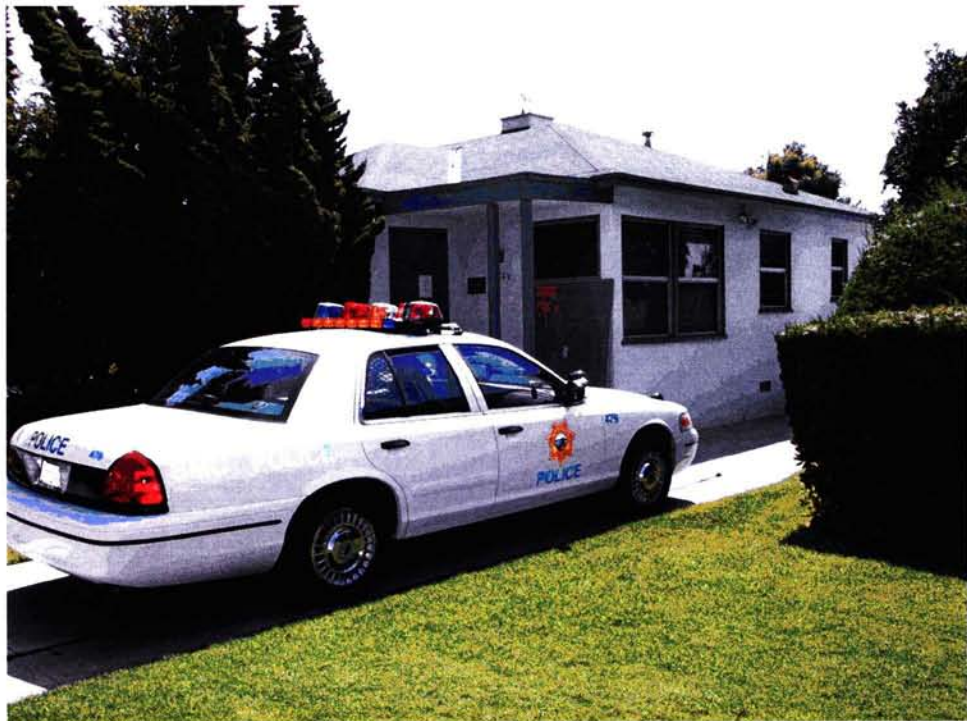
Campus Police Annex, Southeast Quadrant

There is no sprinkler system and compliance with handicap requirements is minimal.

These systems are typical of fifty-year-old homes and need to be updated.
