### Facility Executive Summary

**Facility:** Santa Monica Community College\Southeast Quadrant\Counseling Annex

Facility: Santa Monica Community College\Northeast Quadrant\Art Complex

**Facility:** Santa Monica Community College\Northeast Quadrant\Amphitheater

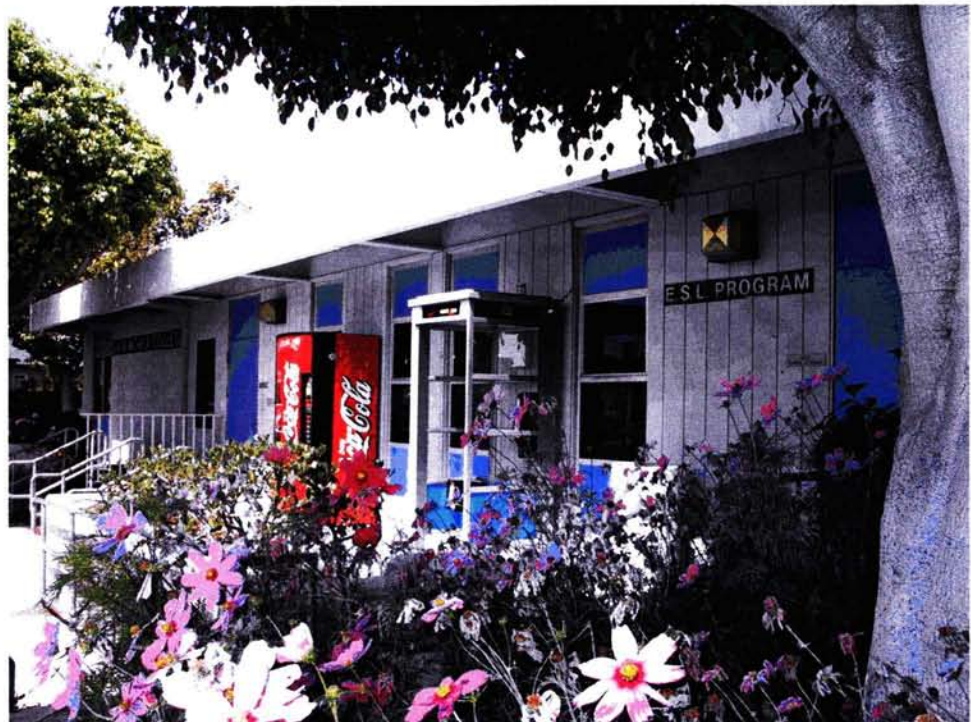
This facility lacks both fire sprinklers and a centrally monitored fire alarm system. Additionally, the building is not handicap compliant, lacking accessible toilets.

ESL, Southwest Quadrant

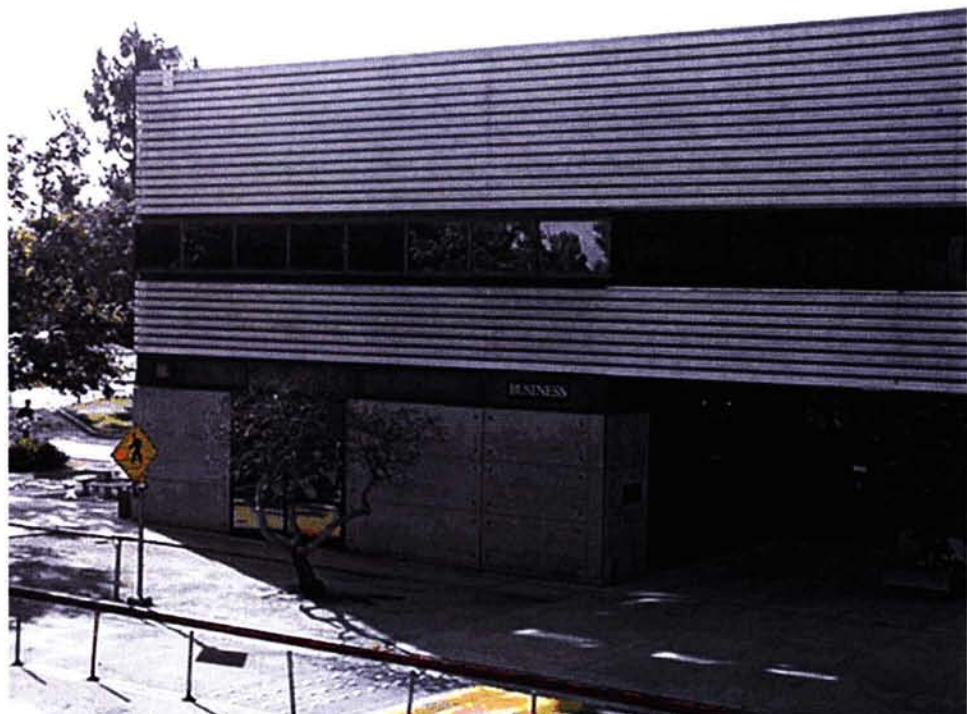
The Business Building is located in the northwest quadrant of the campus. The one (2) story, 53,772 square foot facility was originally constructed in 1980. The second floor is built around a balcony which overlooks the first floor atrium courtyard.. This facility houses: cosmetology and fashion design as well as other related fields.

The interior finishes include concrete and ceramic tile in the lobby, carpet and VCT in the classrooms, and ceramic tile in the restrooms. The roofing is a membrane system which has some minute leaks.

There are several roof mounted toilet exhaust fans that are original equipment installed in 1980. The Cosmetology department has a separate large exhaust fan that is scheduled for replacement in the near future.
