Facility Executive Summary

Facility: Santa Monica Community College\Southeast Quadrant\Greenhouse

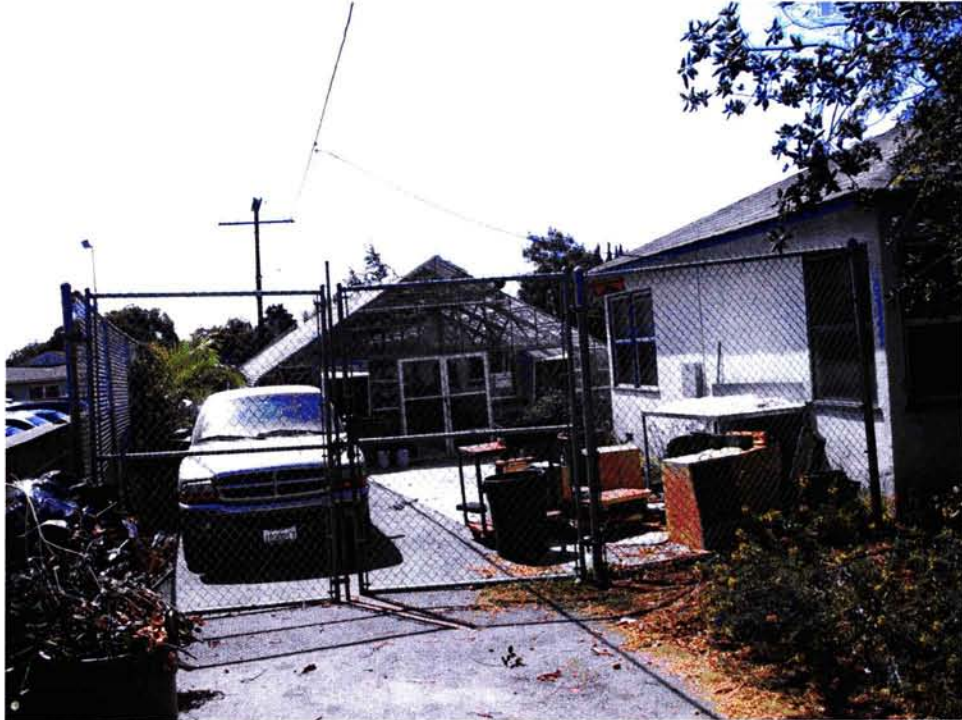
Greenhouse, Southeast Quadrant

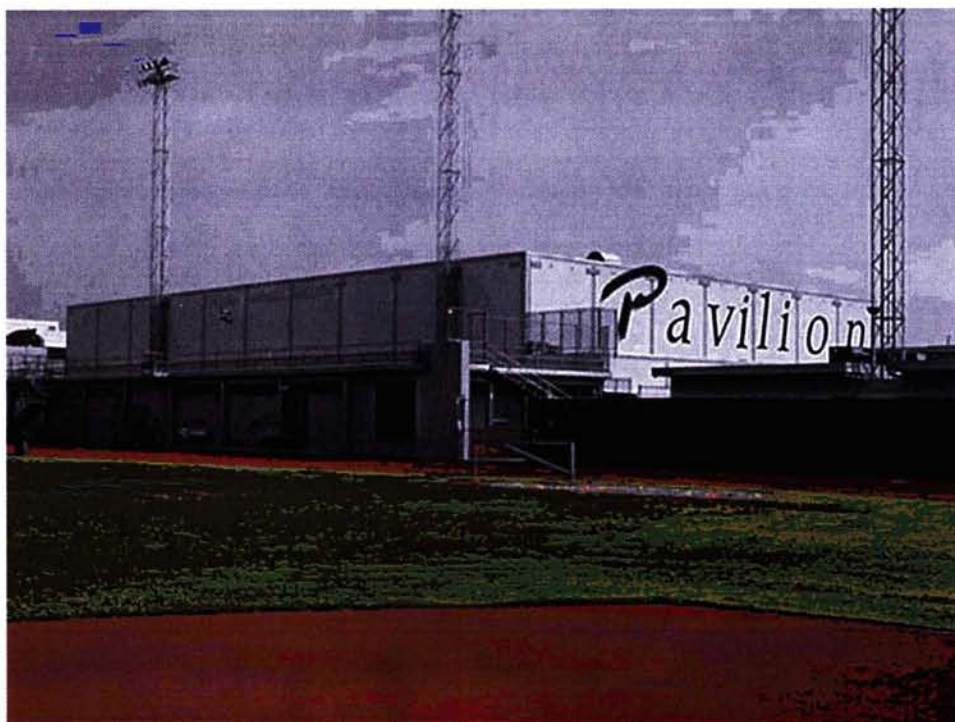
The complex rests on spread footings that are showing no signs of damage or settlement. The gymnasium roof suffered severe damage to all of the perimeter ledger locations at the roof level requiring a seismic retrofit and bracing in 1996. The asbestos in the roof was abated in 2000 and a modified bituminous roof system was installed at that time. The roof is not experiencing any leaks.

The interior flooring in the classrooms is 12" x 12" V.C.T. and is in need of replacement. The classrooms and halls have 2" x 4" tegular ceiling tiles. The ceiling in the gym is an exposed metal truss system. The interior non-bearing walls are constructed of metal studs and cement plaster. The interior and exterior wood doors were replaced in 2000.

The elevator is ADA accessible as are the ground level toilets. The fire alarm system is not centrally monitored and the facility is not equipped with strobe or audio fire alarms. Illuminated exit signs and pull-down fire alarms were present.

All equipment within this building is obsolete, beyond its useful life, and should be replaced and upgraded.

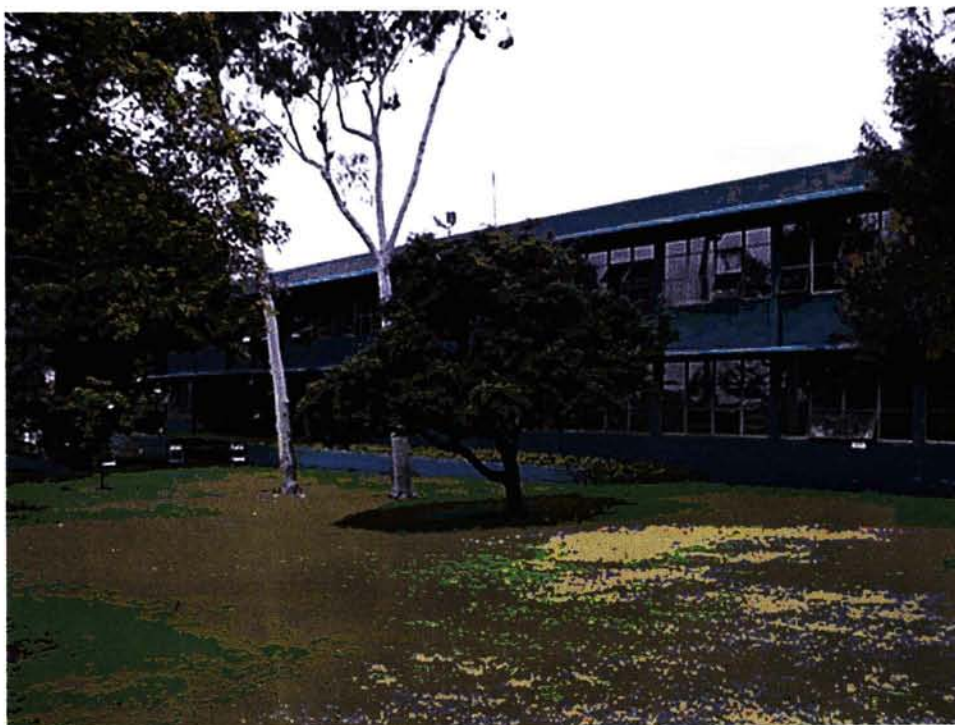
The building rests on spread footings that are showing no signs of damage or settlement. The building structural system was constructed of reinforced concrete exterior walls. The interior walls are wood studs with metal lathe and cement plaster. The exterior storefront system and doors are single pane glazing with metal frames. Portions of the western exterior wall sustained major seismic damage during the 1994 Northridge Earthquake and were repaired with epoxy injection in 1995. Additionally, 45% of the exterior windows sustained damage in the 1994 Northridge Earthquake and were replaced in 1998. The skylights in the eastern portion of the building that were patched and repaired in 2000 are still sustaining major leaks.

The interior building finishes contain asbestos in V.A.T. and floor tile mastic that cover approximately 75% of the building (offices & classrooms). The balance of the building floor area is covered with substandard carpeting in the hallways.

The building doesn't have: fire sprinklers, strobes, annunciators, nor a functioning fire alarm system. Additionally, 25% of the exterior operable single pane windows contain asbestos-containing glazing putty. The building is handicap accessible and handicap restrooms are provided on the first floor. The second floor of the building is not handicap accessible.

The heating system consists of baseboard style radiators that are served with hot water from natural gas fired boilers in the basement of the Admissions building. The radiators, boilers, and piping are obsolete and beyond their expected useful life, and should be replaced and upgraded.

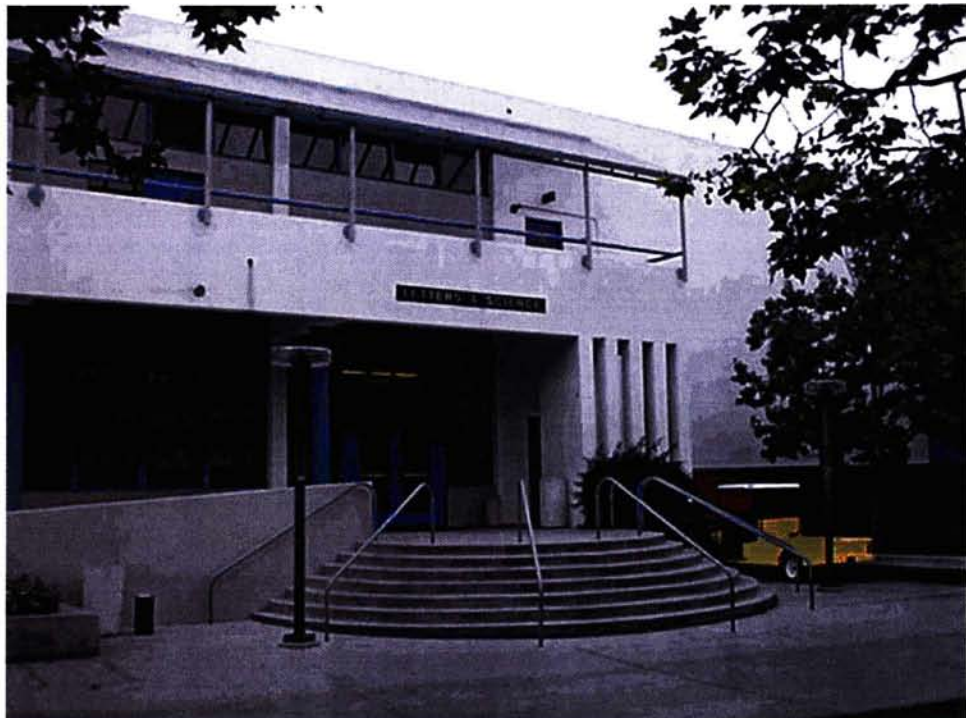
The building rests on spread footings that are showing no signs of damage or settlement. The building structural system was constructed of poured in place reinforced concrete exterior walls. The interior walls are wood studs with metal lathe and cement plaster. The exterior storefront system and doors are single pane glazing with metal frames. The original roofing system was replaced with "monoform" in 1982 and is experiencing leaks at the northeast and western perimeter walls.

The interior finishes include 12"x12" glue down ceiling tiles that contain asbestos in the mastic.

The building contains illuminated exit signs and fire alarm pull stations. A centrally monitored fire alarm system with strobes and annunciators is not present and the egress corridors do not have the appropriate fire separation. The building has accessible ramps and ADA compliant toilet rooms on the first floor. The second floor of the building is not handicap accessible.

The mechanical system consists of three (3), aging, air-handling units (AHU). These AHU's, located in attic mechanical rooms, are single coil, multizone, constant volume types, and are served hot water only from two different boiler rooms. The first boiler room located in the basement of the Admissions building, contains natural gas fired boilers that serves several buildings. The AHU's, boilers, ducting, piping, and pneumatic controls are obsolete and beyond their expected useful life, and should be replaced and upgraded. Exposed pipe insulation is fiberglass.

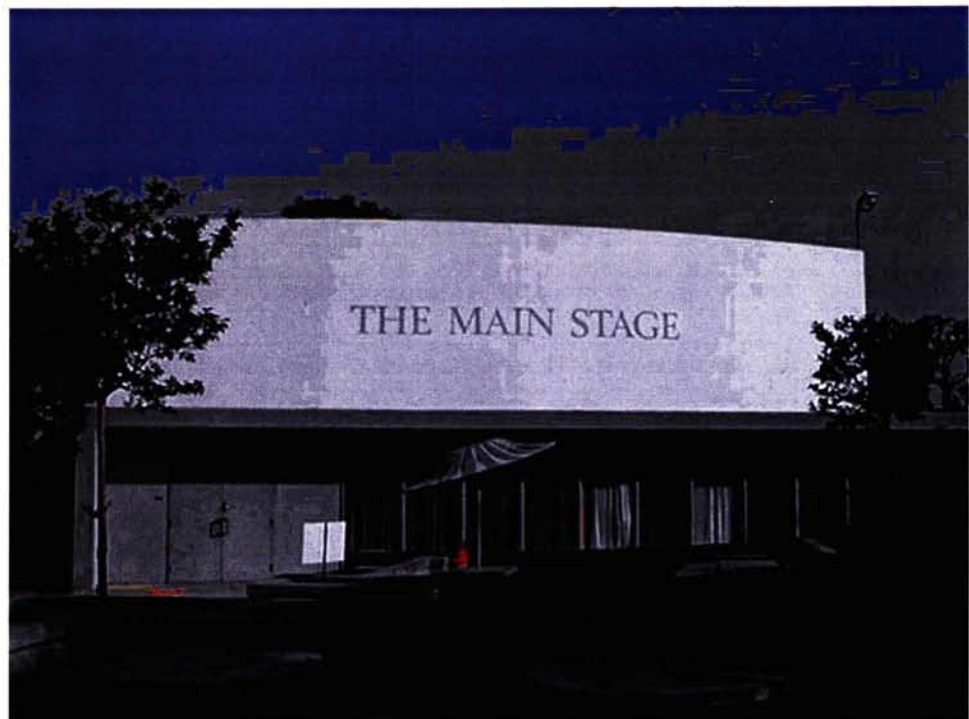
This facility lacks both fire sprinklers and a centrally monitored fire alarm system. Additionally, the building is not handicap compliant, lacking accessible toilets.

Main Stage, Northeast Quadrant
