Facility Executive Summary

Facility: Santa Monica Community College\Southwest Quadrant\PE Building

Facility: Santa Monica Community College\Northeast Quadrant\Music Complex

Facility: Santa Monica Community College\Northeast Quadrant\Concert Hall

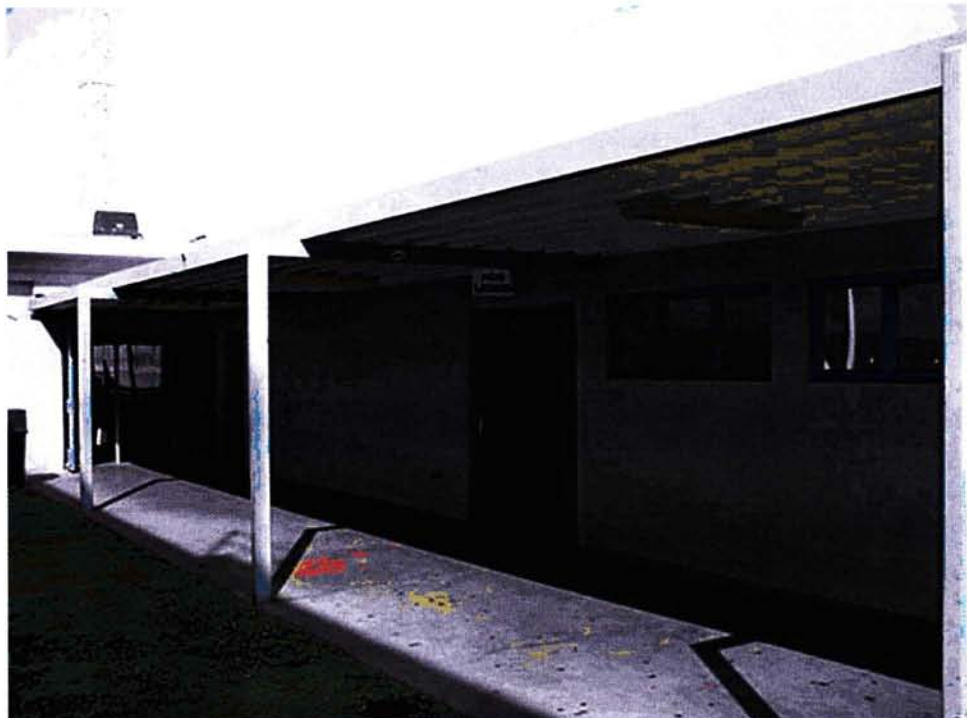
The P.E. Building is located in the southwest quadrant of the campus adjacent to Corsair Field. The 24,653 s.f. single story structure was constructed in 1958 and has not had any major renovations. The facility houses the fitness center, offices, men's shower and locker rooms, and women's shower and locker rooms.

The building rests on spread footings that are showing no signs of damage or settlement. The poured in place concrete exterior walls are approximately 16' high and show no signs of seismic damage that the adjacent gymnasium sustained in the 1994 Northridge earthquake. The original monoform roof has severe leaks in the former location of the roof-top mounted solar panels.

The fire alarm system consists of an antiquated and marginally functioning simplex system without annunciators or strobes. Illuminated exit signs and pull-down fire alarms were present. The building has ADA accessible ramps and ADA accessible mens and womens rest rooms.

The roof mounted exhaust fans serving the building are all roof mounted, obsolete, beyond their useful life, and should be replaced and upgraded.

The electrical system is fed from a 500 KVA transformer that delivers 120/208 volt, 3-phase power via a 1400-amp distribution panel located in the ground floor electric room. This distribution panel serves smaller panels located throughout the Physical Education and Gymnasium buildings. Most equipment and wiring are original, obsolete, beyond its useful life, and should be replaced and upgraded.

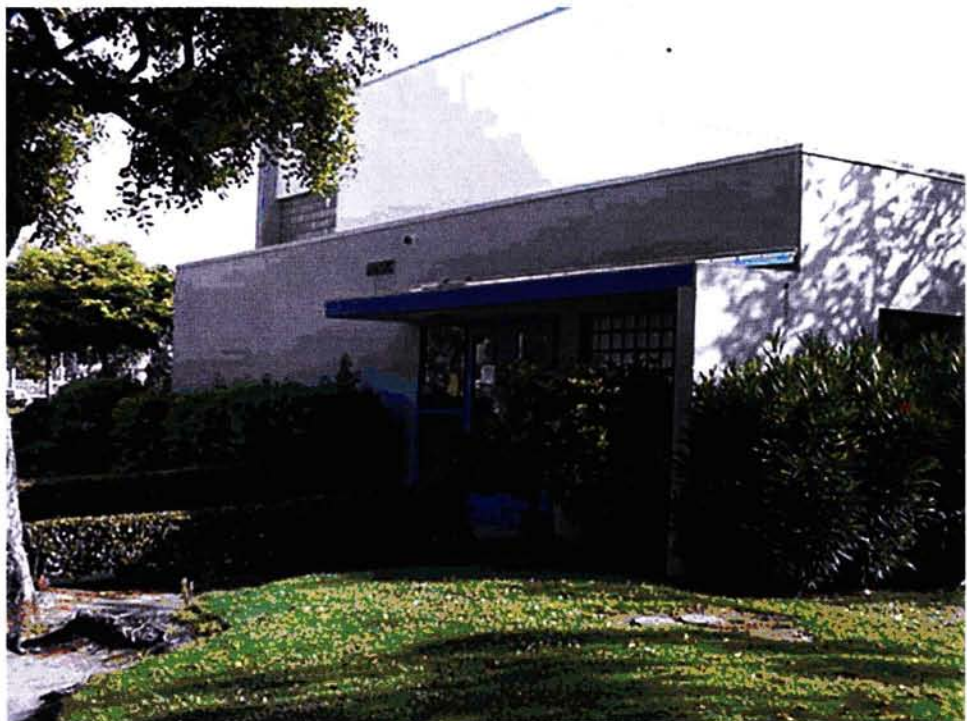
The Music Building is located in the northeast quadrant of the campus. The western one (1) story, 10,000 square foot facility was originally constructed in 1952, and the eastern addition was completed in 1978. The facility houses classrooms, offices and a 25'-0" high recital/practice room.

The interior finishes include 12" x 12" VCT tile in the classrooms and large recital/practice room with 12" x 12" direct glue down ceiling tile. Two (2) classrooms and all the small (6 x 8) practice rooms contain 9" x 9" VAT tile containing asbestos.

The fire alarm system is an antiquated and obsolete "Simplex" system that lacks both battery backup and memory. The building does not have a fire sprinkler system.

The lighting for the complex contains different types of fixtures depending on when the structure was built or remodeled. Some of the fluorescent lighting appears original, is obsolete, beyond its useful life, and should be replaced. Some of the ballasts may contain PCB's. Hallways and practice rooms have fluorescent lighting with T-12 lamps that should be upgraded and replaced with electronic ballasts and T-8 lamps. The classrooms with pendant lighting have upgraded fluorescent lighting with electronic ballasts and T-8 lamps that are approximately 6 years old.

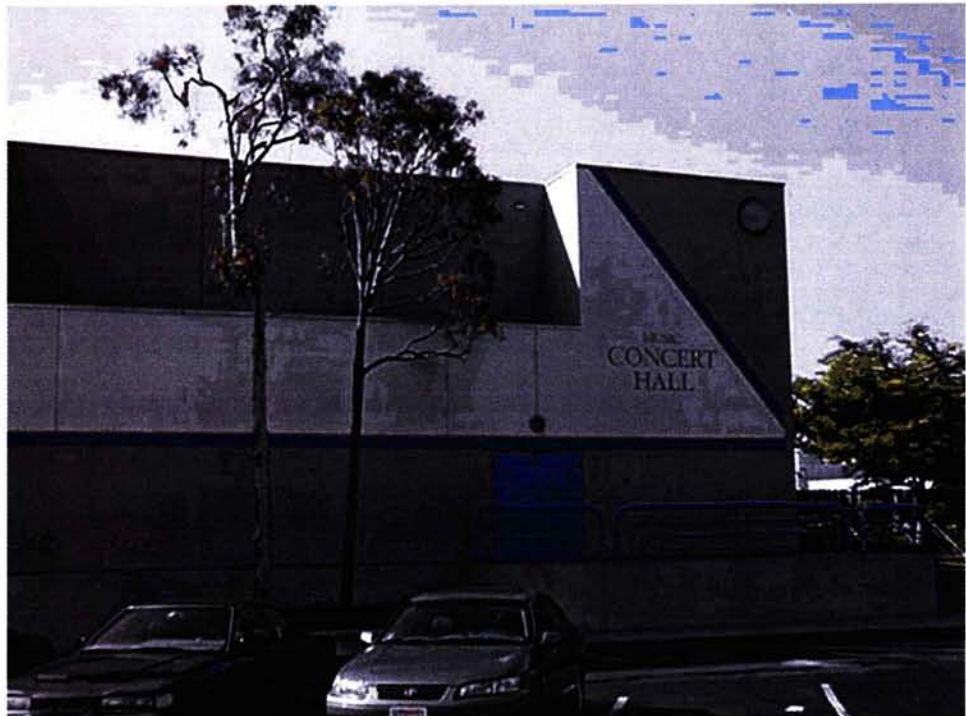
Concert Hall, Northeast Quadrant

The roof was replaced with a modified bitumorous roofing system in August 2000 and is experiencing continuous minor leaks. The entire eastern portion of the building's exterior perimeter wall at grade leaks; a below grade waterproofing repair job was completed in June 2001.

The fire alarm system is an antiquated and obsolete "Simplex" system that lacks both battery backup and memory. The building does not have a fire sprinkler system.

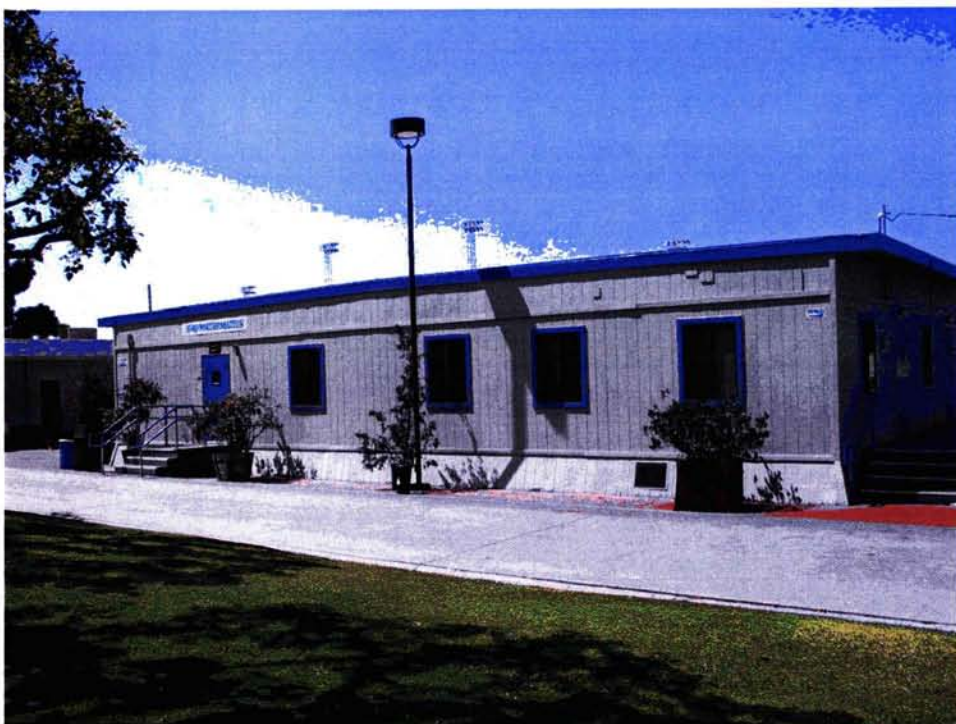
Science Village, Northwest Quadrant

This facility lacks both fire sprinklers and a centrally monitored fire alarm system. Additionally, the building is not handicap compliant, lacking accessible toilets.

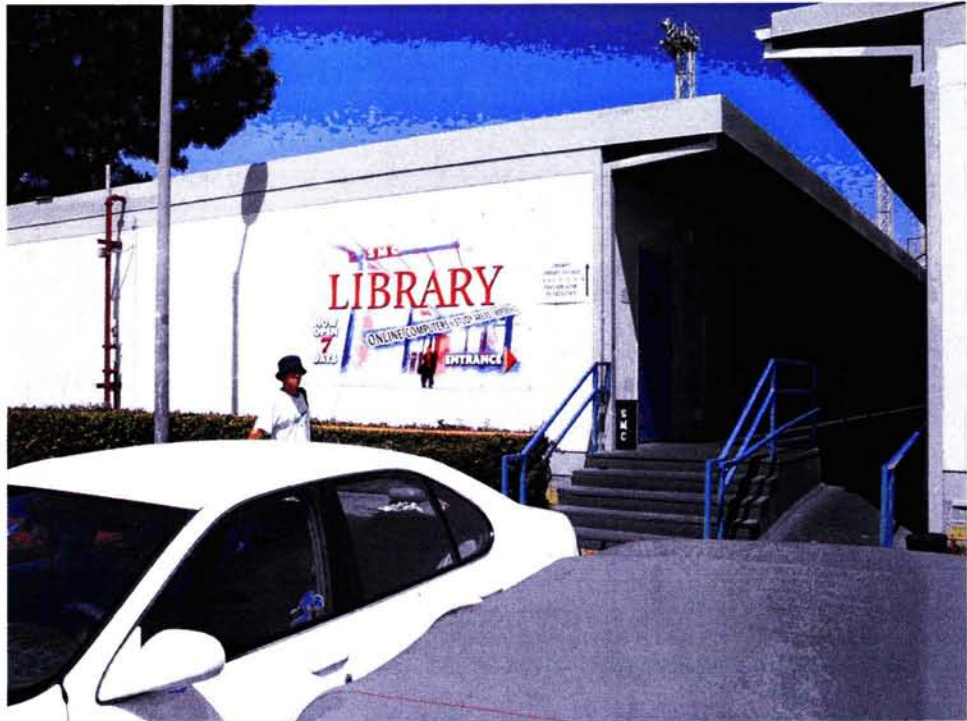
Library Village, Southwest Quadrant

This facility lacks both fire sprinklers and a centrally monitored fire alarm system. Additionally, the building is not handicap compliant, lacking accessible toilets.
