**Facility Executive Summary****Facility:** Santa Monica Community College\Southwest Quadrant\Stadium/Maint, Oper, & Warehs**Facility Description:**

**Facility:** Santa Monica Community College\Southeast Quadrant\Student Activities

**Facility Executive Summary****Facility:** Santa Monica Community College\Southeast Quadrant\Science**Facility Description:**

**Facility:** Santa Monica Community College\Northwest Quadrant\Technology

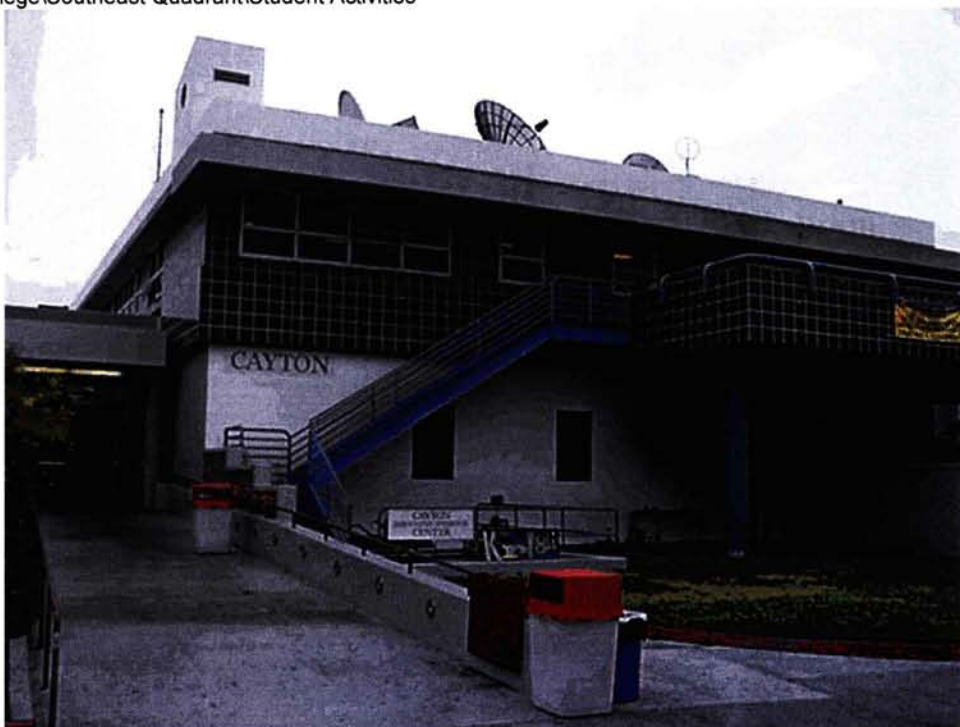
Student Activities, Southeast Quadrant

The interior building finishes are painted drywall, flooring in the high traffic area is sheet vinyl. The roof over the Student Activities Center has numerous leaks.

There is an emergency central battery backup system that is not functioning. This system was designed to provide emergency power to exit signs and some additional building lighting. This unit has exceeded its useful life and should be replaced.

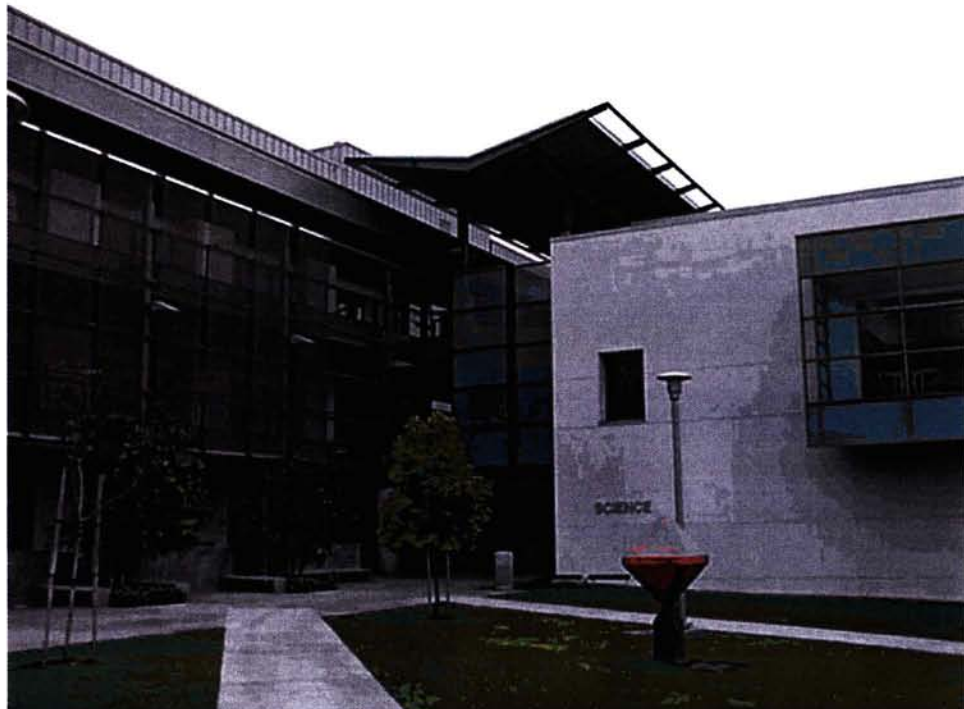
Science, Southeast Quadrant

The building rests on spread footings and isolated concrete column bases that are showing no signs of damage or settlement. The building's structural system was constructed of steel frames with cement plaster exterior skin. The interior walls are metal studs with drywall. The exterior storefront system is dual glazed with metal frames. The western wing roof is constructed of standing seam metal roofing and it experiences severe leaking at the outboard gutter locations.

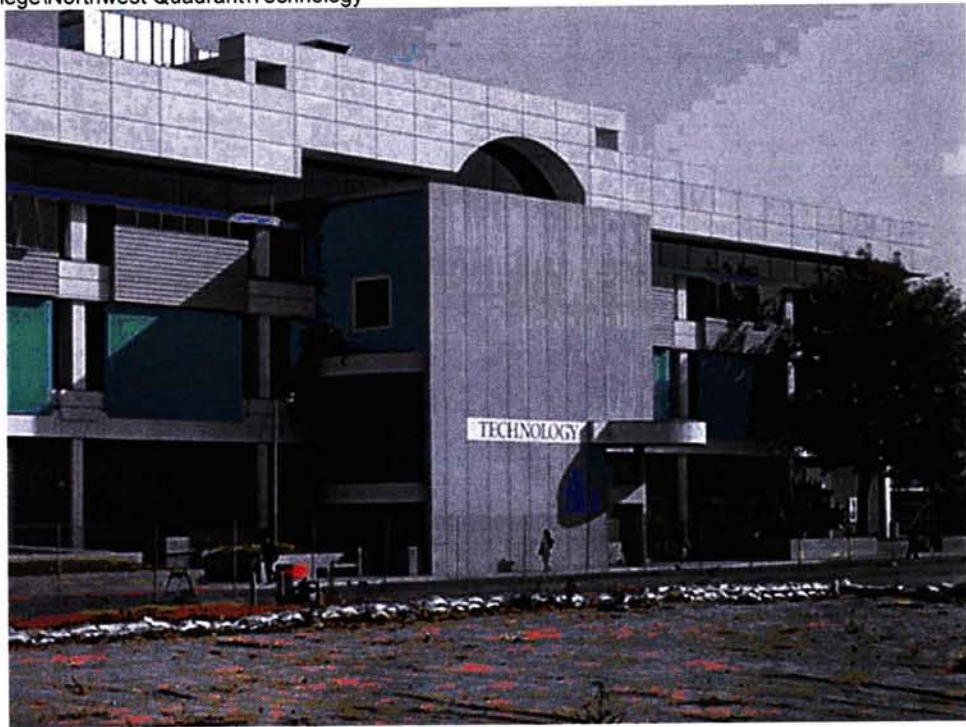
Technology, Northwest Quadrant

Most of the distribution equipment has served its useful life, is obsolete, and should be replaced. The fluorescent fixtures on the first floor with T-12 lamps have served their useful life, are obsolete, and should be replaced.

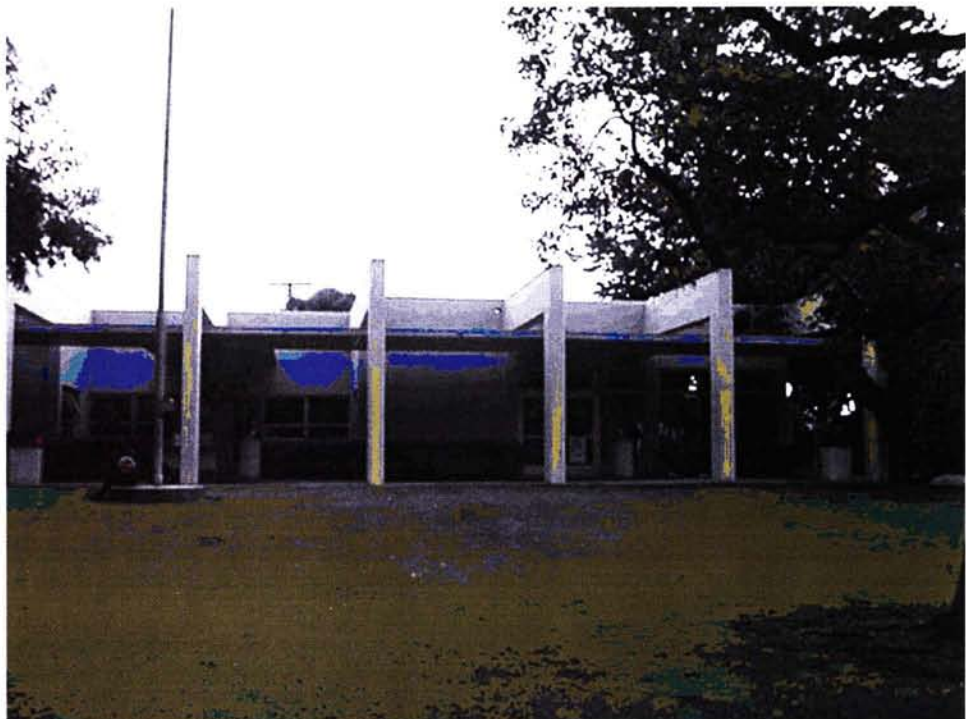
Admissions, Southeast Quadrant

The interior building finishes contain asbestos in the ceiling tile mastic and floor tile mastic that cover approximately 50% of the building. The balance of the building floor area is covered with substandard carpeting in the offices.

The building doesn't have: fire sprinklers, strobes, annunciators, nor a functioning fire alarm system. Additionally, 50% of the exterior single pane windows contain asbestos, and the building is not handicap compliant.

The heating system consists of baseboard style radiators that are served with hot water from three (3) natural gas fired boilers in the basement. Some of the baseboard radiators are not functioning due to malfunctioning valves. The radiators, boilers, and piping are obsolete and beyond their expected useful life, and should be replaced and upgraded.
