Facility Condition Assessment Report

October 2002

3D/I

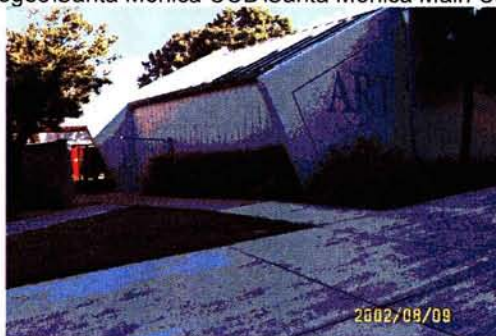
Photo Description: Art Building

The building rests on a slab on grade and spread footings at exterior walls, columns and interior load bearing walls which show no signs of settlement or damage. The exterior walls are wood framed with a stucco finish. The roof system used is modified Bitumen which was replaced in May of 2000. It is in good condition and inspected annually. The exterior doors are wood with glass windows and outdated hardware. The windows are aluminum framed single pane units.

Interior wall finishes are typically painted plaster and range from fair to poor condition. Ceiling finishes are typically 1' x 1' acoustic ceiling tiles or suspended grid with acoustic tiles and painted plaster in utility areas. These finishes are generally in poor condition. Flooring in most areas is either 9" x 9" vinyl tiles or 12" x 12" vinyl tiles and is generally in poor condition. Interior doors are solid core wood, many with single lites and outdated hardware.

The electrical system is fed from a 150 KVA transformer that delivers 120/208 volt, 3-phase power via an 800-amp distribution panel. This transformer and distribution serve smaller panels located throughout the Art and Music complexes. Most equipment and wiring is beyond its useful life and should be replaced or upgraded. The lighting for the complex contains different types of fixtures depending on when the structure was built or remodeled. Several rooms have been recently remodeled with upgraded fluorescent lighting with electronic ballasts and T-8 lamps. There is still some older fluorescent lighting with T-12 lamps that should be replaced or upgraded. Some of the rooms have been upgraded for computer services. The building is equipped with some illuminated exit signs and wall mounted emergency battery lighting units.
