Facility Condition Assessment Report

September 17, 2003

3D/I

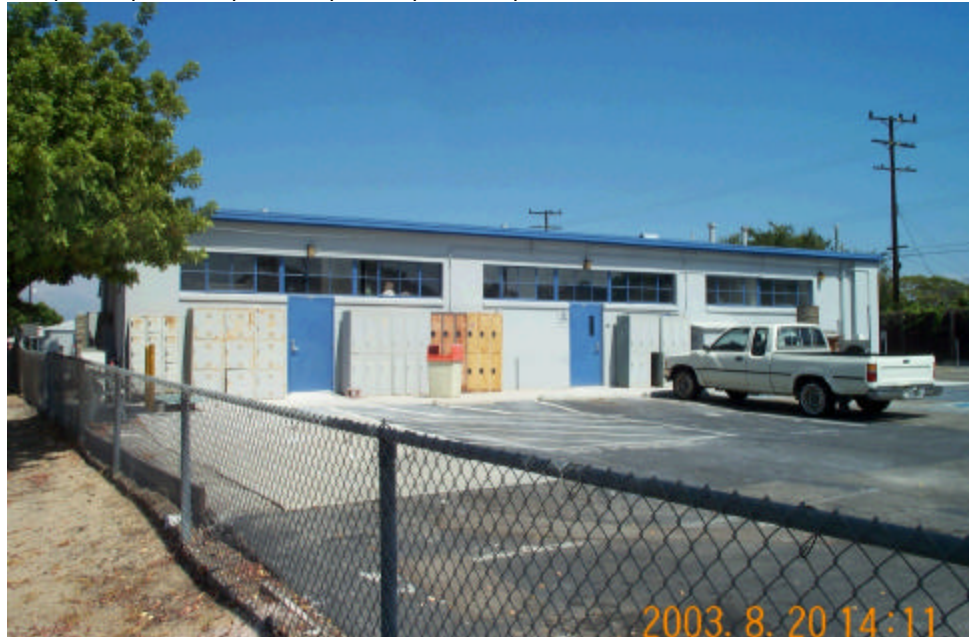
Airport Campus Complex - Airport Campus Annex

Concrete sidewalks immediately adjacent to the facility are in good condition and pose no hazard. The parking surface on both sides of the building should be resurfaced.

The building rests on a slab on grade and spread footings at exterior walls, columns and interior load bearing walls which show no signs of settlement or damage. The main structure is concrete block. Exterior doors are metal with new hardware. Windows are typically steel framed single pane units.

Interior wall finishes are typically painted plaster with vinyl wall covering in some areas and ceramic tile in the restrooms; all are generally in good condition. Ceiling finishes is typically exposed and are in fair condition. Floor finishes are concrete and are good condition. Interior doors are solid core wood.

Airport Campus Ceramics building located west of the main building.

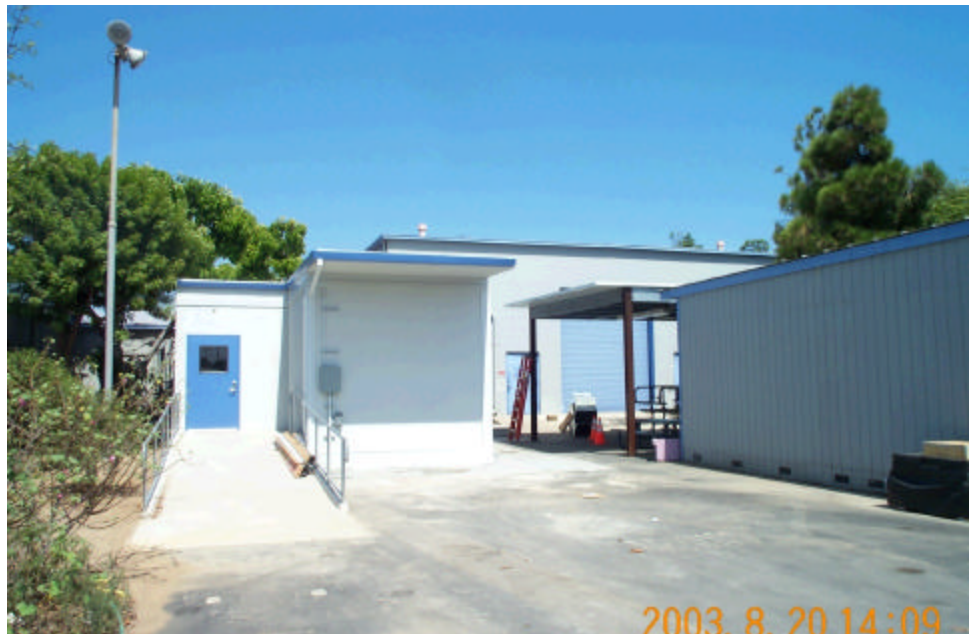
Concrete sidewalks immediately adjacent to the building are in good condition and pose no hazard. The parking surface near the building should be resurfaced. There is a handicap accessible ramp along with railing provided at the exterior entrance.

The building rests on a slab on grade and interior walls are non-load bearing and show no signs of settlement or damage. The main structure is wood frame with a stucco exterior finish. Exterior door and frame is metal with new hardware. There are no windows.

Interior wall finishes are painted gypsum board and ceramic tile in the restrooms; all are in great condition. The ceiling is an acoustical suspended type in great condition. The floor finish is 12"x12" vinyl composite tile they also are in great condition. Interior doors are metal door and frames.

New 2003 toilet addition attached to the main airport campus building.

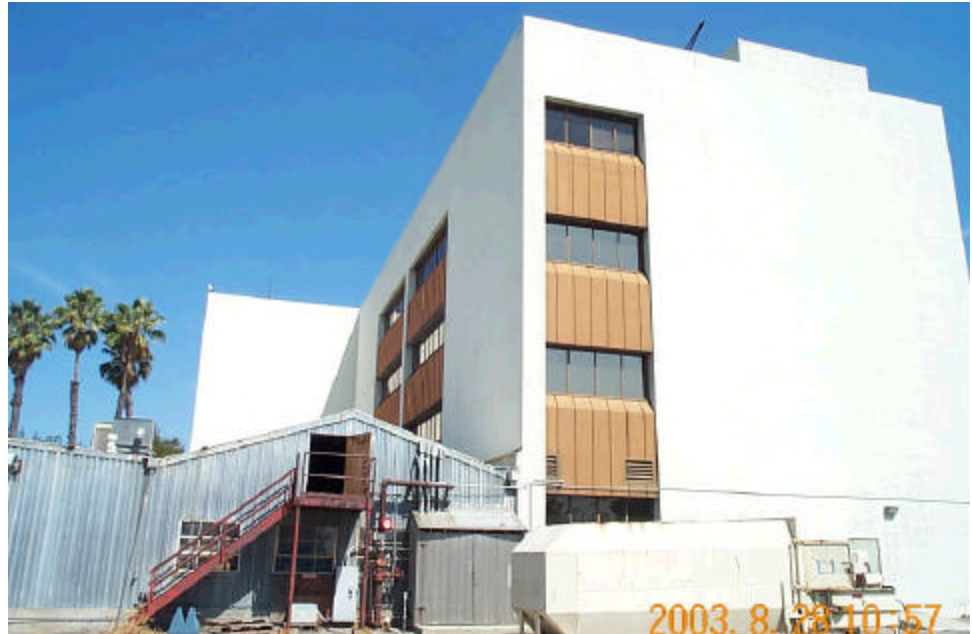
BAE Complex - Butler Building

The building on the lower left of the picture is what we are considering the butler building.

The concrete sidewalks immediately adjacent to the facility are in good condition and pose no hazard. The parking lot is in poor condition but does provide off-street parking. The site is also surrounded by a chainlink fence and guard booths for security purposes.

The main building is a masonry structure with structural steel framing members with flat built-up ply roof. The other building is a masonry structure as well with pitch roofs. There are no signs of any structural damage. The roof appears to be in fair condition but is probably past its expected useful life. The exterior doors are metal with metal frames and the windows are steel frame single pane units. Both are in poor to fair condition.

The partition wall types include painted CMU and drywall. The interior wall finishes are in fair condition for the most part. Most of the ceilings are suspended acoustical tile in fair condition. Flooring throughout is mostly vinyl composite tile and or carpet. The interior doors are wood with metal frames. All of the interior finishes throughout are past there expected useful life.

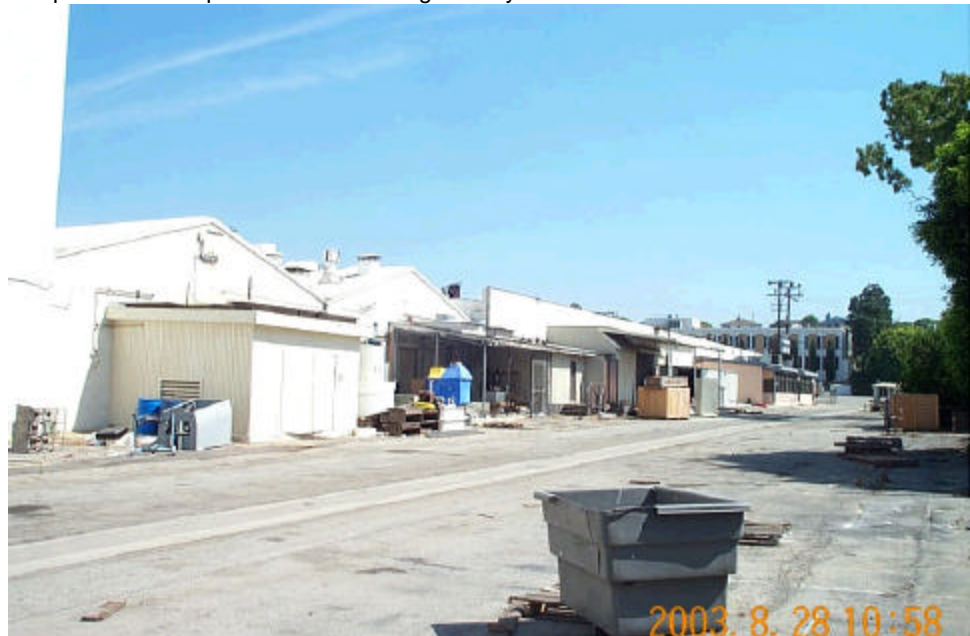
BAE Complex - Central Building 1-Story

The main central building is located at the right side of the photograph and the pitched roof buildings appear to have been additions added to bridge the area between the 4-story and central building. The square footage breakdown is described in the executive summary.

The concrete sidewalks immediately adjacent to the facility are in good condition and pose no hazard. The parking lot is in poor condition but does provide off-street parking. The site is also surrounded by a chain link fence and guard booths for security purposes.

The building is a masonry structure with structural steel framing members with metal pan flat built-up ply roof. There are no signs of any structural damage. The roof appears to be in good condition but is probably past its expected useful life. The exterior doors mostly glass or steel with metal frames and the windows are aluminum frame single pane units. Both are in fair to good condition.

The partition wall types include painted CMU and drywall. The interior wall finishes are in fair condition for the most part. Most of the ceilings are suspended acoustical tile in fair condition. Flooring throughout the high traffic areas are tile, vinyl composite tile and or carpet. The interior doors are solid wood.

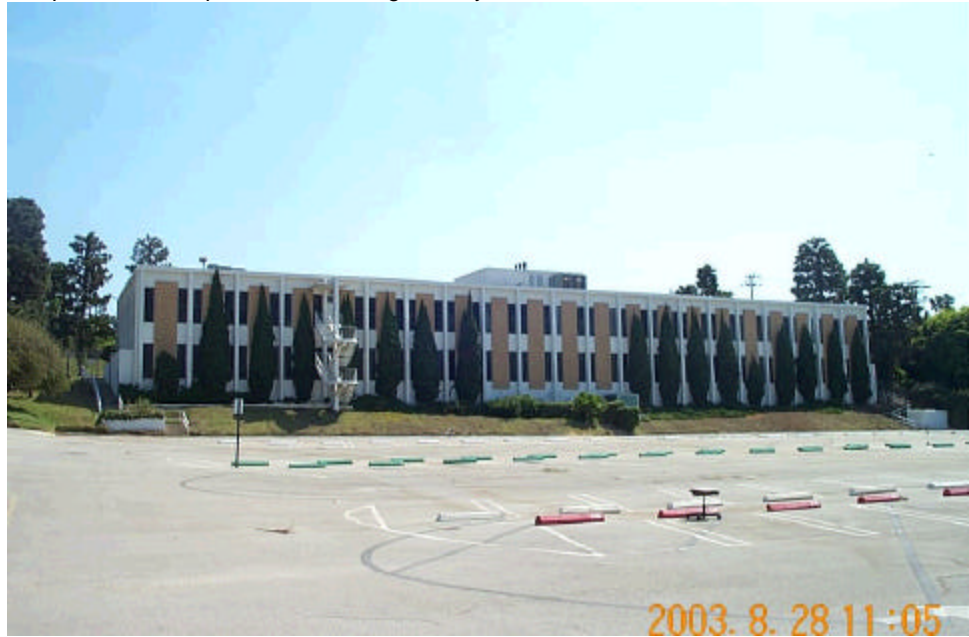
BAE Complex - East Building 2-Story

B/AE Complex - East Building (2-Story) elevation from the adjacent parking lot.

The concrete sidewalks immediately adjacent to the facility are in good condition and pose no hazard. The parking lot is in poor condition but does provide off-street parking. The site is also surrounded by a chainlink fence and guard booths for security purposes.

The building is a masonry structure with structural steel framing members with metal pan flat built-up ply roof. There are no signs of any structural damage. The roof appears to be in good condition but is probably past its expected useful life. The exterior doors mostly glass with metal frames and the windows are aluminum frame single pane units. Both are in fair to good condition.

The partition wall types include painted CMU and drywall. The interior wall finishes are in fair condition for the most part. Most of the ceilings are suspended acoustical tile in fair condition. Flooring throughout the high traffic areas are tile, vinyl tile and or carpet. The interior doors are solid wood.

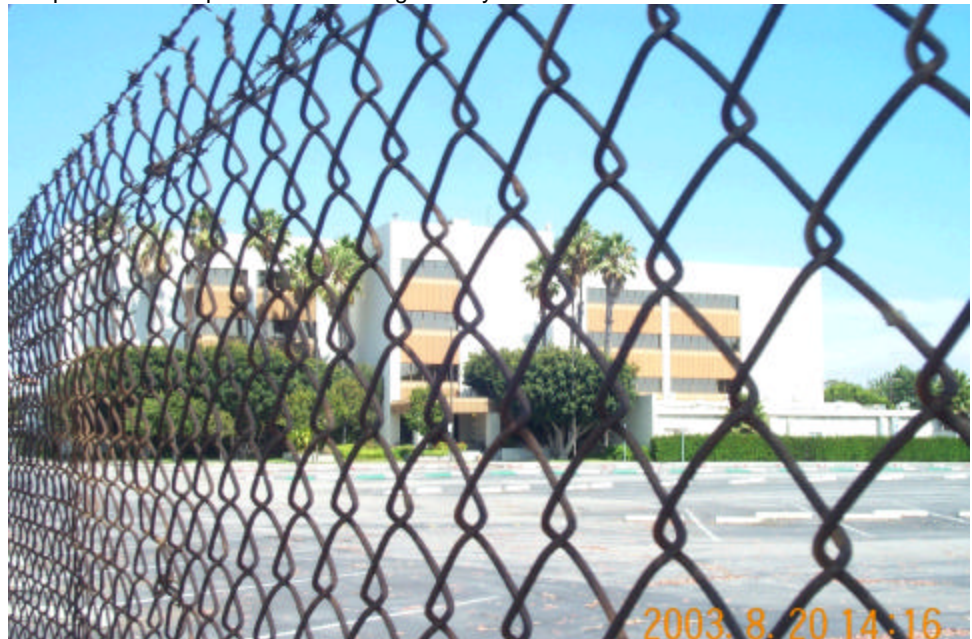
BAE Complex - West Building 4-Story

BÆE Complex - West Building (4-Story) elevation from adjacent street.

The concrete sidewalks immediately adjacent to the facility are in good condition and pose no hazard. The parking lot is in fair condition at best but does provide some off-street parking. The site is also surrounded by a chainlink fence for security purposes. Most of the concrete surfaces and play areas are covered with a foam type material for safety. Playground equipment is also provided.

The building rest on a slab on grade that show no signs of settlement or damage. The main structure is brick veneer on CMU. The roof is flat built-up type with an aggregate with no signs of damage but appears to be past its useful life expectancy. The exterior doors are wood and windows are steel frame single pane units.

The partition wall types include painted CMU and drywall. The interior wall finishes are in fair condition. Most of the ceilings are 12"x12" glued on acoutical tile in good condition. Flooring throughout the high traffic areas are tile with some areas covered with rugs. The interior doors are solid wood.

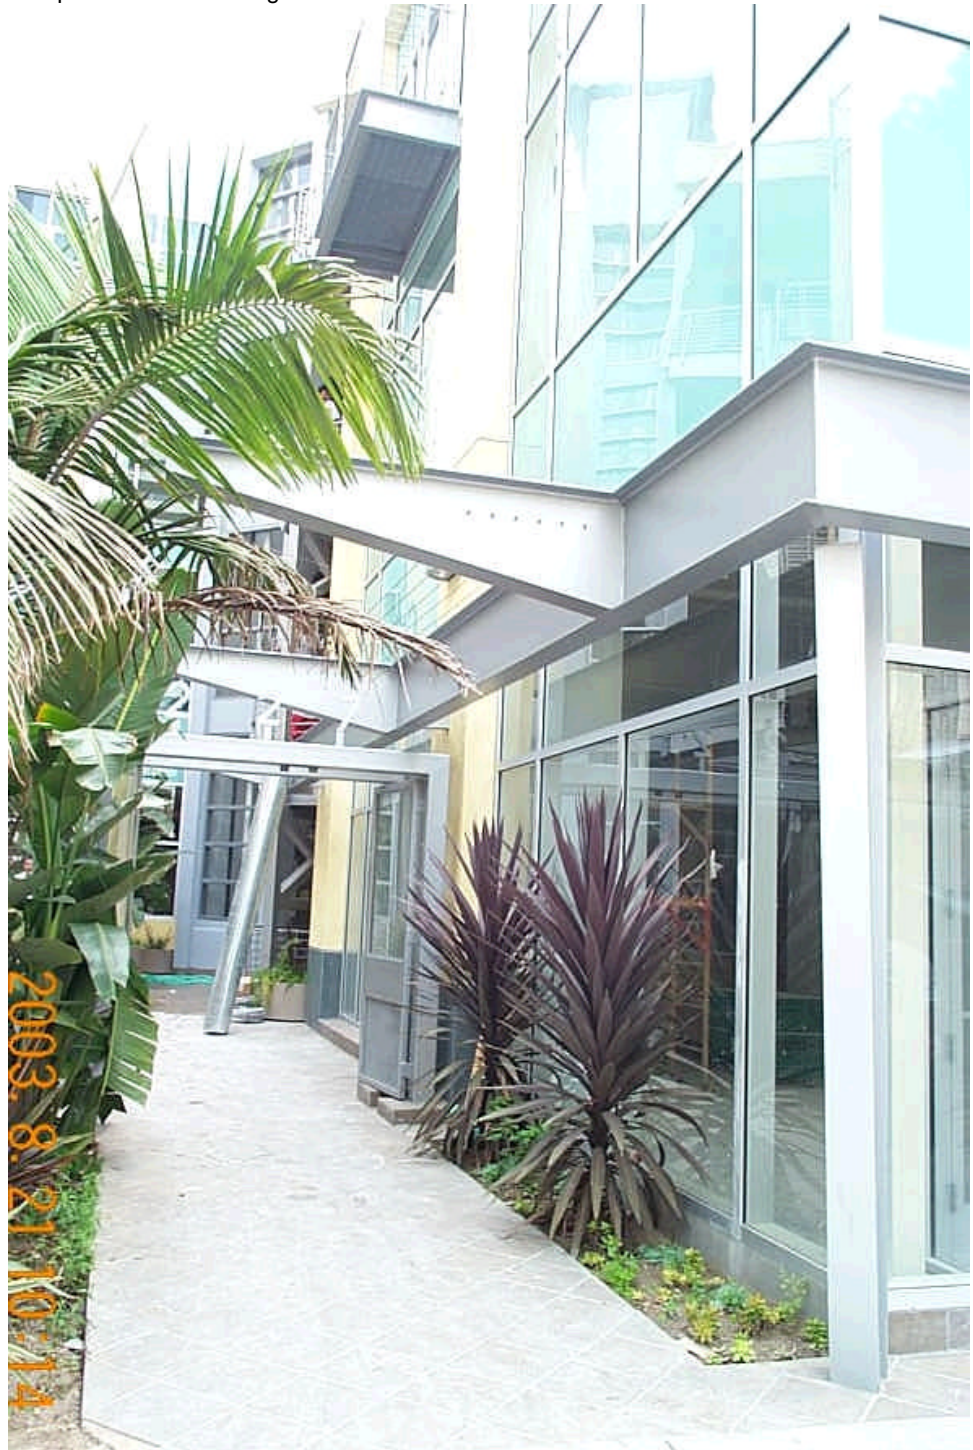
Front elevation of Emeritus College from 2nd Street.

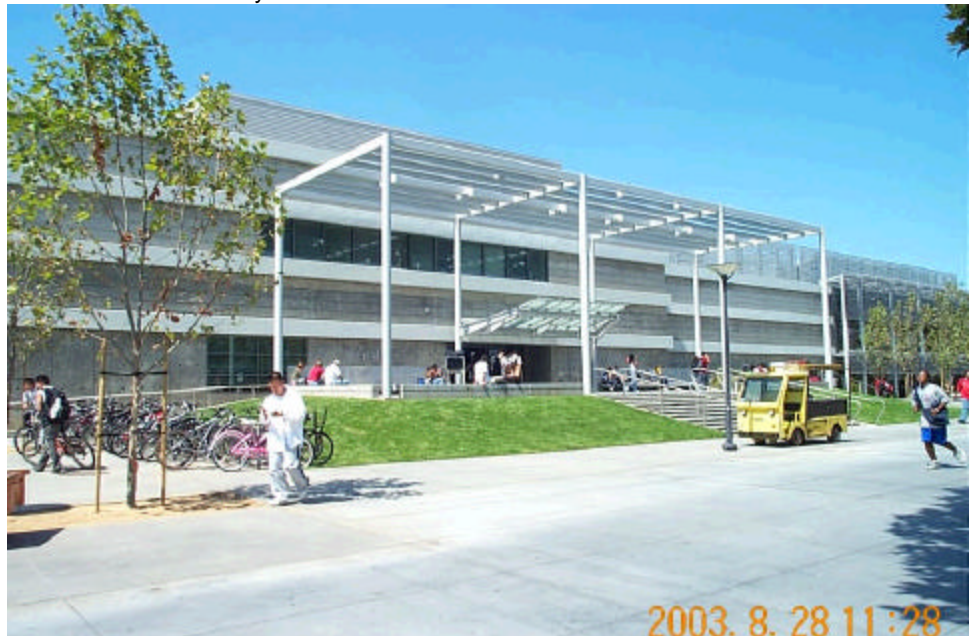
Southwest Quadrant - Library

Elevation of newly renovated Library along with the addition from mid campus.
