Facility Condition Assessment Report

August, 2001

3D/I

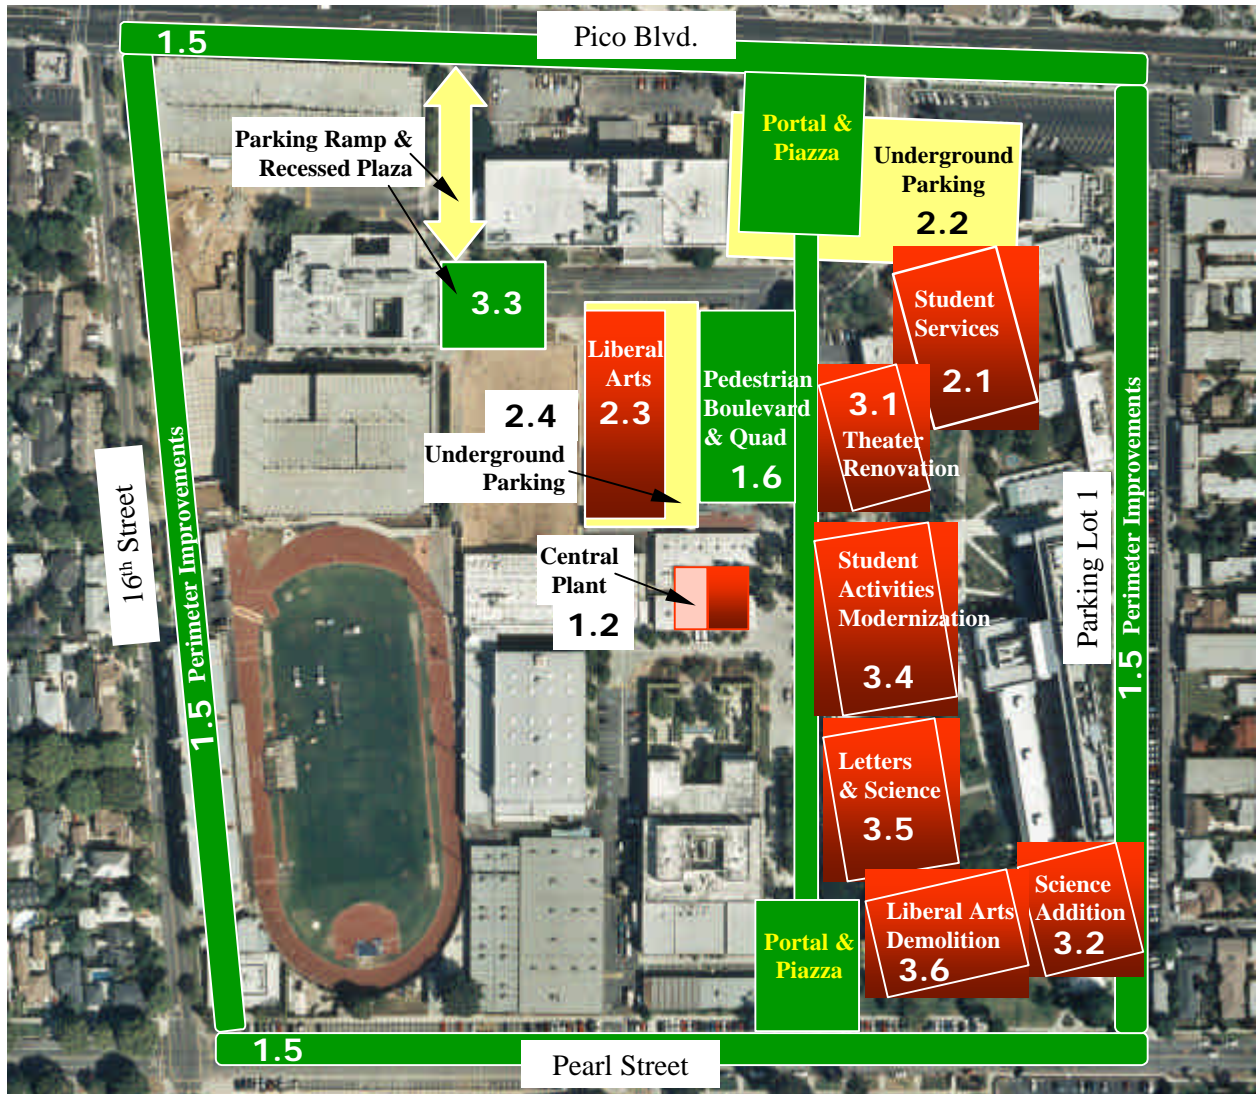
Project Listing Map

A map diagramming the approximate location for the proposed modernization and new construction projects is shown below. The numbering corresponds to the Project Listing shown above. Many of the new buildings would replace existing older, obsolete, temporary or modular facilities. The majority of the new projects would occur on the East side where the College originated along Pearl and 20th Street.

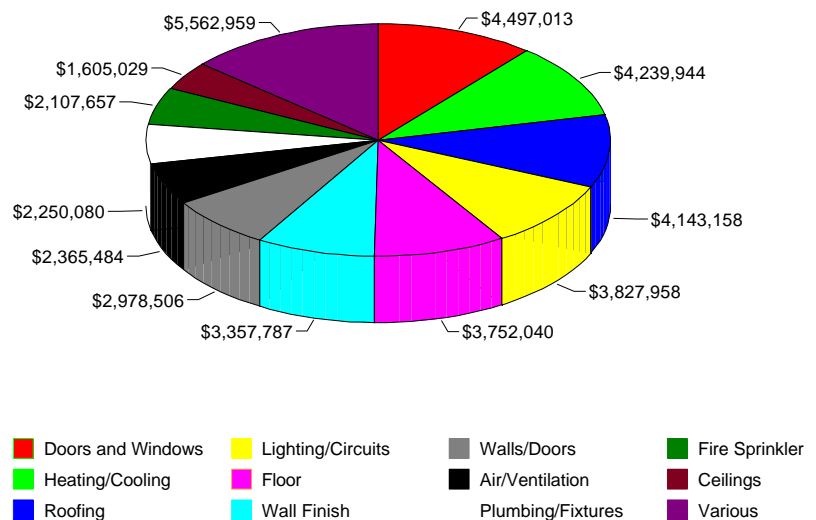
The \$40.7 million estimated cost to repair all facilities consists of the following 12 building system components. The exterior closures (window, door, roofing replacements) and the heating/cooling, electrical, plumbing systems (Various) require major renewal and make up the majority of the costs. The added burden to comply with handicapped accessibility standards and building code requirements increase these costs significantly.

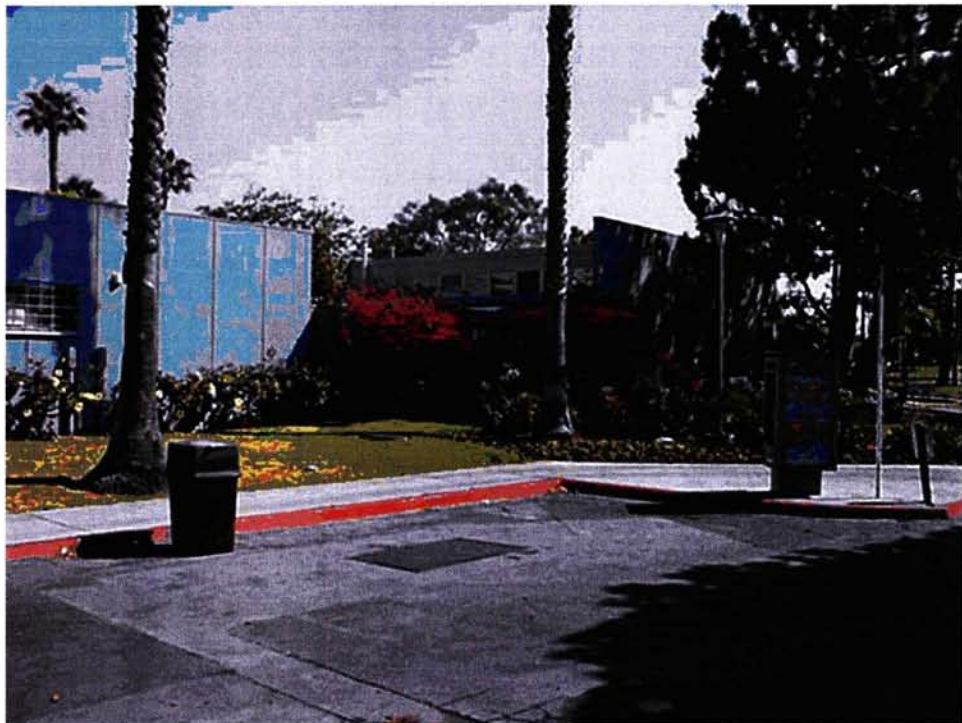
Administration, Northeast Quadrant

The Administration Buildings, A, B, C, D, and E are located in the northeast quadrant of the campus adjacent to Pico Blvd. The one (1) story, 18,014 square foot complex was originally constructed in 1957, and beginning in August 2001, houses Admissions, some Student Services, and Faculty Offices.

The complex rests on spread footings that are showing no signs of damage or settlement. The building's structural systems consist of wood frame construction with metal lath and cement plaster exterior skin.

The roof was last replaced in 1976 with a "monoform" system and is experiencing numerous leaks.

The interior finishes include carpet that is well past its useful life, exposed concrete exterior walkways and 12" x 12" direct glue down ceiling tile.

A centrally monitored fire alarm system does not exist and fire sprinklers are not present.

There are no ADA accessible toilets in this facility.

The mechanical system serving this area contains several different types of systems of various ages. Twelve of the rooms are served with natural gas fired forced air furnace mounted in a closet adjacent to each space. Eight of the units are 12-years old and four of the units are 18-years old. Two rooms are served with split system heat/cooling units. The condensers are roof mounted and serve coils that are mounted on the gas fired forced air furnace that is located in a closet adjacent to the space served. These two systems are three years old.

The toilet facilities use open windows for ventilation and natural gas fired wall furnaces for heat. These furnaces are original, 44-years old, obsolete, beyond their useful life, and should be replaced.

The electrical system is fed from a 225 KVA transformer that delivers 120/208 volt, 3-phase power via an 800-amp distribution panel, all of which is mounted in a ground floor electrical room. This panel further feeds smaller panels located throughout the building. Most of the equipment is 44-years old, obsolete, beyond its useful life, and should be replaced. The transformer is adequate to serve the needs of the building that has undergone numerous renovations to upgrade the power distribution to meet current demands.

The plumbing system - piping and fixtures - appear to be original and well maintained. The toilets have been replaced with low flush units. Faucets and flush valves have also been replaced. Two 30-gallon natural gas fired water heaters that are 10-years old serve the building. The balance of the system is obsolete, beyond its useful life, and should be replaced.
