- Facility Executive Summary -

Facility: California Community Colleges\Santa Monica CCD\Santa Monica Main Campus\15 Music/Concert Hall

- Survey Detail Report -

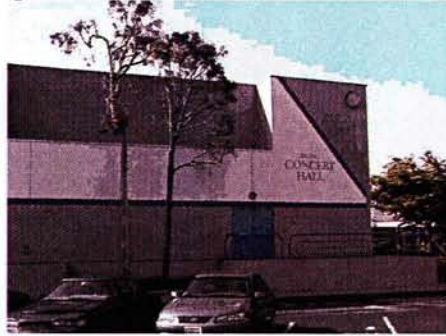
Photo Description:

The building rests on a slab on grade and spread footings at exterior walls, columns and interior load bearing walls. The 1994 Northridge earthquake caused some cracking in the concrete structure which were repaired using an epoxy injection. The building shows no other signs of settlement or damage. The main structure is cast concrete with a stepped cast concrete roof deck that doubles as the floor of the open stadium seating above. Exterior doors are typically steel in steel frames with some rollup service doors. Windows are steel framed single pane units.

Interior wall finishes are typically painted plaster with ceramic tile in the restrooms and are generally in poor condition. Ceiling finishes are typically painted plaster with 1' x 1' acoustic ceiling tiles in some areas and are generally in poor condition. Floor finishes are typically unfinished concrete with vinyl tile in some areas and ceramic tile in portions of the restrooms. These finishes are generally in poor condition. Interior doors are solid core wood with outdated hardware.
