Project Name: SMC Student Center - Construction Emissions

Historic Resource Report

Student Services Replacements, Bookstore Modernization and Pico Promenade Improvements Project

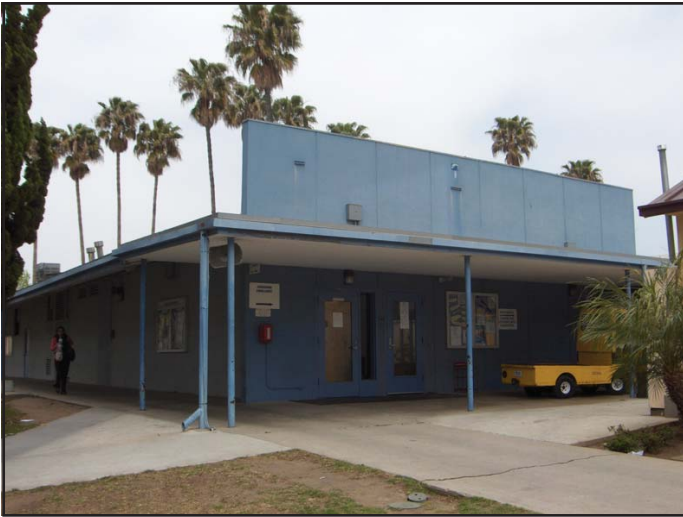
View 1: View of the Admissions and Student Services Complex. Each building is a plain rectangular box covered by a flat roof with overhanging eaves.

The buildings are oriented perpendicular to Pico Boulevard. Each building is a plain rectangular box covered by a low-pitched roof with overhanging eaves. At the north and south ends of each building are tall blank walls with flat parapets. The spaces between the buildings are landscaped. The west elevations are essentially solid walls with slab doors at regular intervals. It appears that many of the original doors have been replaced, as they are now mismatched. New windows openings have also been inserted into the west elevation. The east elevations feature long bands of hopper-style windows; however, they are not original. Based on the field work, initial research and analysis, the Admissions and Student Services Complex was eliminated from further consideration as a potential historic resource due to a lack of physical integrity and architectural distinction.

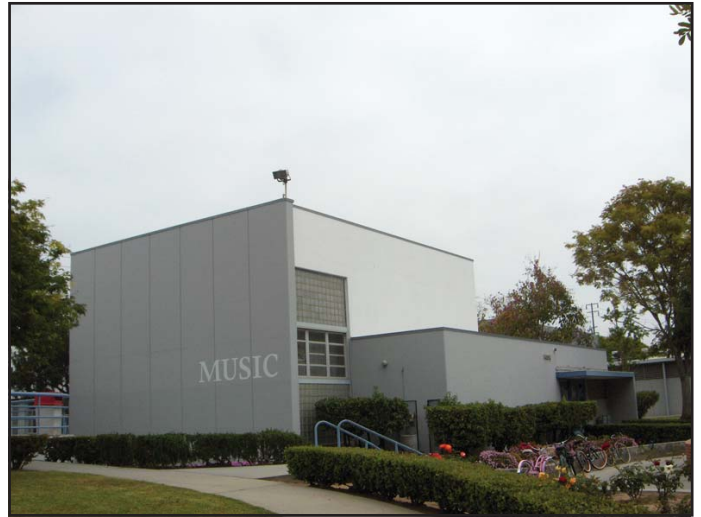
View 2: View of the Music Complex. The main building is a two-story, flat-roofed box, juxtaposed with an attached one-story, rectangular structure.

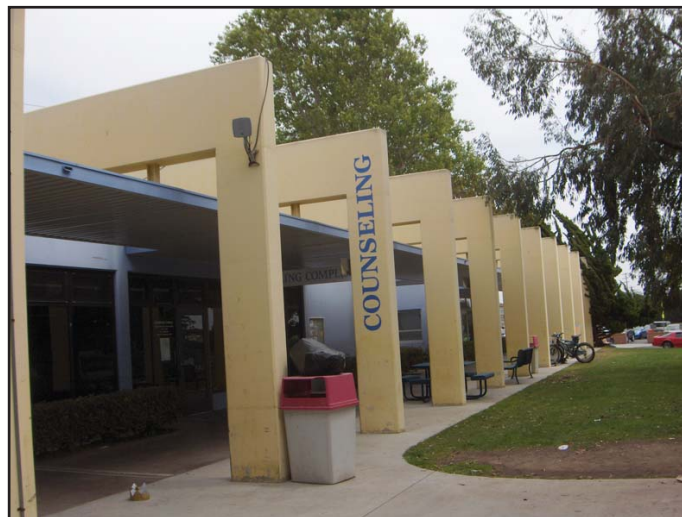
View 3: View of the Counseling Complex. The boxy one-story building is horizontally oriented with a flat roof. The windows are arranged in panels, forming a grid.

The Counseling Complex is located on the southern portion of the Project Site, and was constructed in 1952 (see View 3). While the building is currently used for counseling resources, diagrams of the 1950 Master Plan show the building was then used for administration and admissions purposes. The boxy, one-story building is covered by a flat roof. The windows are arranged in panels, forming a grid. Similar to the other buildings on campus, the Counseling Complex emphasizes the exterior entrances through the walkways that run adjacent to the building. The walkways are covered by a flat overhang projecting from the building. The most distinctive elements of the building are the pillars that project from the building at a ninety-degree angle. The angular pillars create an intimate corridor between the building and the surrounding area. According to college records, the building has not been substantially altered since construction.

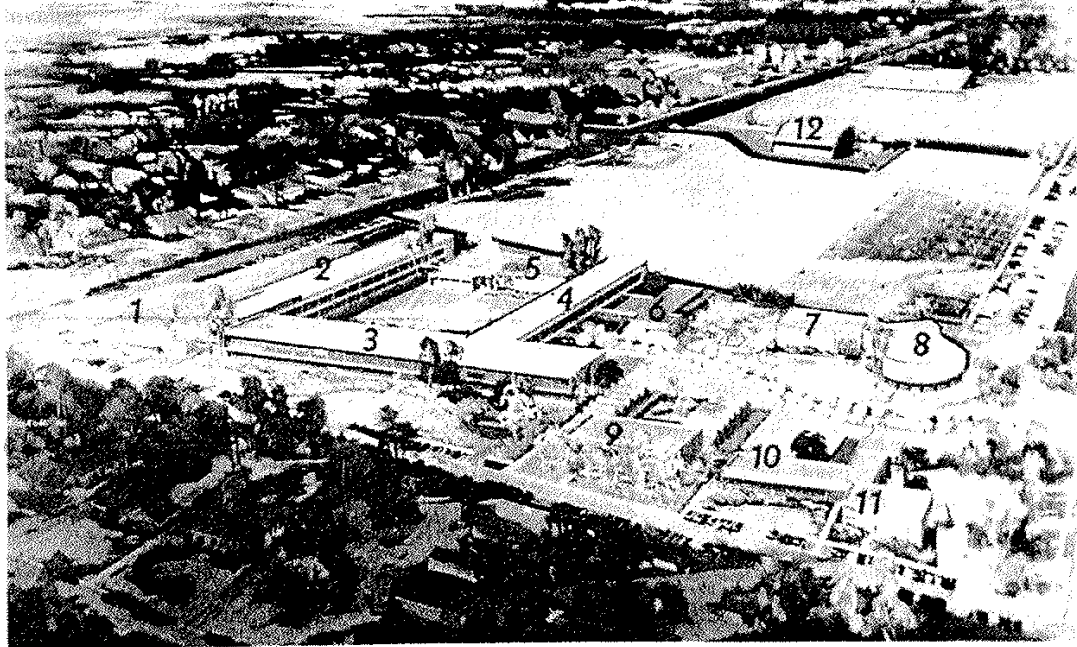
THE NEW LOOK—This is how the new SMCC will look when completed. 1. Administration Building. 2. Liberal Arts Building. 3. Life Sciences Building. 4. Business Administration Building. 5. Library. 6. Student Union Building. 7. Speech Arts Building. 8. Auditorium. 9. Art Building. 10. Music Building. 11. Recital Hall. 12. Men and Women's Gymnasiums. Buildings 10, 11 and 12. Funds have already been provided for the rest of the buildings and 8 are to be built in the near future as funds become available. The Bonds voted on yesterday provided for the construction of buildings 3, 4

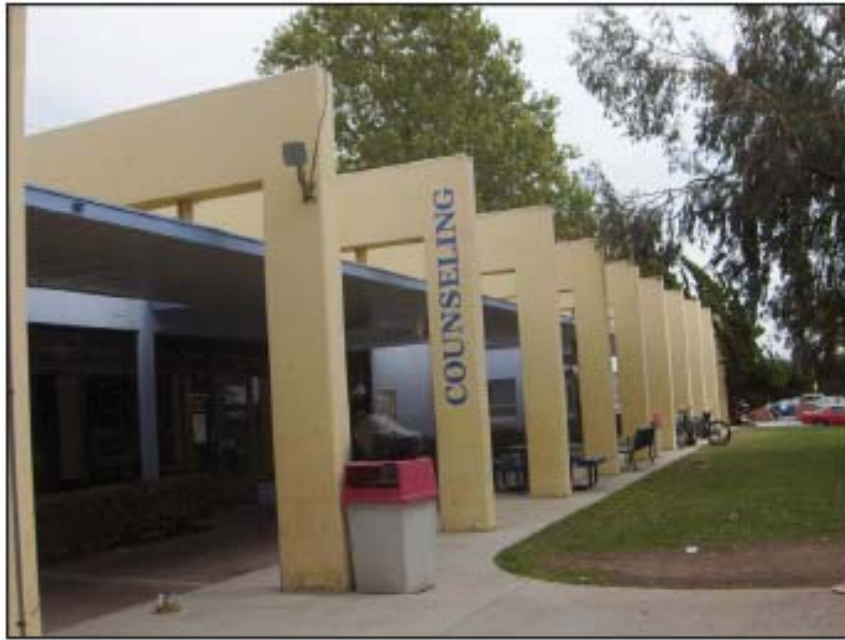
P5b. Description of Photo: (view, date, accession #) _____
View of the walkways and elevation.

*P3a. Description: (Describe resource and its major elements. Include design, materials, condition, alterations, size, setting, and boundaries)
The boxy, one-story building is covered by a flat roof. The windows are arranged in panels, forming a grid. Similar to the other buildings on campus, the counseling complex emphasizes the exterior entrances through the walkways that run adjacent to the building. The walkways are covered by a flat overhang projecting from the building. The most striking elements of the building are the pillars that project from the building at a ninety-degree angle. The angular pillars create an intimate corridor between the building and the surrounding area. According to college records, the building has not been substantially altered since construction.

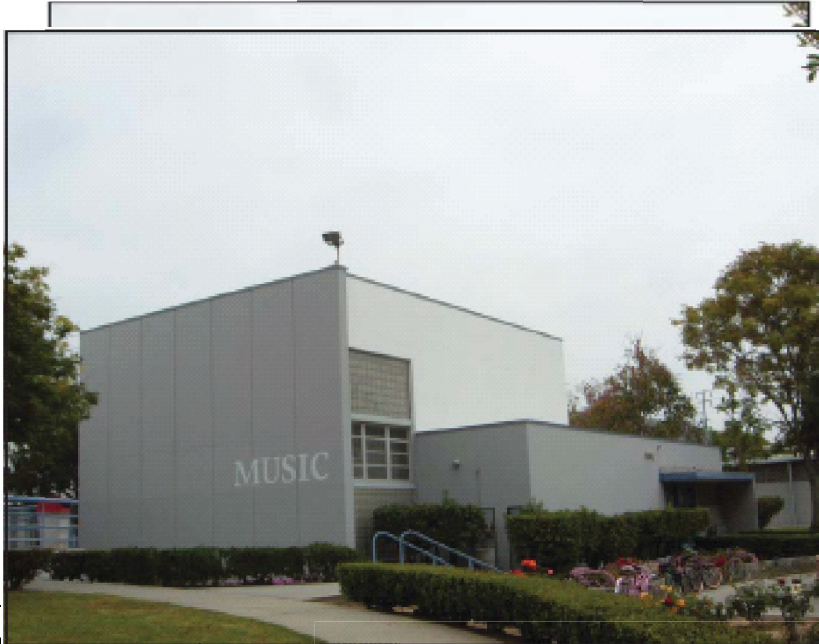
View of the front facade.
