# SANTA MONICA COLLEGE

## 2040 CAMPUS MASTER PLAN

### FACILITIES CONDITIONS ASSESSMENT

*CREATED JUNE 2020; SUBMITTED JUNE 2024*

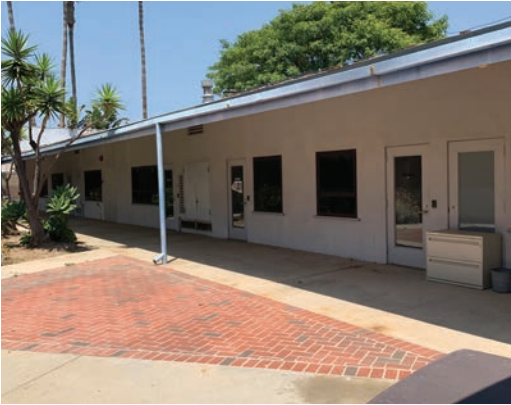
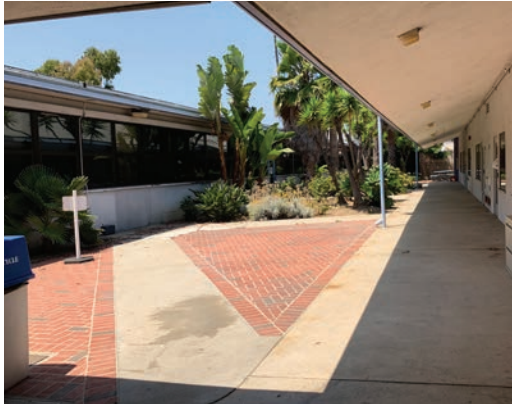
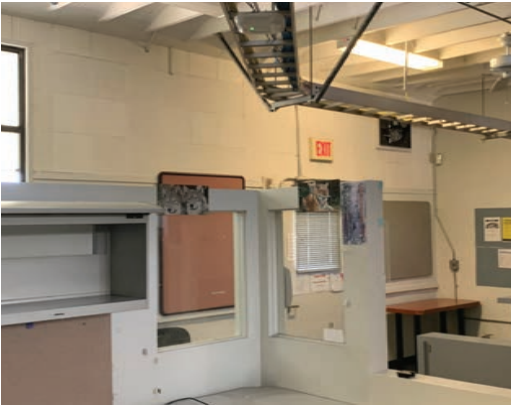
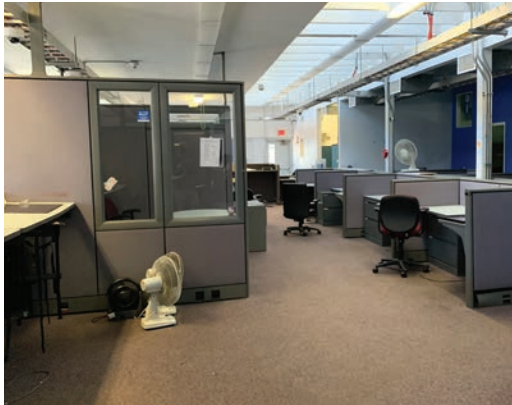
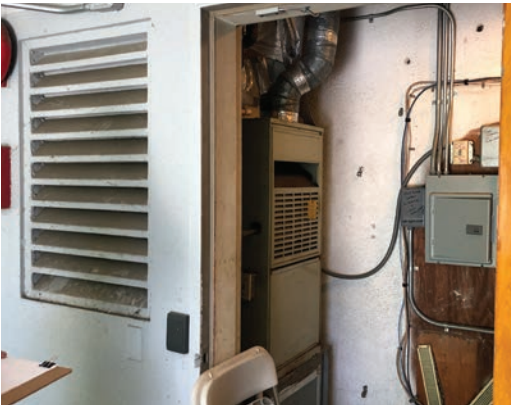
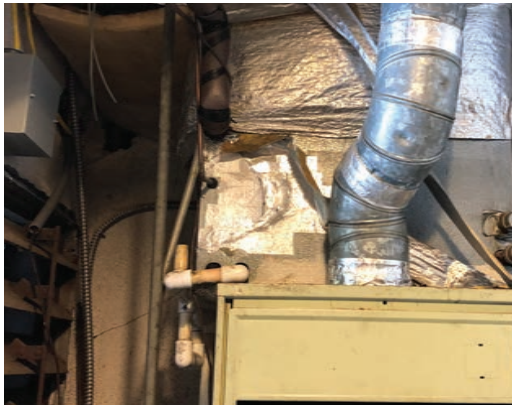
# BUILDING 1 - STUDENT SERVICES/ ADMISSIONS

SYSTEM	COMMENTS (CONDITION)	SHORT-TERM RECOMMENDATIONS
<b>ARCHITECTURE/ INTERIORS</b>	<p>Admissions complex consist of 6 buildings. Building is wood framing with painted stucco finish. Roof system is sloped wood structure. Doors are metal and wood with metal frame, and aluminum/glass sliding automatic door. Windows are dual pane with aluminum frame. Carpet flooring. Window treatments require replacement. Gutters require replacement.</p> <p>At the time of the survey the roof was not accessible. Protective tarp observed over low roof for possible water protection. Restrooms need upgrade; i.e. Insulation for the sinks. Overall spacial quality: small/cramped divided rooms, narrow corridors, no flexibility of space use, old infrastructure. Significant technology upgrades required. Existence of multiple ceiling and wall fans, indicate that the HVAC system is inadequate for proper cooling.</p>	<p>Replace roof and potential substrate/substructure due to existing water intrusion; access and accessibility are deficient and all areas will need renovation to bring to current compliance; building services are deficient and must be replaced; restrooms need to be added/upgraded to the facility; windows and exterior doors to be replaced for energy compliance; likely require exterior wall/roof insulation for energy compliance; replace gutters for proper drainage.</p>

<b>STRUCTURE</b>	<p>Structural Assessment noted here is data reported on Fusion, 2017. "The building rests on a slab on grade using wood framing with a painted stucco finish." Further assessment requires more in-depth investigation.</p>	
<b>MECHANICAL</b>	<p>This complex contains a number of small (under 2000 CFM) split Air Conditioning systems. Most of the systems are consisted vertical constant volume gas furnaces retrofitted with DX cooling coils. One of the systems is a split heat pump. The system controls are outdated and the systems do not employ economizers, which is useful in areas with the cool climate conditions and not compliant with T24 Energy Efficiency Standards. Systems start/stop is provided from the time clock. It appears, there was no environmental cleaning provided for the air distribution systems and it might be feasible simply to replace entire systems.</p>	<p>All split AC equipment have exceeded useful service life should be replaced with new. The new units shall be retrofitted with economizer and connected to BMS for control and maintenance program implementation.</p>

SYSTEM	COMMENTS (CONDITION)	SHORT-TERM RECOMMENDATIONS
<b>PLUMBING</b>	<p>The domestic hot water is served to this building from a 1992 AO Smith Energy Saver 38,000 BTU gas-fired storage-type water heater with 38.9 gallon storage capacity. Although this water heater is still functioning, it is well past its expected service life and should be replaced in the near future. The water closet fixtures are in moderate condition and of moderate age, but they still function properly with minimal cosmetic issues. The flush valves have the most wear as there is discoloration from small leaks over time. The urinals appear to be much older and are the floor-mount type, representing their age. The urinal flushometers are fairly new with sensor activation to meet the latest codes. The lavatory fixtures are in moderate condition with some wear, however, not all faucets are ADA-compliant. The p-traps also show small leaks over time with discoloration. In general, although all fixtures are functioning properly, it is recommended that all fixtures be replaced with newer types to improve the conditions, functioning and meet the latest codes.</p>	<p>Add padding to the lavatory P-traps. Replace lavatory faucets with ADA. Replace water heater in the near future. Consider replacing all fixtures if matching conditions desired.</p>

<b>ELECTRICAL</b>	<p>Electrical distribution equipment was observed to be per original construction. They were observed to be in bad condition. This building was served from a 225 KVA transformer, 4160 to 120/208 volt, 3 <math>\phi</math>, 4W. Main distribution panel was observed to be 800 amps. Lighting in this building were observed to be fluorescent type. This building was observed to be using regular wall switches for lighting control. Any future electrical work that involves lighting will require new lighting controls compliant with the California Title 24 energy code and other applicable codes, for this building.</p>	<p>It was observed that this building still utilizes Cat3 &amp; Cat5 cabling for information technology. It was also found that this building still have 10/100 Mbps switches. We recommend to provide new Cat6A cabling and to provide new 1Gbps or 10Gbps switches.</p>
<b>FIRE SPRINKLERS/ FIRE ALARM</b>	<p>There was no smoke detector nor heat detector found in these building. Only fire alarm horns and strobe were found within this building. There was no Emergency Voice/Alarm Communication System (EV/ACS) found in this building.</p>	<p>A fire alarm upgrade is recommended for the building.</p>

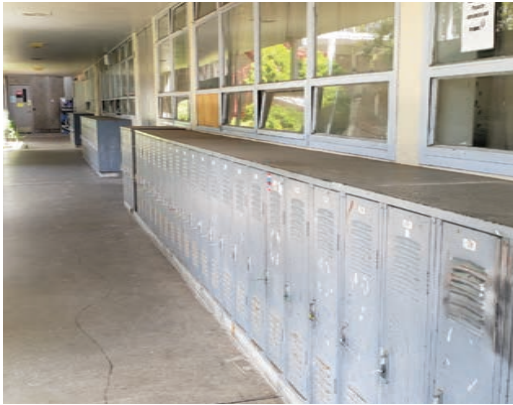
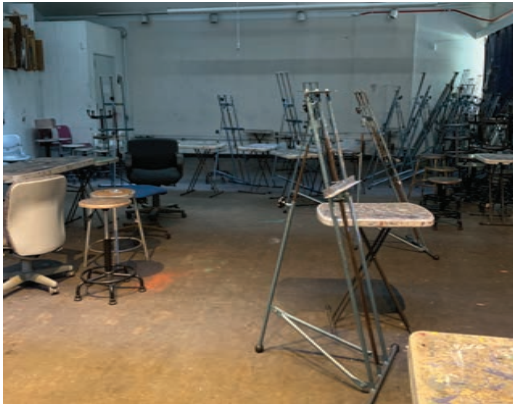
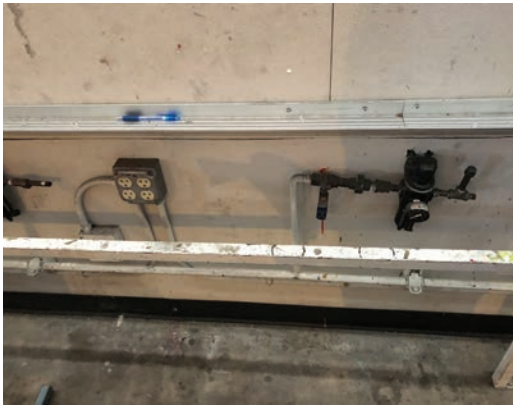
# BUILDING 3 - ART COMPLEX

SYSTEM	COMMENTS (CONDITION)	SHORT-TERM RECOMMENDATIONS
<b>ARCHITECTURE/ INTERIORS</b>	<p>Exterior walls are Cast-in-place concrete. Metal doors with panic hardware. Metal and aluminum windows with double or single pane. At the kiln yard, there is significant leakage through the temporary roof structure. Portions of the roof are broken. Entry door for fork lift is too small and inadequate. Floor drains are clogged. Kilns are old and unsafe to use. Air compressor condensates and blows water instead of air. No air circulation at Kiln yard. No student restroom in the building. Circuits are constantly tripping due to overload. Space is not conducive to student observation of instruction in the kiln and glass blowing areas.</p>	<p>Replace roof and potential substrate/substructure due to existing water intrusion; access and accessibility are deficient and all areas will need renovation to bring to current compliance; building services are deficient and must be replaced; restrooms need to be added to the facility; windows and exterior doors to be replaced for energy compliance; likely require exterior wall/roof insulation for energy compliance; potential to replace gutters for proper drainage</p>

<b>STRUCTURE</b>	<p>Structural Assessment noted here is data reported on Fusion, 2017. "The building rests on a slab on/below grade using spread footings at the exterior walls with a partial basement using cast in place concrete walls." Further assessment requires more in-depth investigation.</p>	
<b>MECHANICAL</b>	<p>The single-story buildings have only heating and ventilating systems, which are provided by space heaters installed in the individual classrooms. There are two existing boilers installed in 2012 in the basement mechanical room. However, the gravity flue vent has excessive numbers of elbows in violation of mechanical code and it needs to be corrected. The existing air conditioning system were installed in 2015 and they are in good operating condition. The existing process area dealing with wood dust, ceramics dust and glass, etc. have no dust collection systems intended to evacuate dust from the space. The ceramic shop has no doors separating from the staircase and combustion openings in the boiler room. The staircase and the boiler room is covered with thick layer of dust. This presents environmental hazard and need to be corrected. People working near kilns complained about poor temperature control associated with hot temperature radiating from equipment. There is also no venting system provided for the kilns from what we observed during site visit.</p>	<p>Provide new dust collection system and local exhaust in front of the kilns. Repair or replace kilns emitting excessive amount of heat creating discomfort for people working near them. Modify flue vent as required to bring it in compliance with the code. As an option provide fan assist at the top of the flue vent. Replace outdated HVAC controls. Provide door in the ceramic shop in order to prevent dust spread to other building areas.</p>

SYSTEM	COMMENTS (CONDITION)	SHORT-TERM RECOMMENDATIONS
<b>PLUMBING</b>	<p>This building has multiple plumbing issues. There are two (2) large floor drains on each side of the ceramics / glass area that have been disconnected and filled in. These drains are essential for cleanup as the floors are washed weekly and water should discharge to these drains. Without these drains, cleanup is far more difficult for the staff and students. The chisels, compressed air reels, and sand blaster machines all cannot function properly as water is quickly introduced into the compressed air system. Filters have been added in multiple places, but they cannot keep up with the amount of water entering the system; water is continuously present in the system. The ceramics sink is fitted with an Eemax storage water heater below the sink along with a clay trap. The sink functions, but it should be replaced with a newer model with a new clay trap. The paint room sinks are well covered in paint as expected, but they function properly with Eemax water heaters.</p>	<p>Replace clogged floor drains. Replace worn out but functional sinks and clay trap. Fix or repair air compressor from accumulating water. Due to the age and longterm use, sinks at paint room should also be replaced.</p>

<b>ELECTRICAL</b>	<p>Electrical distribution equipment was replaced in 1998, They were observed to be in fair condition. This building was served from a 150 KVA transformer, 4160 to 120/208 volt, 3 ø, 4W. Main distribution panel was observed to be 600 amps. Lighting in this building were observed to be fluorescent type. There was no observable lighting control found in this building during the visit. We recommend upgrading the light fixtures to more efficient LED type and providing a new lighting control system compliant with the California Title 24 energy code and other applicable codes, for this building.</p>	<p>It was observed that this building still utilizes Cat3 &amp; Cat5 cabling for information technology. It was also found that this building still have 10/100 Mbps switches. We recommend to provide new Cat6A cabling and to provide new 1Gbps or 10Gbps switches.</p>
<b>FIRE SPRINKLERS/ FIRE ALARM</b>	<p>This building was observed to have smoke/heat detectors but don't have Emergency Voice/Alarm Communication System (EV/ACS).</p>

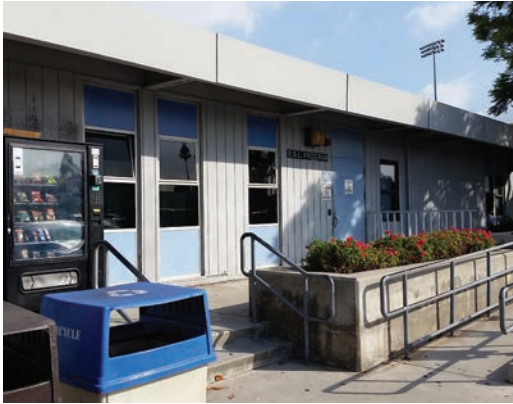
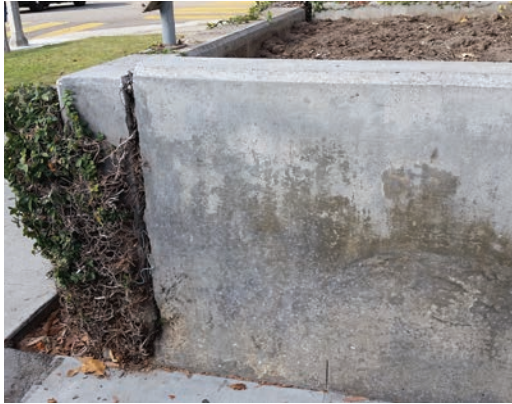
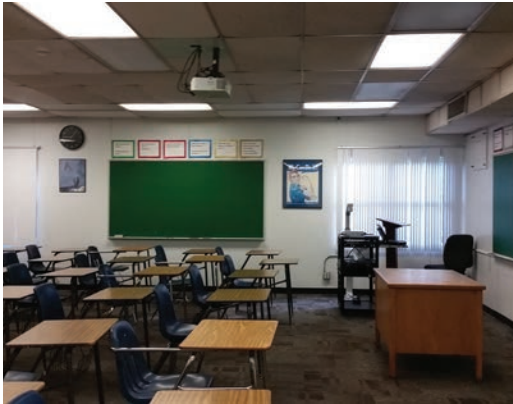
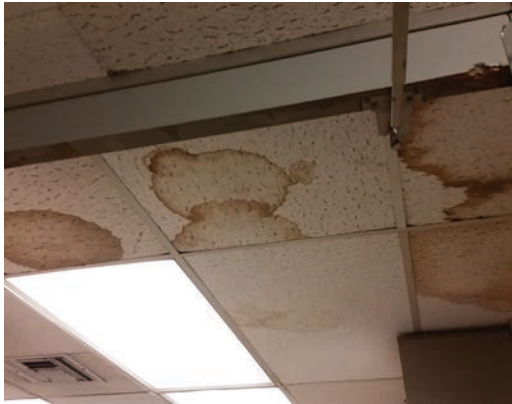
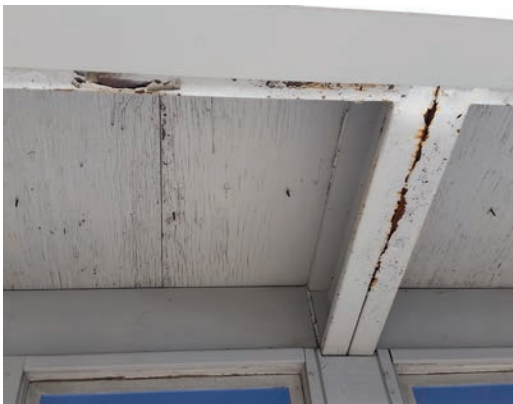
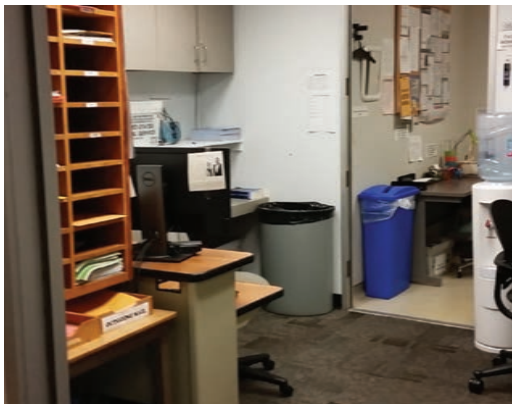
# BUILDING 5 - ESL

SYSTEM	COMMENTS (CONDITION)	SHORT-TERM RECOMMENDATIONS
<b>ARCHITECTURE/ INTERIORS</b>	<p>This is a modular wood framed building with T1-11 siding. Windows are single pane aluminum frame. Exterior doors are wood in aluminum frame. Interior walls are painted stucco. Ceilings are acoustic tiles in metal grid. Flooring is Carpet that are old. Ceilings show water damage. Lighting is dim. Hallways are narrow. Furniture is old and seating layout is not flexible. There is strong mold odor inside the building.</p>	<p>Replace roof and potential substrate/substructure due to existing water intrusion; access and accessibility are deficient and all areas will need renovation to bring to current compliance; building services are deficient and must be replaced; restrooms need to be added to the facility; windows and exterior doors to be replaced for energy compliance; likely require exterior wall/ roof insulation for energy compliance; potential to replace gutters for proper drainage; mold/mildew remediation; replace all interior finishes and systems; replace exterior siding; repair damaged concrete.</p>

<b>STRUCTURE</b>	<p>Structural Assessment noted here is data reported on Fusion, 2017.          “The building rests on perimeter concrete footings supporting a metal frame.          The roof system is mono foam of 1986 vintage,per staff. “          Further assessment requires more in-depth investigation.</p>	
<b>MECHANICAL</b>	<p>The existing building is a single story structure provided with (6) six rooftop packaged units each serving a part of the building. The units are of the original installation, have substantially exceeded useful service life and should be replaced. The systems have not been environmentally cleaned.</p>	<p>The units should be replaced with new rooftop packaged units equipped with the economizers and painted with corrosion protective coating. The duct systems shall be environmentally cleaned. Duct supports on the roof should be designed to comply with the current structural code requirements.</p>

SYSTEM	COMMENTS (CONDITION)	SHORT-TERM RECOMMENDATIONS
<p><b>PLUMBING</b></p>	<p>The water closets, urinals and lavatories with accompanying flushometers and faucets are all in good condition. All are automatic sensor type with minimal to no cosmetic wear and function properly. Some toilets are tank type. Bath tub are sealed and not used. Recommend to remove or replace. Recommend to replace electric water heater, and service sink.</p>	<p>Replace water heater and service sink. Replace bath tub or demolish if not to be used.</p>
<p><b>ELECTRICAL</b></p>	<p>Electrical distribution equipment was observed to be per original construction. We recommend having electrical distribution equipment to be replaced. Service for this building was observed to be 400 amps, 120/240 volt, 1 ø, 3W. Lighting in this building were observed to be fluorescent type. We observed absence of motion sensors for lighting control within rooms and hallways. We also observed presence of fire life safety devices such as pull station and notification appliance. But there was no smoke detector found during the visit. We recommend upgrading the light fixtures to more efficient LED type and providing a new lighting control system compliant with the California Title 24 energy code (which would require additional lighting control devices such as dimmers, daylight harvesting sensors. Etc.) and other applicable codes, for this building. We also recommending updating fire life safety system for compliance to latest code.</p>	<p>It was observed that this building still utilizes Cat3 &amp; Cat5 cabling for information technology. It was also found that this building still have 10/100 Mbps switches. We recommend to provide new Cat6A cabling and to provide new 1Gbps or10Gbps switches.</p>

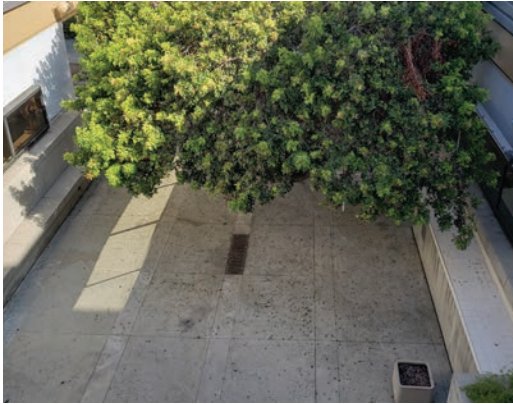
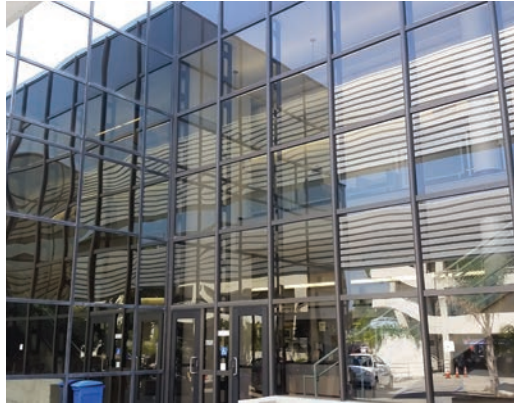
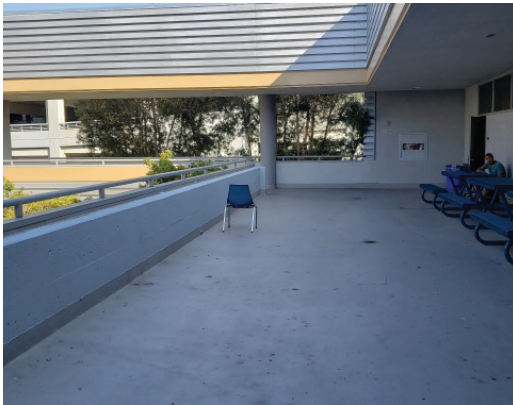
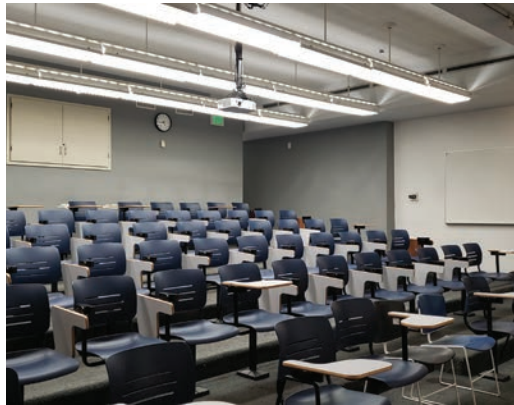
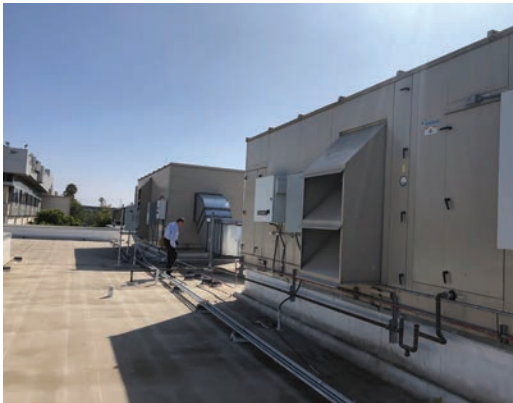
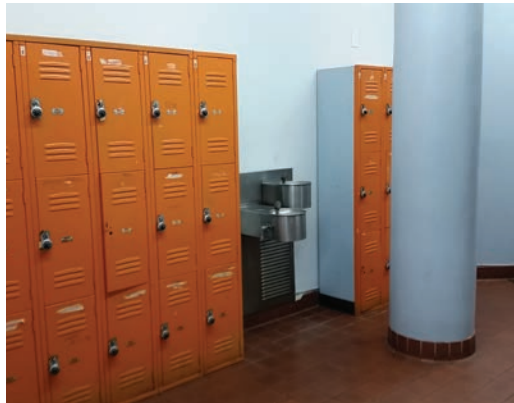
# BUILDING 6 - BUSINESS

SYSTEM	COMMENTS (CONDITION)	SHORT-TERM RECOMMENDATIONS
<b>ARCHITECTURE/ INTERIORS</b>	<p>The exterior walls at Business building are cast concrete. Façade is mostly large panels of glass storefront system with metal frames to the roof. Roofing system is rolled asphalt. Interior walls are painted drywall and CMU. Ceilings are suspended acoustic tiles. Flooring is VCT vinyl tiles or carpet. Doors are wood, metal, or aluminum with metal and aluminum frames.</p> <p>Some rooms have water damage from ceiling. Corridor paint is in good condition. Exterior glass walls need cleaning. Carpets need to be replaced. Seating layouts generally open and flexible. Second floor courtyard balcony floor needs to be painted. Some ceiling tiles showed water damage from the roof. Restroom sink pipes were not insulated. Some hallway ceilings showed water damage.</p> <p>Cosmotology building was treated for Bed bugs.</p>	<p>Replace roof and potential substrate/substructure due to existing water intrusion; access and accessibility are deficient in some areas and will need renovation to bring to current compliance; interior finishes to be replaced (flooring, ceiling tiles, some painted walls, etc); signage may need replacing</p>

<b>STRUCTURE</b>	<p>Structural Assessment noted here is data reported on Fusion, 2017.</p> <p>“The building rests on a slab on grade using wood framing with a painted stucco finish.”</p> <p>Further assessment requires more in-depth investigation.</p>	
<b>MECHANICAL</b>	<p>The building is provided with variable air volume air conditioning systems delivering air to the individual comfort zones via VAV boxes with terminal reheat. Three roof mounted air handling units serve the majority of spaces in the building. Two heating hot water gas fired boilers, installed in 2012, are located in the penthouse and provide heating for the terminal reheat. Boiler-2 primary circulating pump has water leak and it needs to be repaired. Chilled water for the building is provided from the central plant.</p> <p>Although the building went through renovation in some areas, the majority of VAV boxes are existing and may need to be retrofitted with new controls. Environmental exhaust is provided by several roof mounted exhaust fans. The building controls are by the Automated Logic and interconnected with the campus BMS.</p>

SYSTEM	COMMENTS (CONDITION)	SHORT-TERM RECOMMENDATIONS
<b>PLUMBING</b>	<p>The water closets, urinals and lavatories with accompanying flushometers and faucets are all in good condition having been replaced in recent years. All are automatic sensor type with minimal to no cosmetic wear and function properly. The domestic water heating system consists of two (2) 1998 American Standard storage-type gas-fired water heaters with 100 gallon storage capacity each, 270,000 BTU input. While these water heaters are still operating properly, they have passed their expected service life and should be replaced in the near future with more-efficient types.</p>	<p>Replace only the water heater in the near future. No other repairs or replacement needed.</p>
<b>ELECTRICAL</b>	<p>Electrical distribution equipment was observed to be per original construction. They were observed to be in fair condition. This building was observed to have its own service from SCE. Existing service equipment was observed to be 1600 amps, 277/208 volts, 3 ø, 4W. Lighting in this building were observed to be fluorescent type. This building was observed to be using motion sensors for lighting control. We recommend upgrading the light fixtures to more efficient LED type and providing a new lighting control system compliant with the California Title 24 energy code (which would require additional lighting control devices such as dimmers, daylight harvesting sensors, etc.) and other applicable codes, for this building.</p>

<b>FIRE SPRINKLERS/ FIRE ALARM</b>	<p>This building was observed to have smoke/heat detectors but don't have Emergency Voice/Alarm Communication System (EV/ACS).</p>

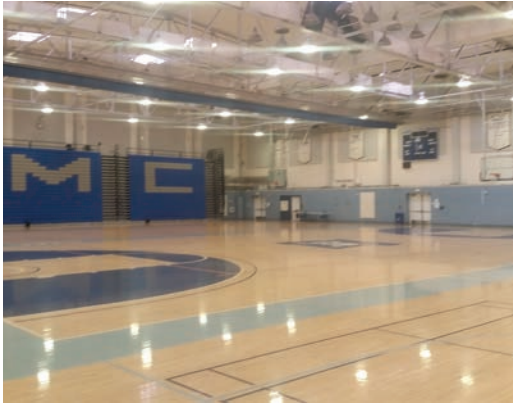
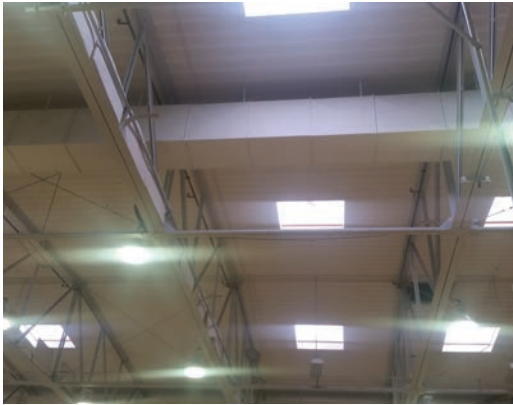
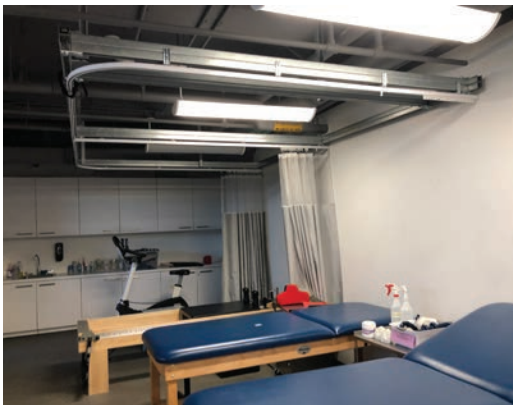
# BUILDING 8 - GYMNASIUM

SYSTEM	COMMENTS (CONDITION)	SHORT-TERM RECOMMENDATIONS
<b>PLUMBING</b>	<p>The drinking fountains in the gym space are of mixed ages and types. One group is very old and should be replaced while the other set is rather new, but needs maintenance repairs. It is suggested that both be replaced. The locker rooms and restroom areas are newer and in good operating condition with automatic sensor-type flushometers and faucets; all fixtures have minimal cosmetic wear. No suggestions for upgrades are suggested in these areas.</p>	<p>Only replace drinking fountains at this time.</p>
<b>ELECTRICAL</b>	<p>Electrical distribution equipment was observed to be per original construction. They were observed to be in fair condition. This building was served from a 500 KVA transformer, 4160 to 120/208 volt, 3 ø, 4W. Main distribution panel was observed to be 1400 amps. Lighting in this building were observed to be high bay hid type. Lighting control for this building were also from original built-out using lighting contractors and time clocks. We recommend installing new lighting controls compliant with the California Title 24 energy code and other applicable codes, for this building.</p>

<b>FIRE SPRINKLERS/ FIRE ALARM</b>	<p>There was no smoke detector nor heat detector found in these building. Only fire alarm horns and strobe were found within this building. There was no Emergency Voice/Alarm Communication System (EV/ACS) found in this building. We are recommending for a fire alarm upgrade for this building.</p>

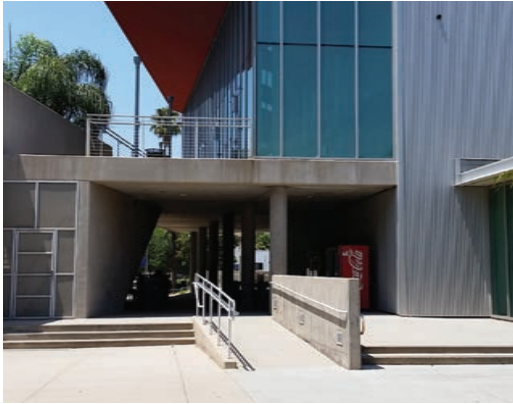
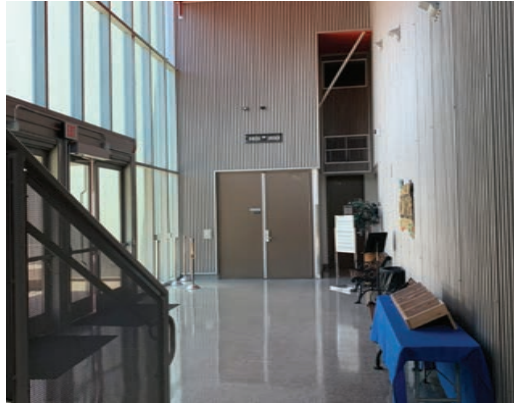
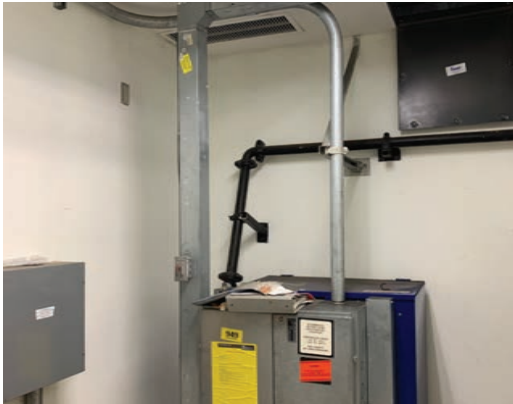
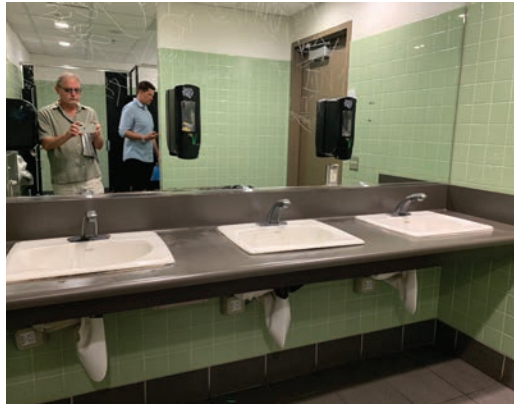
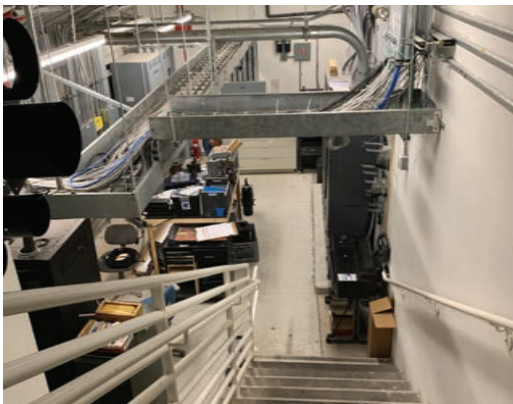
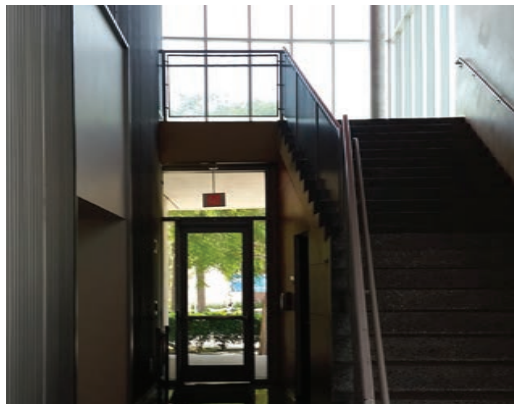
SYSTEM	COMMENTS (CONDITION)	SHORT-TERM RECOMMENDATIONS
<b>ARCHITECTURE/ INTERIORS</b>	<p>Exterior walls of the Theater Arts building are tilt-up concrete with corrugated metal finish. Interior walls are painted gypsum. Exterior doors are aluminum frame store front system with single pane glass. Interior doors are metal in metal frame. Windows are dual pane glass. Flooring is a combination of carpet, concrete, terrazzo, hardwood, and VCT. Theater area has acoustic walls and ceiling panels. Overall lighting, temperature, and acoustics are adequate in the building. Architectural elements are in good condition.</p>	<p>Areas of interior paint (handrails); bathroom mirrors replace due to etched tags.</p>
<b>STRUCTURE</b>	<p>Structural Assessment noted here is data reported on Fusion, 2017.          “The building is a concrete slab on and below grade using metal framing and pan deck and the exterior walls are tilt-up type concrete construction with corrugated metal and concrete wall finishes.”</p>

<b>MECHANICAL</b>	<p>The existing HVAC systems went through major renovation approximately 15 years ago, with new rooftop packaged gas/electric units provided as a replacement to the existing HVAC equipment. The units serve individual comfort zones. The majority of the units are constant volume with the exception of the AC-2 serving studios 2 &amp; 3. There are also four split system located on the roof and serving support areas. All units are at the end of useful service life and should be replaced.          The existing HVAC controls are provided by Automated Logic controls.</p>	<p>Replace rooftop packaged units with VFDs and outdoor condensing units. Provide environmental ducts cleaning.</p>
<b>PLUMBING</b>	<p>The water closets, urinals and lavatories are all in moderate condition fitted with primarily automatic sensor-type flushometers and lavatories. Some wear is seen on the water closets and lavatories. Upgrades are suggested, but not required.</p>	<p>No repairs needed at this time but consider and/or revisit in the near future.</p>

SYSTEM	COMMENTS (CONDITION)	SHORT-TERM RECOMMENDATIONS
<b>ELECTRICAL</b>	<p>This building was remodeled around 2013. Electrical distribution equipment was observed to be fairly new and in very good condition. Electrical building service was observed to be 1600 amps, 277/480 volt, 3 ø, 4W. Lighting in this building were observed to be fluorescent type for general and house lighting and professional theatrical lighting for performance stage. Lighting control for theatrical portion of the building was observed to be professional dimming racks with lighting console. For other room lighting controls, it was observed to have motion sensors.</p>	
<b>FIRE SPRINKLERS/ FIRE ALARM</b>	<p>This building was observed to have smoke/heat detectors but don't have Emergency Voice/Alarm Communication System (EV/ACS).</p>

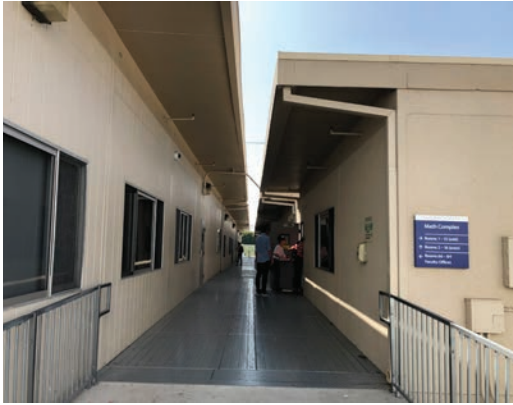
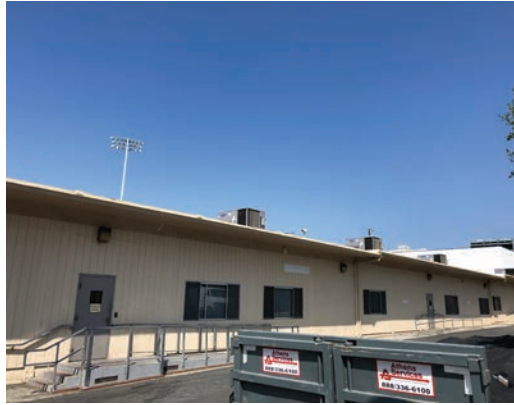
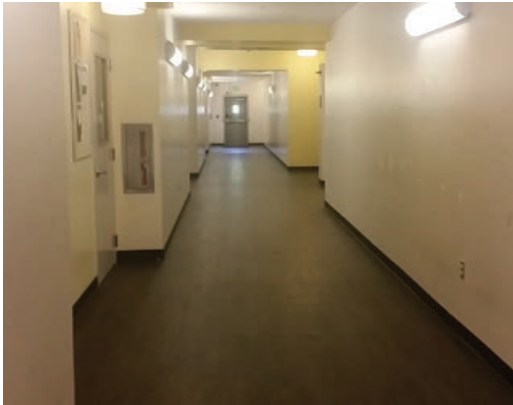
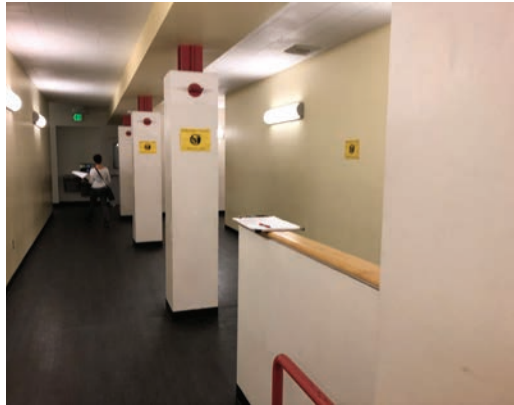
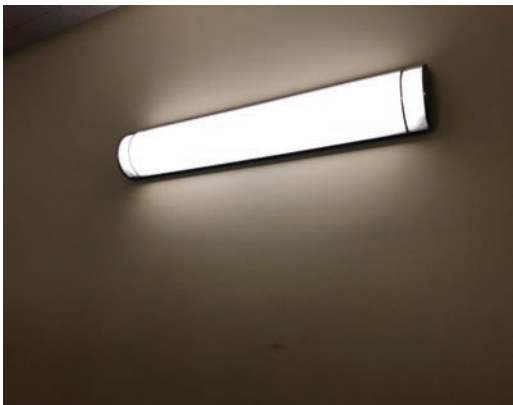
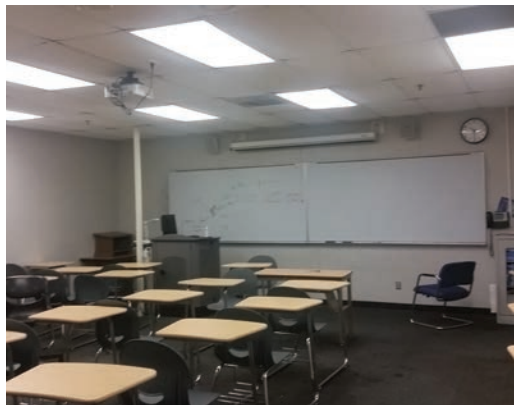
SYSTEM	COMMENTS (CONDITION)	SHORT-TERM RECOMMENDATIONS
<b>ARCHITECTURE/ INTERIORS</b>	The Math complex consists of 2 separate buildings sharing a wood/trex raised deck outdoor corridor on metal frame. Walls are wood and stucco siding. Doors are wood and metal in metal frame. Windows are single pane in aluminum frame. Walls and ceilings need maintenance, fixing and painting. Carpets are old and have mold smell. Lighting is insufficient. There is no acoustical surfaces. Rooms are small and cramped. Furniture is old and layouts are not flexible.	Windows and exterior doors to be replaced for energy compliance; likely require exterior wall/roof insulation for energy compliance; finishes need updating or replacing; mold/mildew remediation; replace lighting; given these buildings were meant to be temporary, they should be replaced.
<b>STRUCTURE</b>	Structural Assessment noted here is data reported on Fusion, 2017. “(The buildings) rest on concrete stem walls using metal framing supporting a wood sub floor.”

<b>MECHANICAL</b>	The building was retrofitted less than a year ago with rooftop packaged heat pump units intended to serve individual spaces.	Provide environmental ducts cleaning.
<b>PLUMBING</b>	The domestic water heater, water closets, urinals and lavatories are all in good operating condition. No recommendations are suggested.	No worked needed

SYSTEM	COMMENTS (CONDITION)	SHORT-TERM RECOMMENDATIONS
<b>ELECTRICAL</b>	<p>Electrical distribution equipment was observed to be per original construction. Main distribution equipment is all located outdoors. Equipment enclosure were observed to have small amount metal corrosion, but equipment is in fair condition. It was observed that this building have a 225 amp panelboard, 120/240 volt, 1 ø, 3W Lighting in this building were observed to be fluorescent type. This building was observed to be using motion sensors for lighting control. "We recommend upgrading the light fixtures to LED type and providing a new lighting control system compliant with the California Title 24 energy code (which would require additional lighting control devices such as dimmers, daylight harvesting sensors, etc.) and other applicable codes, for this building.</p>	<p>It was observed that this building still utilizes Cat3 &amp; Cat5 cabling for information technology. It was also found that this building still have 10/100 Mbps switches. We recommend to provide new Cat6A cabling and to provide new 1Gbps or10Gbps switches.</p>

<b>FIRE SPRINKLERS/ FIRE ALARM</b>	<p>This building was observed to have code complaint smoke/heat detectors but don't have Emergency Voice/Alarm Communication System (EV/ACS).</p>

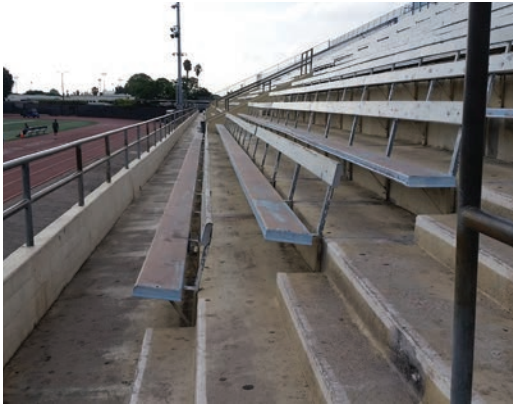
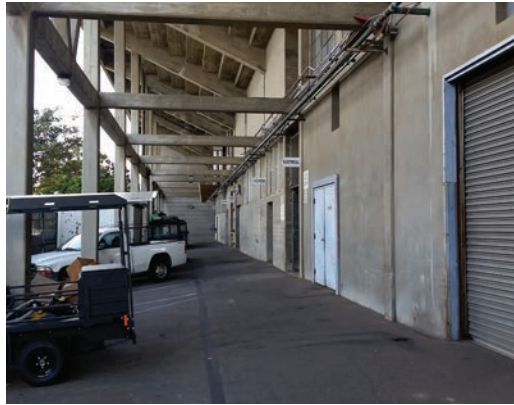
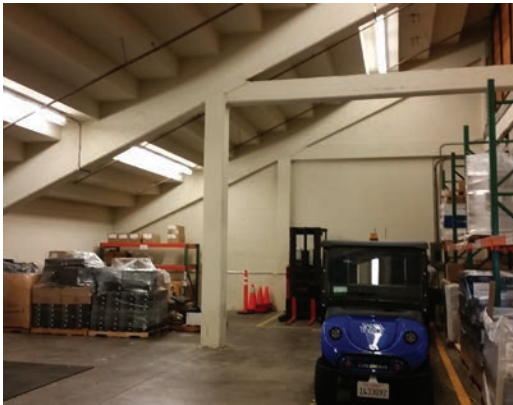
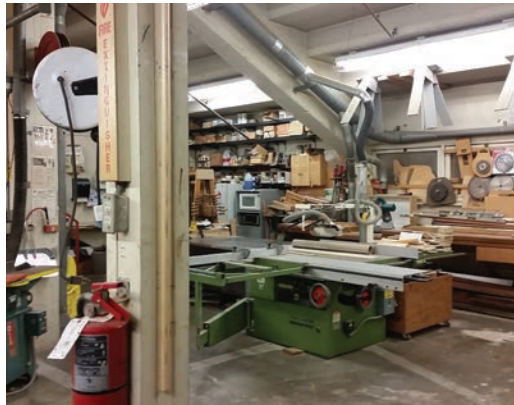
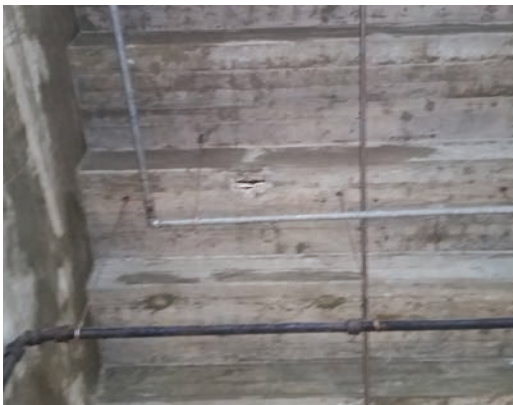
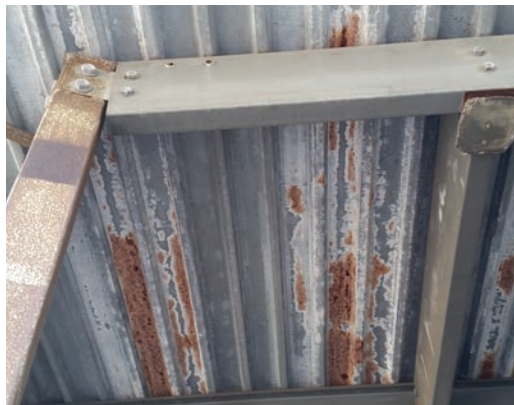
SYSTEM	COMMENTS (CONDITION)	SHORT-TERM RECOMMENDATIONS
<b>ARCHITECTURE/ INTERIORS</b>	<p>Stadium facilities consist of permanent and modular buildings. These buildings house offices, shops, bleachers, press box, storage, and ticket booth. Small buildings are wood framing with wood siding. Doors are metal with metal frame. Windows are wood, metal, and aluminum framed single pane. Roofing is built-up rolled asphalt. Back of office building is filled with combustible material such as Refrigerants, R11, R22, etc. Structure is rusted and the roof leaks. The exhaust fan was permitted in 1980. Spray booth is very old. The Ceiling in Men's bathroom at stadium has large cracks and pieces of concrete fall out. In the past, raw sewage came out of pipes in driveway. Water heater in shops is old and exposed. Doors are rusted aluminum with holes. They do not have accessible hardware. Water in Bathroom pipe is brown. Many pipes are old and exposed.</p> <p>Storage space under bleachers is underused and not utilized fully. There is no Eyewash station for storage area. There is no A/C. There is no ventilation. Circulation is poor with only one access door for the space. There is no exhaust in the Bathrooms. Floors are unfinished concrete and many areas have cracks. Concrete beams are damaged. There is no floor drainage. Interior doors are wood or metal, in wood or aluminum frames using a combination of level and knob type hardware.</p> <p>Bleachers are old and some are broken. There are no accessible path or seating areas. No FLS strobes. Stairs leak into space below.</p>

<b>STRUCTURE</b>	<p>Structural Assessment noted here is data reported on Fusion, 2017.</p> <p>“Some buildings are slab on grade cast in place concrete and concrete block construction and others are metal frame resting on green plate on asphalt.”</p> <p>Further assessment requires more in-depth investigation.</p>	
<b>MECHANICAL</b>	<p>The building has no air conditioning to provide comfort for the users or to maintain space temperature for the stored materials. No ventilation is available when the exterior doors are closed. Flue vents and environmental exhaust are located adjacent to operable windows in violation of the Mechanical Code.</p>	<p>Demolish all obsolete HVAC systems and replace with split HEAT pump systems and functional exhaust systems. Provide OA intakes required by code.</p>

SYSTEM	COMMENTS (CONDITION)	SHORT-TERM RECOMMENDATIONS
<p><b>PLUMBING</b></p>	<p>The Gym restrooms appear to be very old and the fixtures age matches overall architectural conditions. Although most fixtures function properly, it remains cosmetically outdated. Drinking Fountains are located inside the restroom, should be outside and some do not work. Lavatories should be replaced with ADA compliant padding on the P-Traps. HVAC shop has water heater in ceiling and appears old but functioning. Recommend replacing. Services sinks are old and should be replaced. Eye Wash Station works but it not is locations outside the shops where it is not easily accessible in case of emergency. Should be replaced with new and put inside the shop rooms. The rest of the fixtures are in mixed conditions and should be replaced on a case by case basis.</p>	<p>Provide new drinking fountain currently in restroom but relocate them outside. Provide new lavatories with ADA compliant. Piping under lavatories are not padded. Replace Urinals with partitions for privacy. Water closets are functional. Replace if matching with new restroom desired to have same overall clean look. Replace service sink. Replace eye wash and shower but relocate to where its easily accessible in shop rooms. Replace service sink and heater in shop.</p>

<p><b>ELECTRICAL</b></p>	<p>Electrical distribution equipment was observed to be per original construction. We recommend having electrical distribution equipment to be replaced. Service for this building was observed to be 600 amps, 120/240 volt, 1 ø, 3W. Lighting in this building were observed to be fluorescent type. We observed absence of motion sensors for lighting control within rooms and hallways. We also observed the absence of fire life safety devices such as smoke detectors, and fire alarm pull stations. We recommend upgrading the light fixtures to more efficient LED type and providing a new lighting control system compliant with the California Title 24 energy code (which would require additional lighting control devices such as dimmers, daylight harvesting sensors. Etc.) and other applicable codes, for this building. We also recommending updating fire life safety system for compliance to latest code.</p>	<p>It was observed that this building still utilizes Cat3 &amp; Cat5 cabling for information technology. It was also found that this building still have 10/100 Mbps switches. We recommend to provide new Cat6A cabling and to provide new 1Gbps or 10Gbps switches.</p>

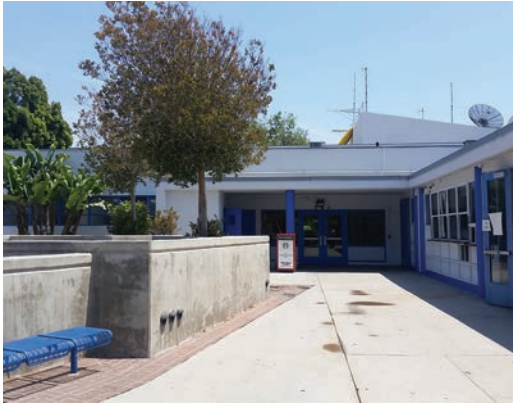
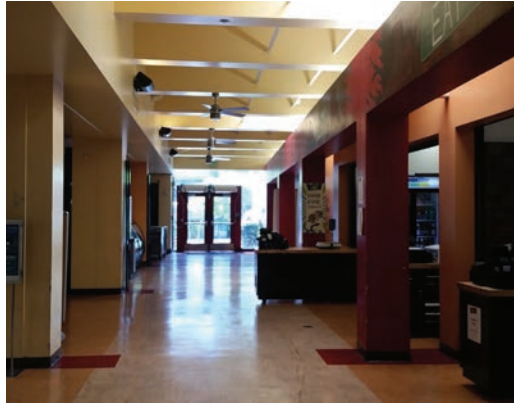
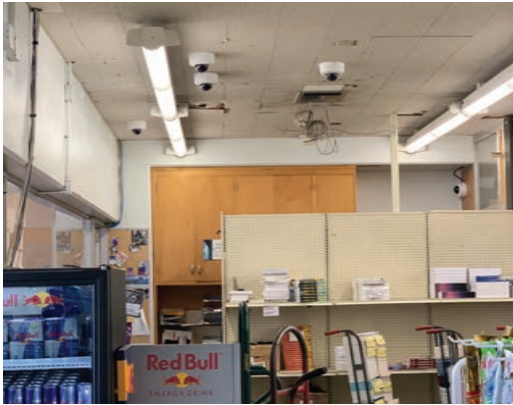
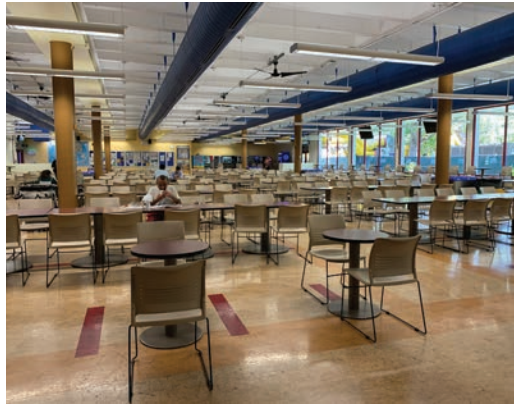
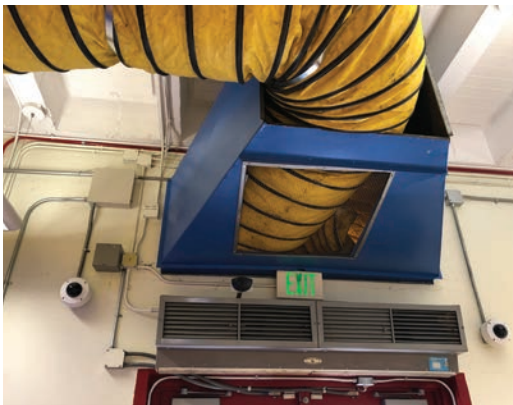
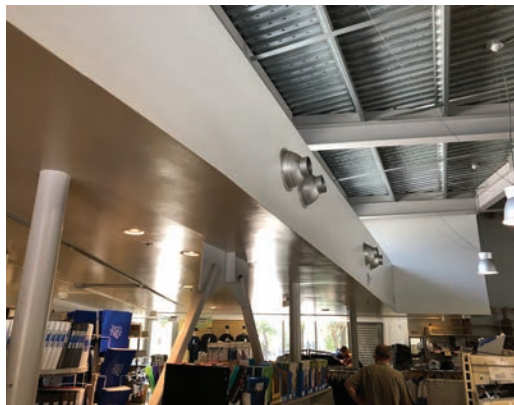
SYSTEM	COMMENTS (CONDITION)	SHORT-TERM RECOMMENDATIONS
<b>ARCHITECTURE/ INTERIORS</b>	<p>Students Activities building contains classrooms, offices, health center, cafeteria, dining hall, student study center, and the bookstore. Various portions have been remodeled or added over time. The second floor was added in 1990. The main structure is cast concrete. Exterior doors are aluminum frame storefront system. Windows are aluminum frame double and single pane. Interior walls are painted drywall or concrete. Ceilings are acoustic tile. Interior doors are wood with metal frame.</p> <p>The student store is generally in good condition. The bookstore interior needs update. Ceiling tiles are loose or missing. Floors and ceilings need repair. Walls need painting. There is poor security for visibility. Lighting is dim. Casework is damaged and needs repair. There is no permanent AC at the dining hall. Large windows provide good view to the outdoor courtyard. There is no acoustic panels in ceiling. Floors are easily cleanable. Seating layout is outdated and not flexible. Flooring needs buffing.</p>

<b>STRUCTURE</b>	<p>Structural Assessment noted here is data reported on Fusion, 2017.</p> <p>“The building rests on a slab on and below grade and spread footings using cast in place concrete exterior walls, with columns and interior load bearing walls. The main structure is cast concrete with a steel frame. The roof system looks like built up rolled asphalt of 2003 vintage.”</p>	
<b>MECHANICAL</b>	<p>The complex is consisted of single-story bookstore, cafeteria and two-story student activities space. The student cafeteria and activity center have heating ventilation system provided from the units located on the roof. The unit is installed in 1950’s and has reached the end of its service life. Inside second floor student activity center, the elevation of thermostat is a code violation.</p> <p>For the bookstore area, there is a heating ventilation system in the janitor room serving the bookstore and it is beyond its useful life. The bookstore only has several window type AC units to provide cooling.</p> <p>During the site visit, the temporary air conditioning units were operating with majority of spaces being unoccupied. It appears the temporary units are rented every summer for a number of years.</p> <p>In summary, all units appear to be over 20 years and have exceeded useful service life. The HVAC control system in the building is outdated and needs to be replaced.</p>	<p>Remove and replace all HVAC systems with rooftop packaged units. Redesign the systems as required utilizing variable air volume systems with economizers and terminal reheat in order to achieve sustainable and energy efficient environment. Provide new HVAC controls and connect to the campus BMS. Provide environmental ducts cleaning for the portion of ductwork to remain.</p>

SYSTEM	COMMENTS (CONDITION)	SHORT-TERM RECOMMENDATIONS
<b>MECHANICAL</b>	<p>The complex is consisted of single-story bookstore, cafeteria and two-story student activities space. The student cafeteria and activity center have heating ventilation system provided from the units located on the roof. The unit is installed in 1950's and has reached the end of its service life. Inside second floor student activity center, the elevation of thermostat is a code violation.</p> <p>For the bookstore area, there is a heating ventilation system in the janitor room serving the bookstore and it is beyond its useful life. The bookstore only has several window type AC units to provide cooling.</p> <p>During the site visit, the temporary air conditioning units were operating with majority of spaces being unoccupied. It appears the temporary units are rented every summer for a number of years.</p> <p>In summary, all units appear to be over 20 years and have exceeded useful service life. The HVAC control system in the building is outdated and needs to be replaced.</p>	<p>Remove and replace all HVAC systems with rooftop packaged units. Redesign the systems as required utilizing variable air volume systems with economizers and terminal reheat in order to achieve sustainable and energy efficient environment. Provide new HVAC controls and connect to the campus BMS. Provide environmental ducts cleaning for the portion of ductwork to remain.</p>

<b>PLUMBING</b>	<p>The water closets, urinals and lavatories are all in decent operating condition with some cosmetic wear. Minimal upgrades are suggested.</p>	<p>No repairs needed at this time but consider and/or revisit in the near future.</p>
<b>ELECTRICAL</b>	<p>Electrical distribution equipment was observed to be good condition except the equipment within book store. We recommend replacement for this equipment within the bookstore. This building also has an existing backup generator. This building was served from two 300 KVA transformer, 4160 to 120/208 volt, 3 ø, 4W. Main distribution panel was observed to be 1600 amps, typical of two. Lighting in this building were observed to be fluorescent type. This building was observed to be using motion sensors for lighting control. We recommend upgrading the light fixtures to more efficient LED type and providing a new lighting control system compliant with the California Title 24 energy code (which would require additional lighting control devices such as dimmers, daylight harvesting sensors. Etc.) and other applicable codes, for this building.</p>	<p>It was observed that this building still utilizes Cat3 &amp; Cat5 cabling for information technology. It was also found that this building still have 10/100 Mbps switches. We recommend to provide new Cat6A cabling and to provide new 1Gbps or 10Gbps switches.</p>

<b>FIRE SPRINKLERS/ FIRE ALARM</b>	<p>This building was observed to have smoke/heat detectors but don't have Emergency Voice/ Alarm Communication System (EV/ACS).</p>
