# SANTA MONICA COLLEGE

## 2040 CAMPUS MASTER PLAN

### FACILITIES CONDITIONS ASSESSMENT

*CREATED JUNE 2020; SUBMITTED JUNE 2024*

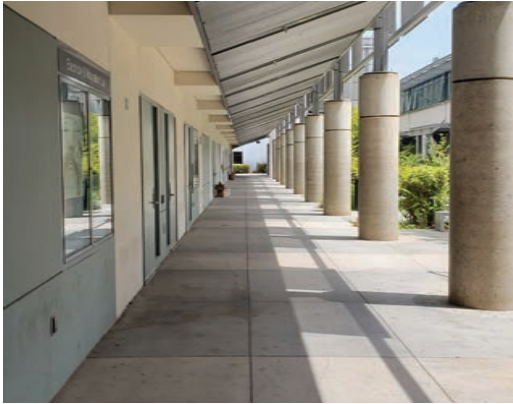
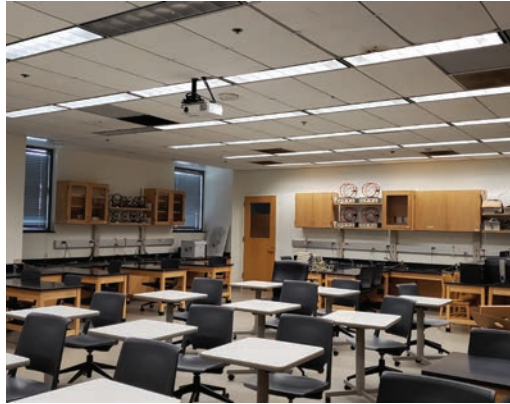
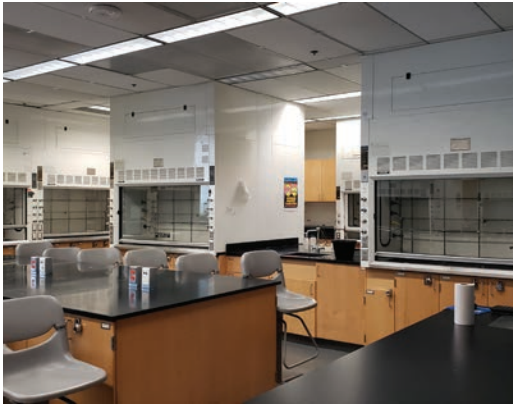
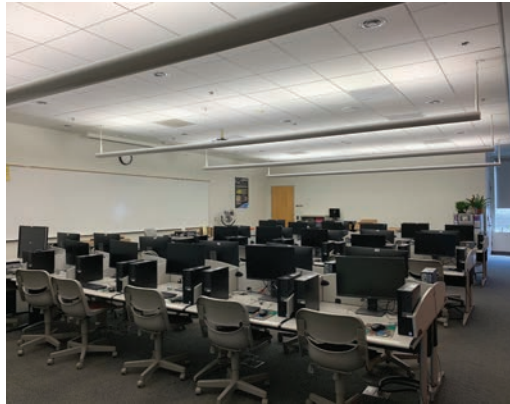
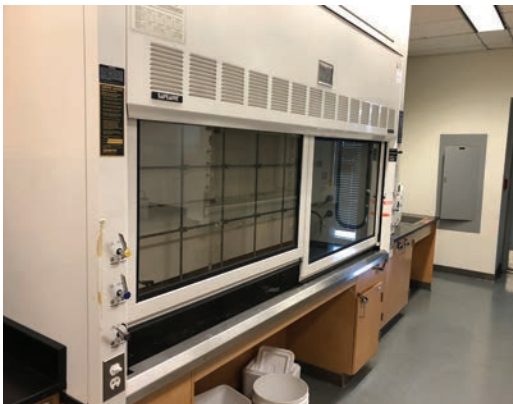
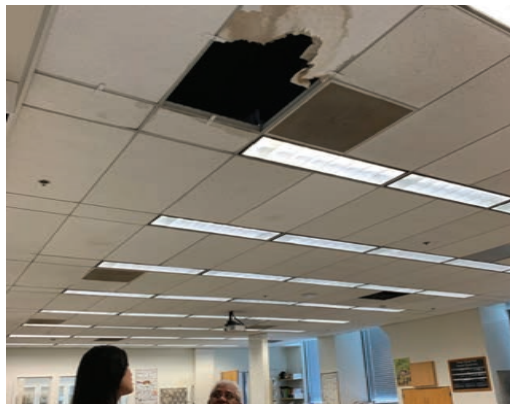
<p><b>STRUCTURE</b></p>	<p>Structural Assessment noted here is data reported on Fusion, 2017.</p> <p>“The building is of brick and steel frame construction with exterior window walls and architectural metal siding resting on a slab on grade and spread footings at exterior walls. The main structure is cast concrete. The roof system looks like built up rolled asphalt and metal standing seam that is original to construction.”</p>	
-------------------------	--	--

SYSTEM	COMMENTS (CONDITION)	SHORT-TERM RECOMMENDATIONS
<p><b>MECHANICAL</b></p>	<p>The Life and Physical Science building is consisted of a two-story and three-story building. The three-story portion is consisted of lab, auditorium, computer learn/ research space and is served by several variable air volume air handling units located on the roof. Chilled water is provided from central plant and the connection was implemented in 2015 to the new tertiary pumps provided at the same time. The existing cooling tower located on the roof was demolished and the chillers were removed from the basement mechanical equipment room. The chemical exhaust systems are manifolded on the roof into a common duct. The air handling units AHU-1, AHU-2, which were built approximately twenty years ago. The air handling units and exhaust fans show severe signs of rust and are approaching the end of its service life. The insulation on AHU-2 supply duct has largely peeled off. The condensate drainage appears to be not very affective and it contributes to the units corrosion problem</p> <p>Three heating hot water boilers provided with circulating pumps installed approximately 10 years ago in the penthouse mechanical room.</p> <p>The two-story building wings, which consist of faculty offices and classrooms do not have air-conditioning. Temporary AC unit are provided to the classrooms to maintain proper level of comfort.</p> <p>The three story building portion only has existing HVAC controls modified in relationship to the central plant project conducted in 2015. The remaining controls are over 20 years old and should be replaced.</p>	<p>Provide air conditioning for the 2-story building portion utilizing air handling units and VAV systems. Replace AHU-1 and AHU-2 approaching the end of useful service life. Replace the existing fume hood exhaust fans with the new equipped with the variable geometry air discharge dampers in order to maintain approximately 3,000 - 3,500 fpm outlet air velocity. Replace 20-years old HVAC controls to match campus standards. Remove and replace damaged duct insulation. Fix the condensate drainage by cleaning the pipe and verify if it has been properly sloped. Consider replacing the existing boilers and pumps with new condensing type boilers configured into primary/secondary loop with the secondary pumps equipped with VFDs. Provide environmental ducts cleaning.</p>

<p><b>PLUMBING</b></p>	<p>The restroom fixtures (water closets, urinals, and lavatories) are all in good condition with automatic sensor-type fixtures with minimal cosmetic wear. No upgrades are suggested. The science classrooms have a variety of lab sinks and chemical ware-washing sinks. These are all in good condition with some typical wear. Upgrades or replacements are suggested in the near future to bring them up to current standards, but this is not seen as critical from a code or operation perspective.</p>	<p>No action needed at this time but consider in the near future.</p>

SYSTEM	COMMENTS (CONDITION)	SHORT-TERM RECOMMENDATIONS
<b>ELECTRICAL</b>	<p>Electrical distribution equipment was observed to be good condition. This building was served from a 2500 KVA transformer, 4160 to 120/208 volt, 3 ø, 4W. Main distribution panel was observed to be 3000 amps. Lighting in this building were observed to be fluorescent type. This building was observed to be using motion sensors for lighting control. We recommend upgrading the light fixtures to more efficient LED type and providing a new lighting control system compliant with the California Title 24 energy code (which would require additional lighting control devices such as dimmers, daylight harvesting sensors. Etc.) and other applicable codes, for this building.</p>	
<b>FIRE SPRINKLERS/ FIRE ALARM</b>	<p>This building was observed to have smoke/heat detectors but don't have Emergency Voice/Alarm Communication System (EV/ACS).</p>

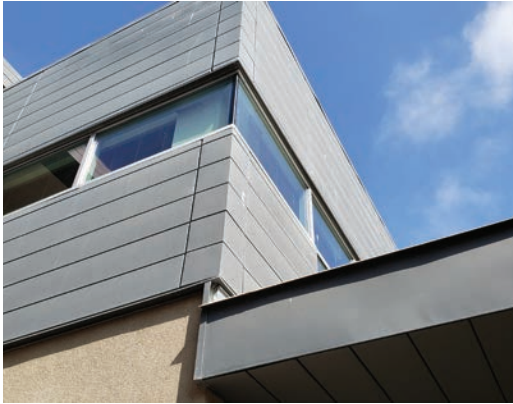
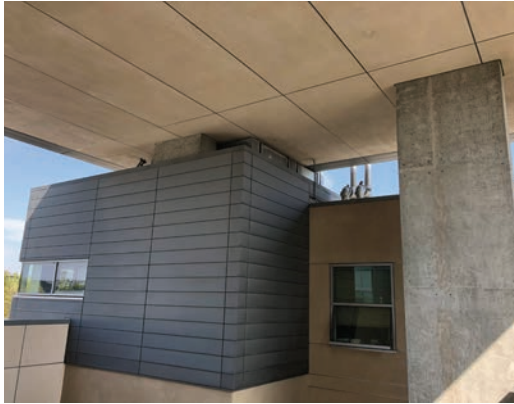
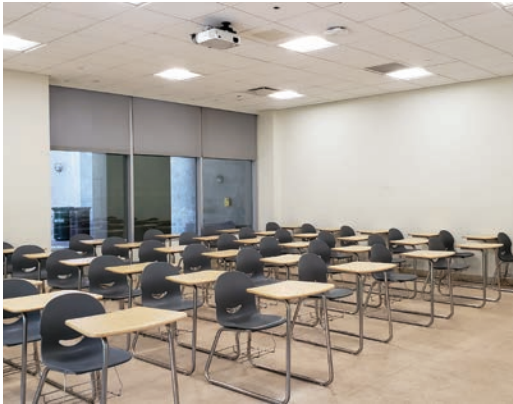
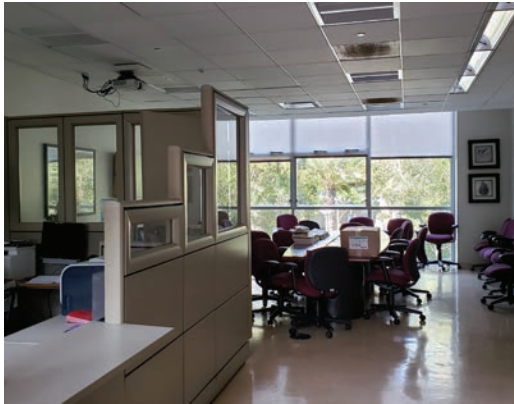
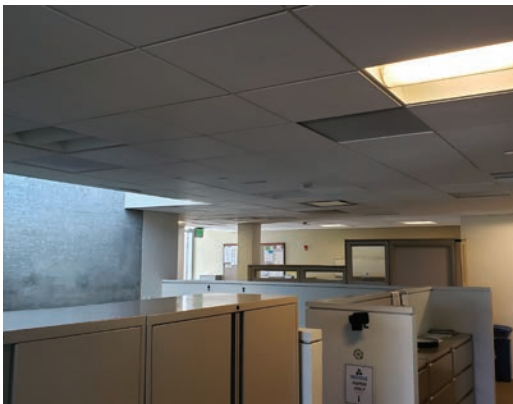
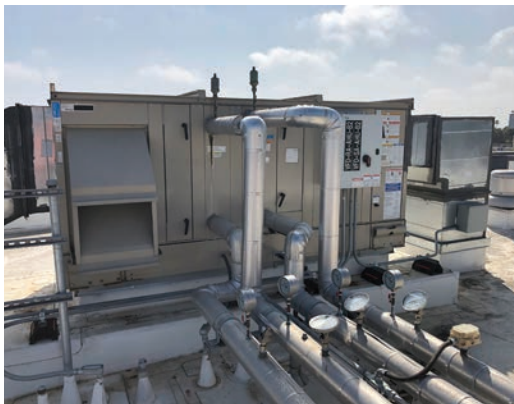
# BUILDING 21 - HUMANITIES & SOCIAL SCIENCE

SYSTEM	COMMENTS (CONDITION)	SHORT-TERM RECOMMENDATIONS
<b>ARCHITECTURE/ INTERIORS</b>	HSS is a cast in place concrete structure. Exterior walls are finished with Stucco, metal panels, and brick veneer. Exterior doors are metal with metal or aluminum frame. Windows are dual pane aluminum frame, fixed an operational with motorized shading system. The building (Interior and Exterior finishes) is in overall great condition. There is adequate natural lighting in classrooms. Furniture is in good condition and seating layout is flexible. Rooms are open and large.	
<b>STRUCTURE</b>	Structural Assessment noted here is data reported on Fusion, 2017. "The building structure is cast in place concrete with steel structure and exterior finishes of brick, stucco, and metal cladding. The roof is a single ply rolled rubberized roof system that is original to construction."	
<b>MECHANICAL</b>	The building has AHU-B2 installed three years ago and it is in good operating condition. The chilled water to the unit is provided from the central plant. There is also a split system provided in the building twelve years ago. The condensing unit on the roof shows in relatively good condition.	Consider replacing the existing outdoor condensing unit approaching the end of useful service life. Provide environmental ducts cleaning.

<b>PLUMBING</b>	The water closets, urinals and lavatories are all in moderate condition fitted with primarily automatic sensor-type flushometers and lavatories. Some wear is seen on the water closets and lavatories. Upgrades are suggested, but not required.	Suggest replacing restroom fixtures but not urgent. No other work needed,

SYSTEM	COMMENTS (CONDITION)	SHORT-TERM RECOMMENDATIONS
<b>ELECTRICAL</b>	<p>Electrical distribution equipment was observed to be good condition.</p> <p>Electrical building service was observed to be 1600 amps, 277/480 volt, 3 ø, 4W. Lighting in this building were observed to be fluorescent type. This building was observed to be using motion sensors for lighting control. We recommend upgrading the light fixtures to more efficient LED type and providing a new lighting control system compliant with the California Title 24 energy code (which would require additional lighting control devices such as dimmers, daylight harvesting sensors, etc.) and other applicable codes, for this building</p>	
<b>FIRE SPRINKLERS/ FIRE ALARM</b>	<p>This building was observed to have smoke/heat detectors but don't have Emergency Voice/Alarm Communication System (EV/ACS).</p>

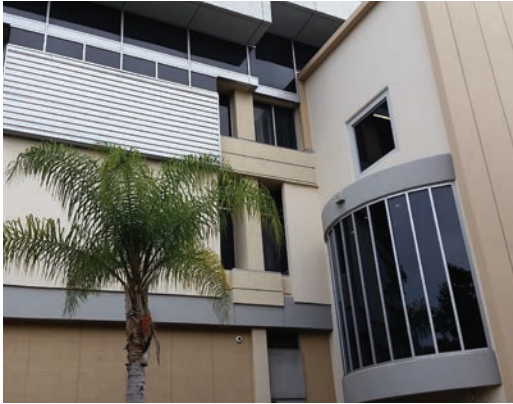
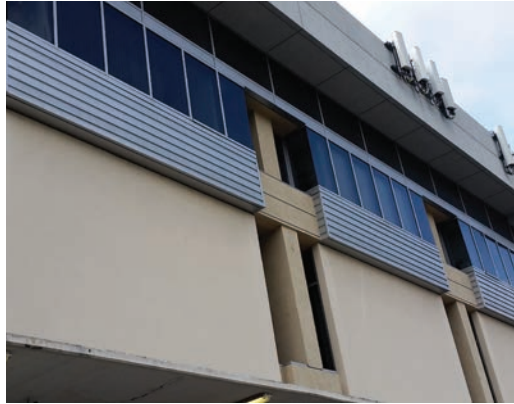
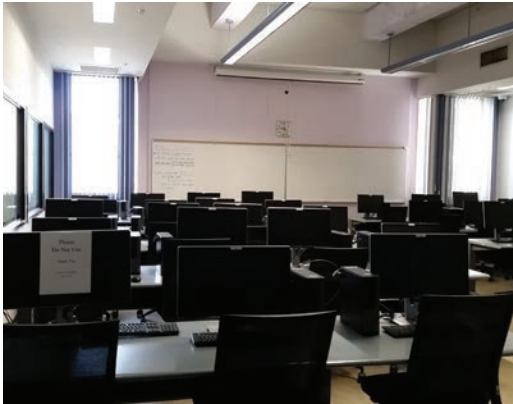
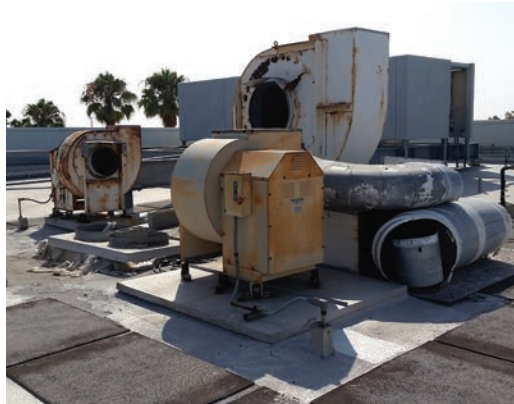
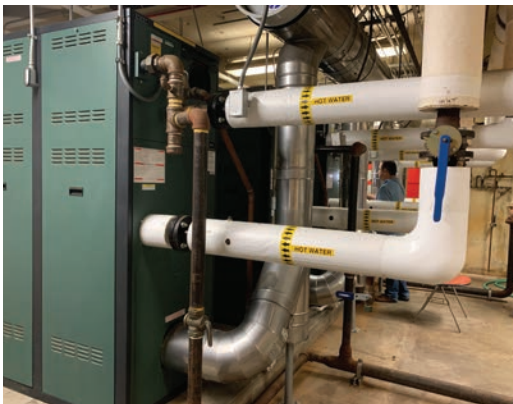
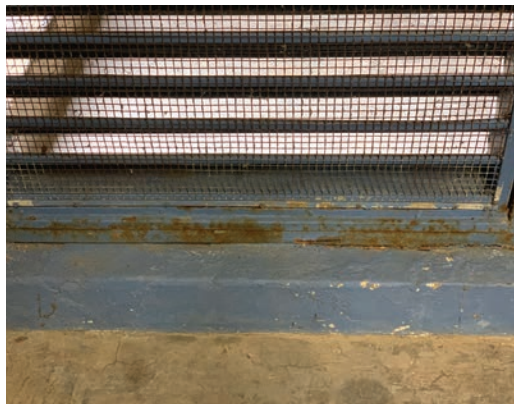
# BUILDING 22 - DRESCHER HALL

SYSTEM	COMMENTS (CONDITION)	SHORT-TERM RECOMMENDATIONS
<b>ARCHITECTURE/ INTERIORS</b>	<p>Drescher Hall is a cast in place concrete structure. The entire 3rd floor was added in 1994. Exterior walls are finished with plaster, Aluminum panels, or painted concrete. Exterior doors are metal with metal frame, and aluminum storefront. Windows are generally double pane with aluminum frame. Interior walls are painted plaster and drywall. Ceilings are suspended acoustical tile, or exposed to metal pan deck. Floor finishes are carpet, vinyl tile, and concrete. Interior doors are wood with aluminum frame or metal with metal frame.</p> <p>Mechanical room requires maintenance. There is no seismic bracing for water pipes. Doors have no label. Ramp outside seems to exceed 2% slope. Floor at electrical room on ground floors shows signs of water damage at door.</p> <p>Wall bases at first floor need repair. Floor in some rooms and hallways on first floor needs to be painted. Some faucets are not accessible. Accessible fixtures in restrooms are not all up to code. There is no accessible parking stall in staff lot on Pico. Potential roof issue on canopy behind building on Pico due to apparent leaking damage. Main electrical room requires 2 doors - only one provided. Water damage seen on some floors. Carpet on 3rd floor needs repair and maintenance. Classrooms have poor natural daylight. Short throw projectors not powerful enough for the size of room. Screens are old. Speaker systems not adequate for size of room. Acoustic panels in Ceilings need repair. Walls and floors in hallways are generally in good condition. Roof is generally in good shape. Old equipment (including acid batteries) to be removed.</p>

<b>STRUCTURE</b>	<p>Structural Assessment noted here is data reported on Fusion, 2017.</p> <p>“The building rests on a concrete slab on and below grade with concrete footings and exterior walls, with columns and interior load bearing walls. The main structure is cast in place concrete using metal frame and pan deck. The roof was installed in 1994 when the 3rd floor was added.”</p>	
------------------	--	--

SYSTEM	COMMENTS (CONDITION)	SHORT-TERM RECOMMENDATIONS
<b>MECHANICAL</b>	<p>The building air conditioning is provided by several built-up air handling units equipped with supply and return fans retrofitted with variable frequency drives and serving variable volume systems. Several constant volume fan coil units serving photo labs.</p> <p>Two existing air-cooled chillers are mounted on the building roof. 100-ton existing chiller has exceeded useful service life, has completely oxidized fins on the condenser coils. The newer 125-ton chiller is of more recent installation (18 years old), but it shows signs of corrosion.</p> <p>There are four gas fired boilers and two hot water pumps in the basement boiler room. The boilers were installed in 2010 and are in good operating condition. The building is controlled by Automated Logic provided building management system (BMS).</p> <p>Existing photo lab exhaust is served by single constant volume Strobic fan operating during occupied building hours.</p>	<p>Replace the existing air handling units with the new custom built. Replace the existing chillers with new air cooled chillers equipped with turbocore compressors Provide photo lab exhaust air system with modulating control valves as required to achieve the system variable air flow. Supply air flow to the photo lab as well as the entire system should be VAV type. Replace the existing Strobic fan with epoxy coated centrifugal fan with VFD driven motor and mounted on the fan air discharge to outside variable geometry damper. Provide environmental ducts cleaning. Set the HVAC controls and the sequence of operation to accommodate the required space functions.</p>

<b>PLUMBING</b>	<p>The first level restrooms have older water closets, urinals and lavatories with aged flushometers. Some water closets are tank-type that are unconventional for commercial spaces. The urinals are the older floor-mount type. These fixtures on the first level should be replaced. The upper floors have restroom fixtures that are in good condition with minimal wear and age; these fixtures do not need to be replaced. The domestic water heaters in the lower basement level are older gas-fired storage-type and show leaks, rust, and deterioration. One water heater is sitting directly on the concrete floor without a drain pan. The water heaters were constructed in early 2000's and are beyond their expected service life. These heaters should be replaced with newer gas-fired heaters with new recirculation pump and interconnected plumbing assembly.</p>	<p>Replace water closet, urinals and lavatories in the first level. Replace all water heater in the lower basement</p>

SYSTEM	COMMENTS (CONDITION)	SHORT-TERM RECOMMENDATIONS
<b>ELECTRICAL</b>	<p>Electrical distribution equipment was observed to be per original construction. They were observed to be in fair condition, except equipment found within level 1 mechanical pump room. Equipment found in this pump room was found to have signs of metal corrosion. This building was observed to have its own service from SCE. It was observed to be 3000 amps, 277/480 volt, 3 <math>\phi</math>, 4W. It was also observed that this building have a non-operation back-up generator. Lighting in this building were observed to be fluorescent type. It was observed that motion sensors were used for lighting control. We recommend upgrading the light fixtures to more efficient LED type and providing a new lighting control system compliant with the California Title 24 energy code (which would require additional lighting control devices such as dimmers, daylight harvesting sensors. Etc.) and other applicable codes, for this building.</p>

<b>FIRE SPRINKLERS/ FIRE ALARM</b>	<p>This building was observed to have smoke/heat detectors but don't have Emergency Voice/Alarm Communication System (EV/ACS).</p>

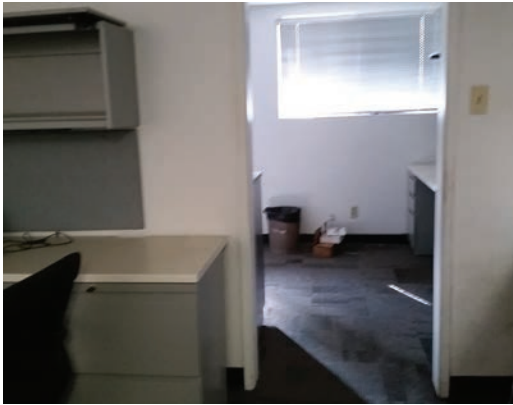
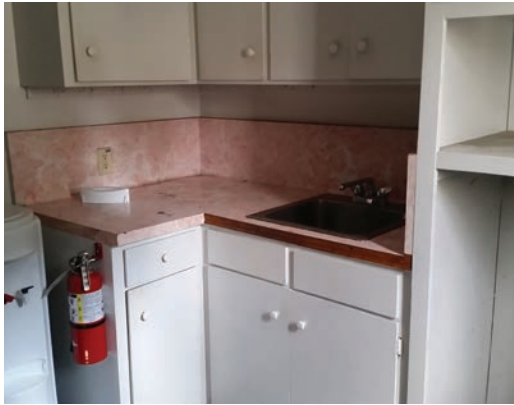
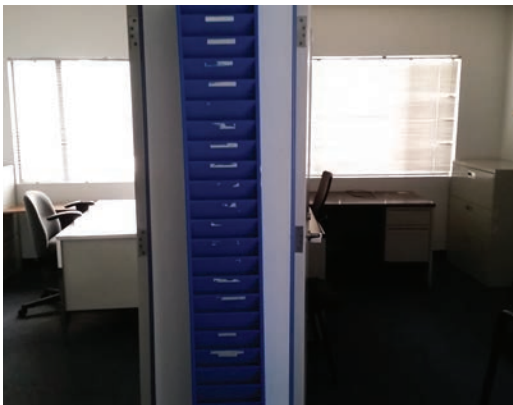
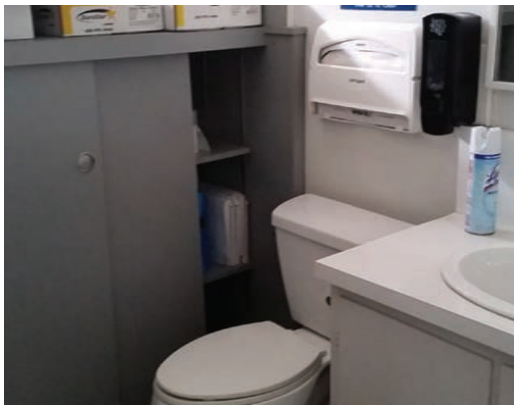
# BUILDING 25 - INTERNATIONAL COUNSELING

SYSTEM	COMMENTS (CONDITION)	SHORT-TERM RECOMMENDATIONS
<b>ARCHITECTURE/ INTERIORS</b>	<p>This residential building was converted for office use. The house is wood framing with wood doors, frames, and single pane windows. Interior walls are painted drywall. A concrete ramp leads up to the house as well as wood stairs. This unit is old and currently not fully utilized. Site is overgrown with plants which raises safety issues. There are not enough space for cars or visitors. There are no electrical charging stations for electrical police cars. No room for police emergency mobile trailer, which is currently parked at the Bundy campus.</p>	
<b>STRUCTURE</b>	<p>Structural Assessment noted here is data reported on Fusion, 2017. "The building uses a concrete perimeter foundation with post and beam wood construction. The roof is composition 3 tab asphalt roof of 1996 vintage,per staff. " Further assessment requires more in-depth investigation.</p>

<b>MECHANICAL</b>	<p>Residential space converted for commercial use. The split 3-ton air conditioning system has exceeded useful service life and shall be replaced with the energy efficient equipment. Duct cleaning will help to improve the indoor air quality.</p>	<p>Revise the HVAC system to deliver the code required minimum amount of outside air during the occupied building hours. Provide building connection to the campus BMS for monitoring.</p>
<b>PLUMBING</b>	<p>The lavatories and water closets are in average condition. No regent repairs need.</p>	<p>If hot water is desired for the kitchen sink, provide insta hot water heater. No other work needed.</p>

SYSTEM	COMMENTS (CONDITION)	SHORT-TERM RECOMMENDATIONS
<b>ELECTRICAL</b>	<p>We observed this building or structure to be within residential zone. Electrical distribution equipment was observed to be per original construction. We found electrical service equipment to be in fair condition. Service for this building was observed to be 200 amps, 120/240 volt, 1 ø, 3W. Lighting in this building were observed to be fluorescent type. We observed absence of motion sensors for lighting control within rooms and hallways. We also observed the absence of fire life safety devices such as smoke detectors, and fire alarm pull stations. We recommend upgrading the light fixtures to more efficient LED type and providing a new lighting control system compliant with the California Title 24 energy code (which would require additional lighting control devices such as dimmers, daylight harvesting sensors. Etc.) and other applicable codes, for this building. We also recommending updating fire life safety system for compliance to latest code.</p>	<p>It was observed that this building still utilizes Cat3 &amp; Cat5 cabling for information technology. It was also found that this building still have 10/100 Mbps switches. We recommend to provide new Cat6A cabling and to provide new 1Gbps or10Gbps switches.</p>

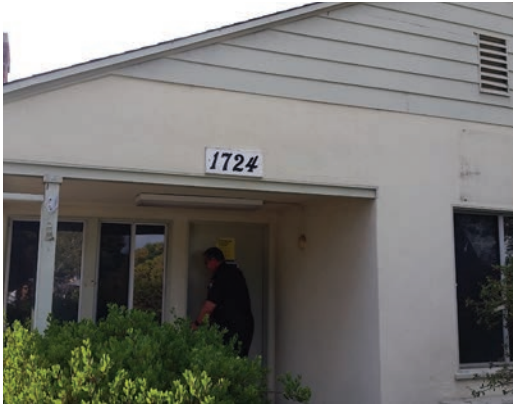
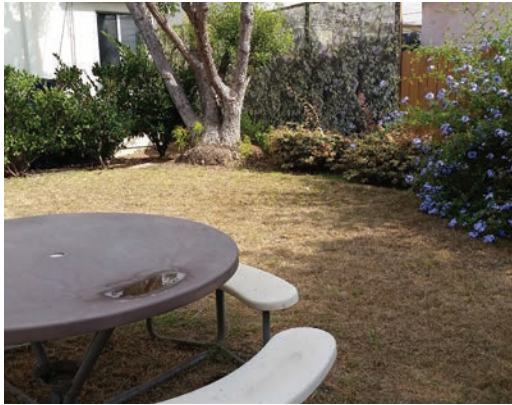
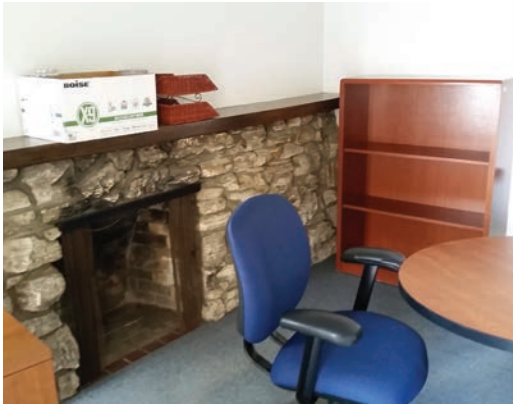
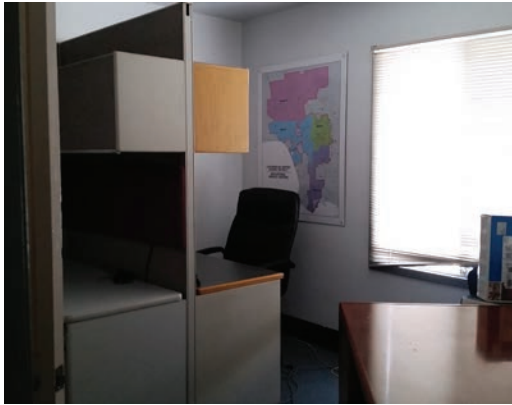
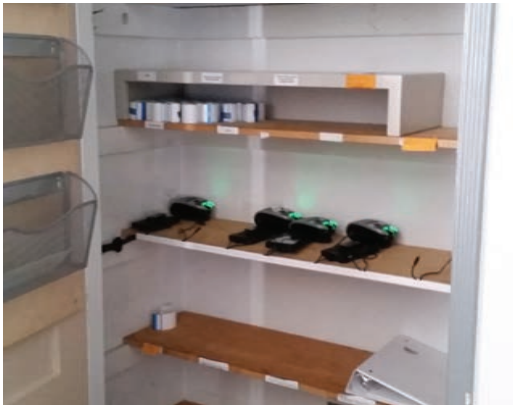
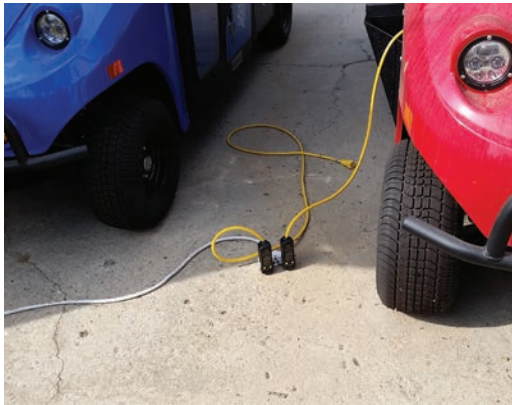
# BUILDING 26 - OUTREACH

SYSTEM	COMMENTS (CONDITION)	SHORT-TERM RECOMMENDATIONS
<b>ARCHITECTURE/ INTERIORS</b>	<p>This residential unit is reconfigured to be used as office space. The unit is wood framing, with wood doors, frames, and single pane aluminum windows.</p> <p>The building is currently vacant. The structure is old and has an old odor. Interiors are not in good condition with old finishes and carpet. A concrete ramp leads up to the house as well as wood stairs. Hallways are narrow, and lighting is dim. The bathroom is used as storage space.</p>	
<b>STRUCTURE</b>	<p>Structural Assessment noted here is data reported on Fusion, 2017.</p> <p>“The building has a concrete perimeter foundation using post and beam wood construction. The roof is composition 3 tab asphalt roof of 2011 vintage, per staff.”</p> <p>Further assessment requires more in-depth investigation.</p>	
<b>MECHANICAL</b>	<p>Residential space converted for commercial use. The split 3-ton air conditioning system has exceeded useful service life and shall be replaced with the energy efficient equipment. Duct cleaning will help to improve the indoor air quality.</p>	<p>Revise the HVAC system to deliver the code required minimum amount of outside air during the occupied building hours. Provide building connection to the campus BMS for monitoring.</p>

<b>PLUMBING</b>	<p>The lavatories and water closets are in average condition. No regent repairs need. Kitchen sink does not provide hot water. If water heater exist, should be reviewed and replace if not in good condition. Other option, provide point of use heater.</p>

SYSTEM	COMMENTS (CONDITION)	SHORT-TERM RECOMMENDATIONS
<b>ELECTRICAL</b>	<p>We observed this building or structure to be within residential zone. Electrical distribution equipment was observed to be per original construction. We found electrical service equipment to be in fair condition. Service for this building was observed to be 200 amps, 120/240 volt, 1 ø, 3W. Lighting in this building were observed to be fluorescent type. We observed absence of motion sensors for lighting control within rooms and hallways. We also observed the absence of fire life safety devices such as smoke detectors, and fire alarm pull stations. We recommend upgrading the light fixtures to more efficient LED type and providing a new lighting control system compliant with the California Title 24 energy code (which would require additional lighting control devices such as dimmers, daylight harvesting sensors. Etc.) and other applicable codes, for this building. We also recommending updating fire life safety system for compliance to latest code.</p>	<p>It was observed that this building still utilizes Cat3 &amp; Cat5 cabling for information technology. It was also found that this building still have 10/100 Mbps switches. We recommend to provide new Cat6A cabling and to provide new 1Gbps or10Gbps switches.</p>

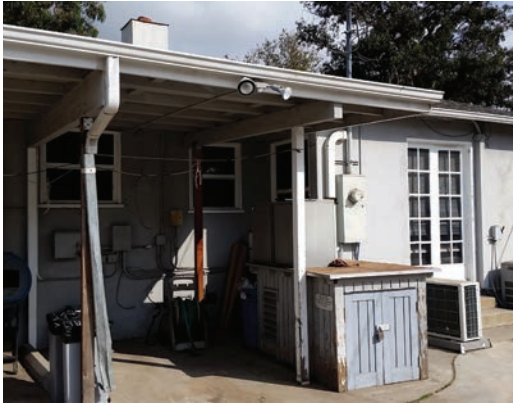
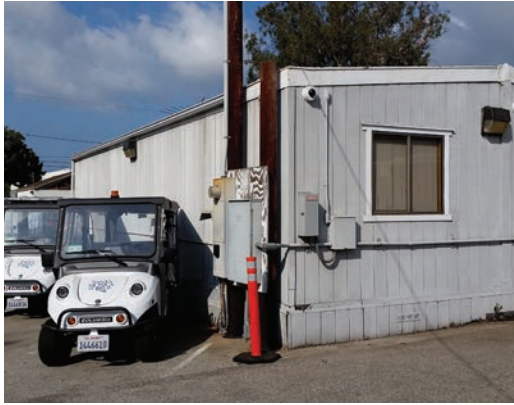
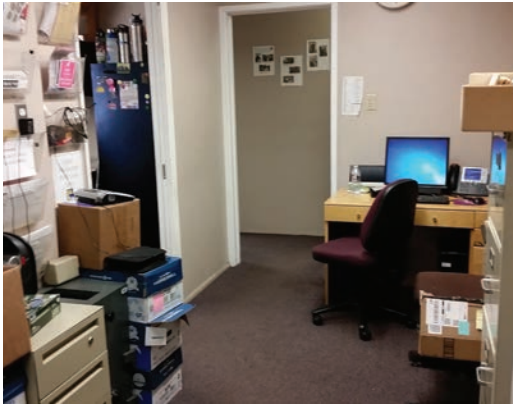
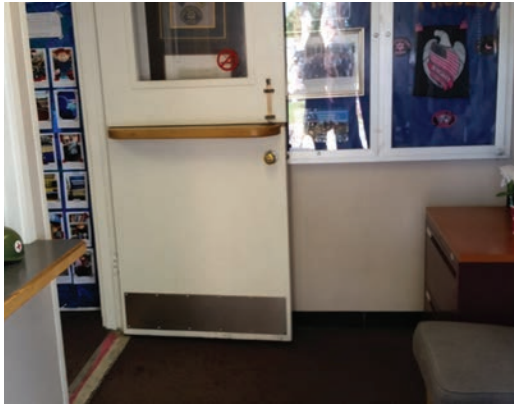
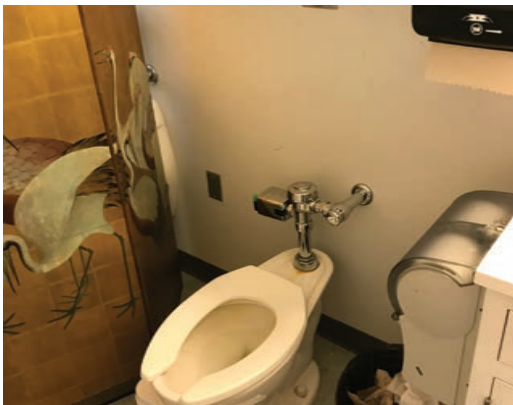
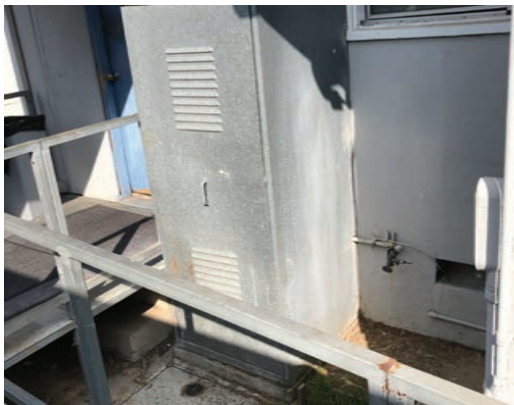
SYSTEM	COMMENTS (CONDITION)	SHORT-TERM RECOMMENDATIONS
<b>ARCHITECTURE/ INTERIORS</b>	<p>This residential type home was built in 1941 and has not been remodeled since. The house is typical wood frame with wood doors, painted drywalls, and aluminum single pane windows. Floors are carpet finish. The unit is in very poor condition. It is termite infested and termite damage can be seen in ceilings. At the modular building in the back, walls show termite damage. Walls do not support TVs. Walls are broken. Floors are broken. Space is packed with old furniture and not flexible. There is not enough room for staff. There is strong odor in both the house and the modular unit. Doors don not have electronic card readers. Locker rooms are small. Ceiling leaks inside locker rooms resulting in puddling on the floor. There is holes in women's bathroom. Bathrooms are not accessible. Door is difficult to close. Hot water does not work. There is no proper storage room for guns, bullets, etc. There is not enough room for all staff to gather for training or meetings. There is no flow inside the residential unit. Poor acoustical for confidentiality purposes. There is no room for bike storage and parking. Not enough room for parking. No power for electric vehicles or charging tools.</p>

<b>STRUCTURE</b>	<p>Structural Assessment noted here is data reported on Fusion, 2017.          “The house uses a concrete perimeter foundation with post and beam wood construction. The house is wood framed with a stucco finish. The roof is composition 3 tab asphalt roof of 1996 vintage, per staff. The modular building is mounted on a concrete perimeter foundation. The building has T-111 siding and a standing seam metal roof original to construction. Both are accessed by wood/concrete steps.”          Further assessment requires more in-depth investigation.</p>	
------------------	--	--

SYSTEM	COMMENTS (CONDITION)	SHORT-TERM RECOMMENDATIONS
<b>MECHANICAL</b>	Residential space converted for commercial use. The split 3-ton air conditioning system has exceeded useful service life and shall be replaced with the energy efficient equipment. Duct cleaning will help to improve the indoor air quality.	Revise the HVAC system to deliver the code required minimum amount of outside air during the occupied building hours. Provide building connection to the campus BMS for monitoring.
<b>PLUMBING</b>	The 2 kitchen sink do not have hot water and they should also be replaced. Urinal appear in good condition. The lavatories and water closet work but mixed individual conditions. (1) water closet did not have a working sensor and should be replaced. Others on a case by case basis	Replace 2 kitchen sink and provide hot water. Inspect each water closet and replace if not functioning. Not all water closet need replacing so each one needs to be inspected.

<b>ELECTRICAL</b>	We observed this building or structure to be within residential zone. Electrical distribution equipment was observed to be per original construction. We found electrical service equipment to be in fair condition. Service for this building was observed to be 200 amps, 120/240 volt, 1 ø, 3W. Lighting in this building were observed to be fluorescent type. We observed absence of motion sensors for lighting control within rooms and hallways. We also observed the absence of fire life safety devices such as smoke detectors, and fire alarm pull stations. We recommend upgrading the light fixtures to more efficient LED type and providing a new lighting control system compliant with the California Title 24 energy code (which would require additional lighting control devices such as dimmers, daylight harvesting sensors. Etc.) and other applicable codes, for this building. We are also recommending to have minimum number of smoke detectors and pull station for code compliance.	It was observed that this building still utilizes Cat3 & Cat5 cabling for information technology. It was also found that this building still have 10/100 Mbps switches. We recommend to provide new Cat6A cabling and to provide new 1Gbps or10Gbps switches.

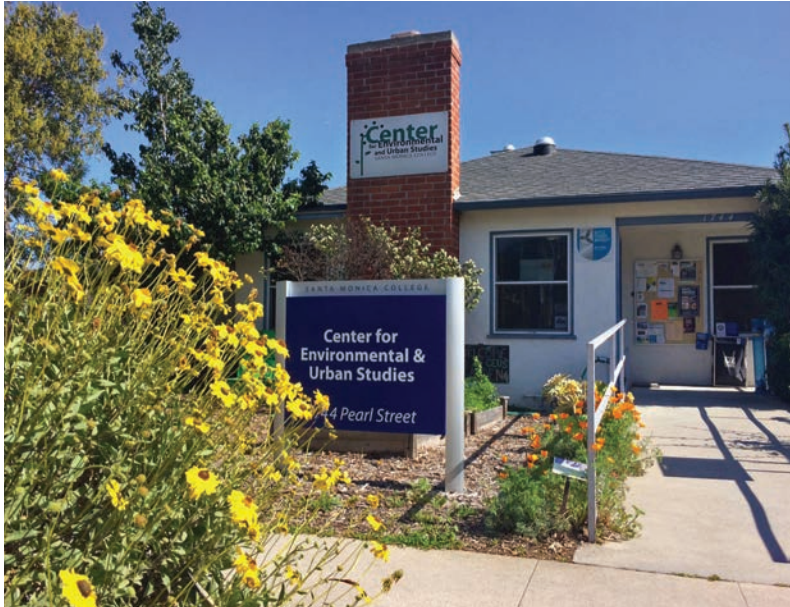
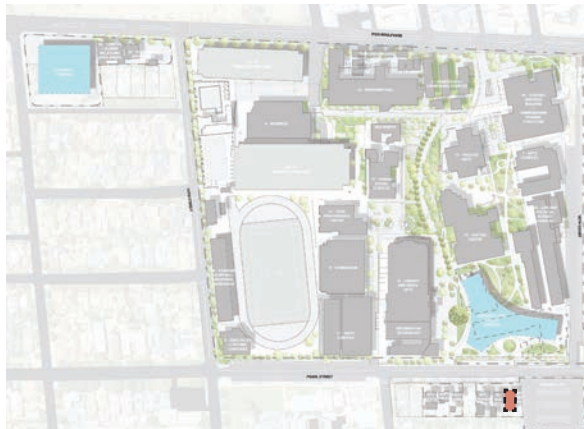
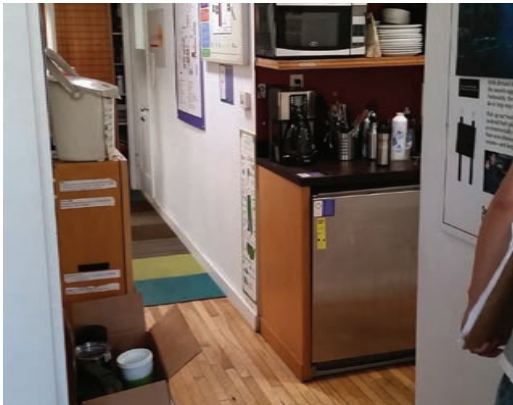
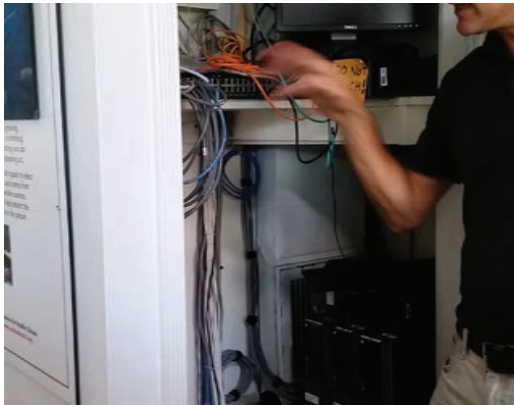
# BUILDING 29 - ENVIRONMENTAL CENTER

SYSTEM	COMMENTS (CONDITION)	SHORT-TERM RECOMMENDATIONS
<b>ARCHITECTURE/ INTERIORS</b>	<p>This residential unit was renovated in 2008 to a center for environmental/sustainability design. It utilizes many sustainable practices. The building is generally in great shape, and systems put in place for sustainable purposes work well. The interior elements are in good condition. The unit as a whole requires low maintenance.</p>	
<b>STRUCTURE</b>		
<b>MECHANICAL</b>	<p>The space is very energy efficient due to the space using controls for heat removal. However, not taken into account is the code required minimum amount of fresh air not provided when the exterior doors are closed.</p>	<p>Revise the HVAC system to deliver the code required minimum amount of outside air during the occupied building hours. Provide exterior doors with end switch to close outside air damper when the doors are open for more than 2 minutes (adjustable). .Provide building connection to the campus BMS for monitoring.</p>

<b>PLUMBING</b>	<p>All fixtures are in great condition. No work need in this building</p>	<p>No work needed</p>

SYSTEM	COMMENTS (CONDITION)	SHORT-TERM RECOMMENDATIONS
<b>ELECTRICAL</b>	<p>We observed this building or structure to be within residential zone.</p> <p>We observed this building or structure had been recently remodeled approximately within 10 - 12 years. Electrical distribution equipment was observed to be per original construction. We found electrical service equipment to be in fair condition. Service for this building was observed to be 60 amps, 120/240 volt, 1 ø, 3W. Lighting in this building were observed recently updated with LED fixtures and 'SOLAR' Tubes to bring sunlight to interior spaces. We observed advance energy management controls for lighting and energy controls. We also observed the absence of fire life safety devices such as smoke detectors, and fire alarm pull stations. We are also recommending having minimum number of smoke detectors and pull station for code compliance.</p>

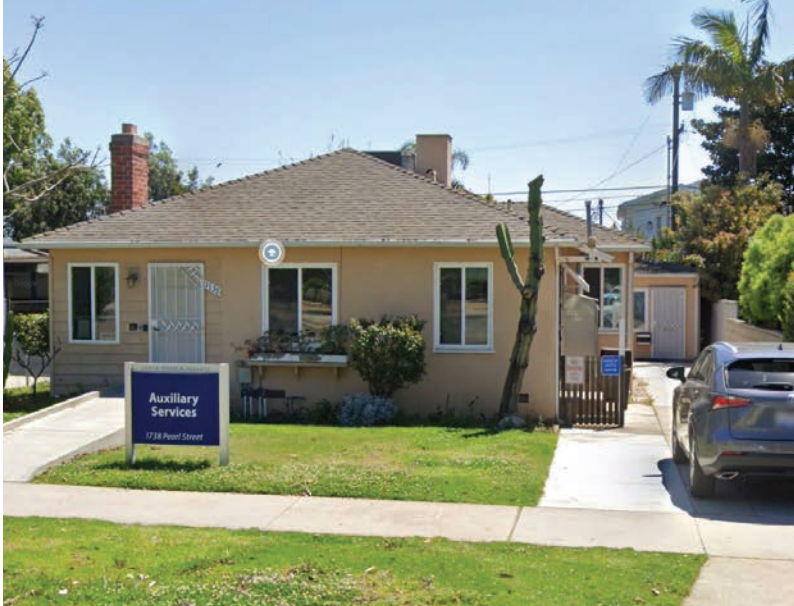
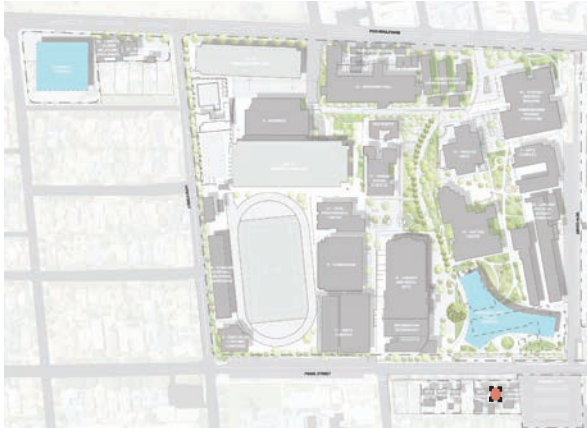
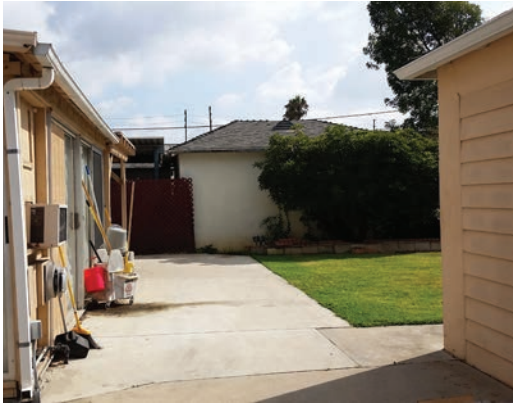
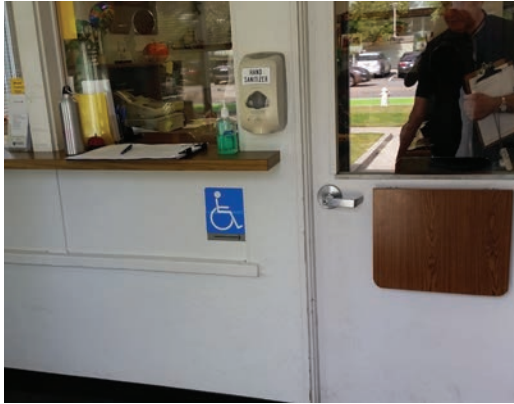
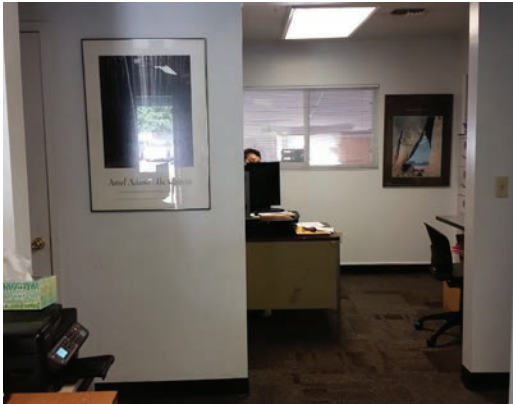
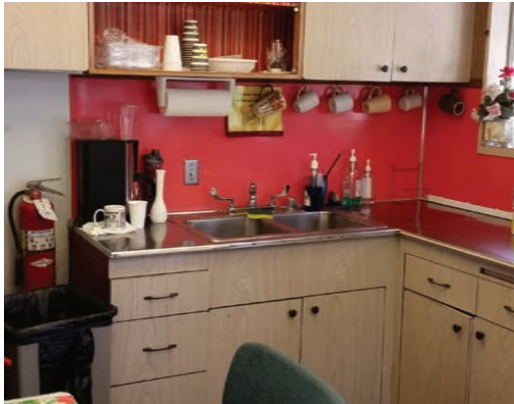
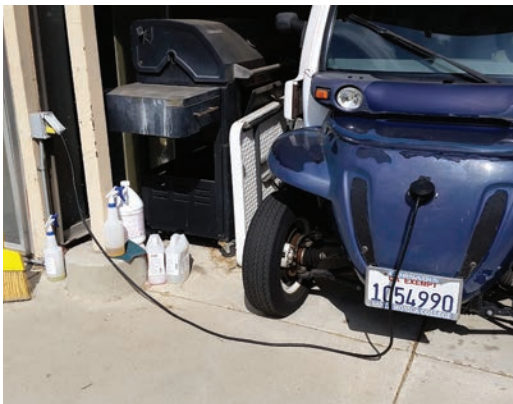
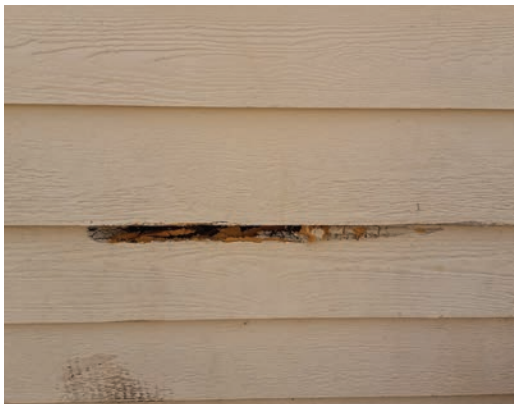
# BUILDING 30 - AUXILIARY SERVICES

SYSTEM	COMMENTS (CONDITION)	SHORT-TERM RECOMMENDATIONS
<b>ARCHITECTURE/ INTERIORS</b>	This residential building was converted for office use. The house is wood framing with wood doors, frames, and dual pane windows. Interior walls are painted drywall. A concrete ramp leads up to the house as well as wood stairs. This unit is generally in stable condition.	
<b>STRUCTURE</b>	Structural Assessment noted here is data reported on Fusion, 2017. "The building uses a concrete perimeter foundation with post and beam wood construction. The roof is composition 3 tab asphalt roof of unknown vintage, per staff. " Further assessment requires more in-depth investigation.	
<b>MECHANICAL</b>	Residential space converted for commercial use. The split 3-ton air conditioning system has exceeded useful service life and shall be replaced with the energy efficient equipment. Duct cleaning will help to improve the indoor air quality.	Revise the HVAC system to deliver the code required minimum amount of outside air during the occupied building hours. Provide building connection to the campus BMS for monitoring.

<b>PLUMBING</b>	Lavatories and water closet area in good condition and need no replacement. Water heater should be considered for replacement and. Kitchen sink is acceptable but not great.	Consider replacing water heater and kitchen sink.

SYSTEM	COMMENTS (CONDITION)	SHORT-TERM RECOMMENDATIONS
<b>ELECTRICAL</b>	<p>We observed this building or structure to be within residential zone. Electrical distribution equipment was observed to be per original construction. We found electrical service equipment to be in fair condition. Service for this building was observed to be 200 amps, 120/240 volt, 1 ø, 3W. Lighting in this building were observed to be fluorescent type. We observed absence of motion sensors for lighting control within rooms and hallways. We also observed the absence of fire life safety devices such as smoke detectors, and fire alarm pull stations. We recommend upgrading the light fixtures to more efficient LED type and providing a new lighting control system compliant with the California Title 24 energy code (which would require additional lighting control devices such as dimmers, daylight harvesting sensors. etc.) and other applicable codes, for this building. We are also recommending to have minimum number of smoke detectors and pull station for code compliance.</p>	<p>It was observed that this building still utilizes Cat3 &amp; Cat5 cabling for information technology. It was also found that this building still have 10/100 Mbps switches. We recommend to provide new Cat6A cabling and to provide new 1Gbps or10Gbps switches.</p>

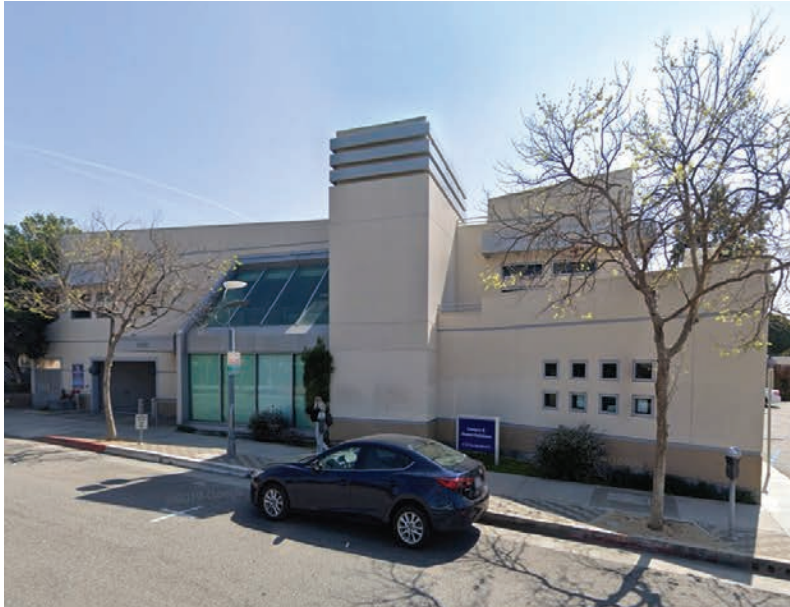
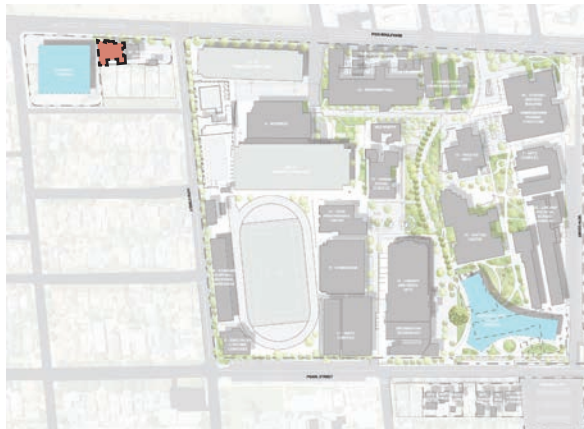
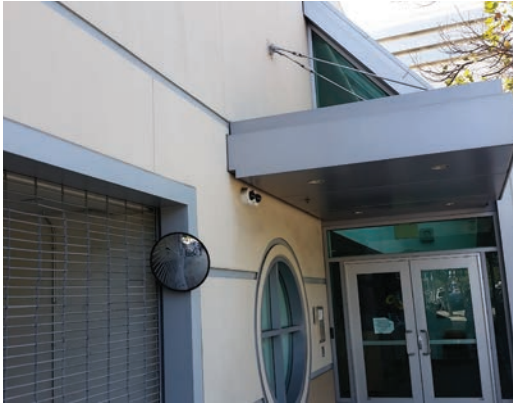
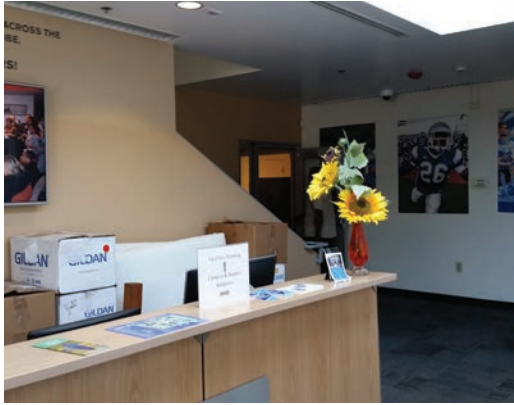
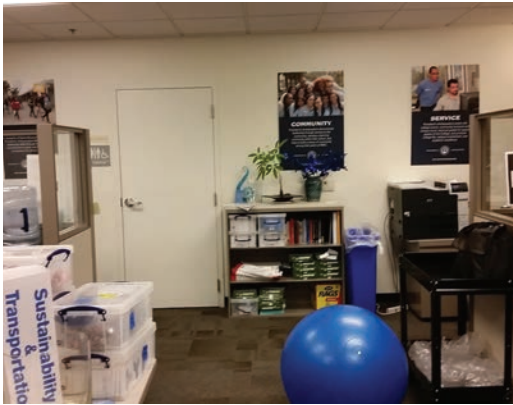
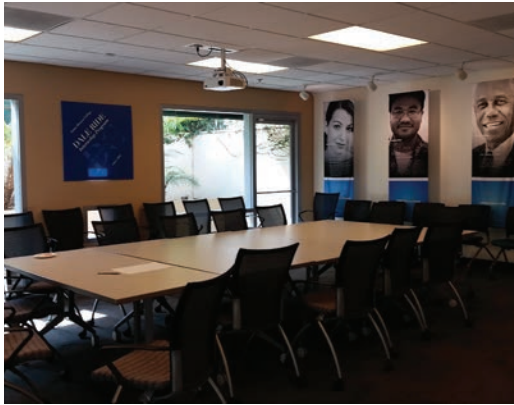
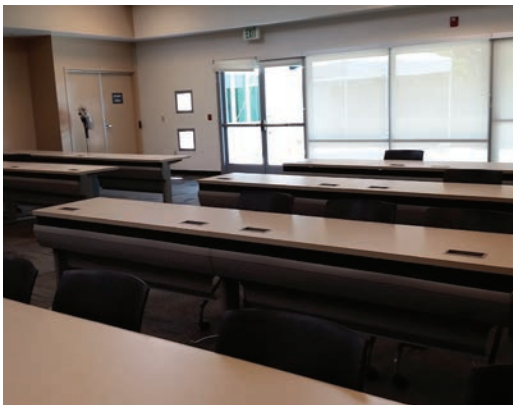
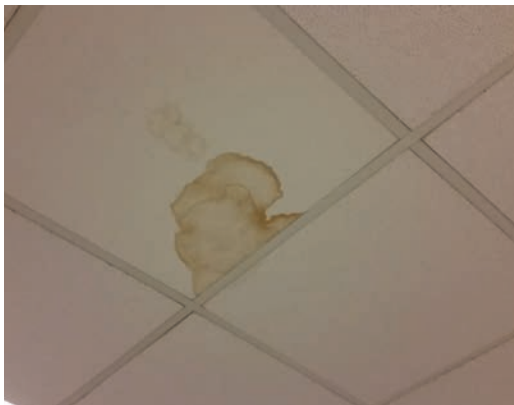
# BUILDING 32 - CAMPUS AND ALUMNI RELATIONS

SYSTEM	COMMENTS (CONDITION)	SHORT-TERM RECOMMENDATIONS
<b>ARCHITECTURE/ INTERIORS</b>	<p>The foundation is a 2 story building that sits over ground level parking. Exterior walls are concrete and store front system. Exterior doors and windows are aluminum framed. Interior walls are painted drywall. Ceilings are acoustical tiles. The building is generally in good condition. There is some ceiling damage on level 1 conference room. Main space on second floor is open and bright. There is open layout and great visual access throughout the room.</p>	
<b>STRUCTURE</b>	<p>Structural Assessment noted here is data reported on Fusion, 2017. "The building rest on a concrete side walls using cast in place concrete/CMU walls with metal framing" Further assessment requires more in-depth investigation.</p>	
<b>MECHANICAL</b>	<p>The building is served by several RTUs and it appears the comfort level is well maintained. No issues with the HVAC except for not easy roof access.</p>	No work needed

<b>PLUMBING</b>	<p>Lavatories and water closet area in good condition and need no replacement. Hot water delivery is acceptable with no issues.</p>	No work needed

SYSTEM	COMMENTS (CONDITION)	SHORT-TERM RECOMMENDATIONS
<b>ELECTRICAL</b>	<p>We observed this building or structure had been recently remodeled approximately within 10 - 12 years. Electrical distribution equipment was observed to be in good condition. Service for this building was observed to be 400 amps, 120/208 volt, 3 ø, 4W. Lighting in this building were observed to be using fluorescent type luminaries. We observed advance energy management controls for lighting and energy controls. We also observed presence of fire life safety devices such as smoke detectors, and fire alarm pull stations. We recommend upgrading the light fixtures to more efficient LED type and providing a new lighting control system compliant with the California Title 24 energy code (which would require additional lighting control devices such as dimmers, daylight harvesting sensors. etc.) and other applicable codes, for this building.</p>
