# SANTA MONICA COLLEGE

## 2040 CAMPUS MASTER PLAN

### FACILITIES CONDITIONS ASSESSMENT

*CREATED JUNE 2020; SUBMITTED JUNE 2024*

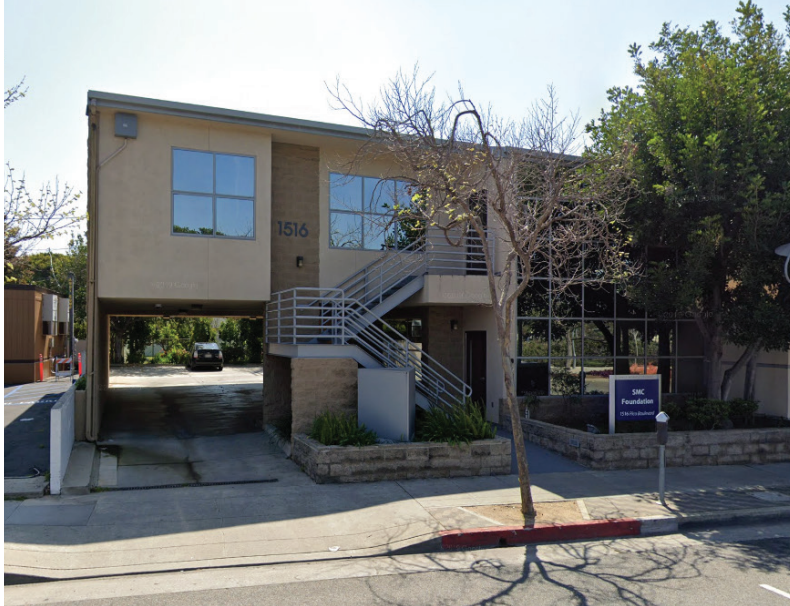
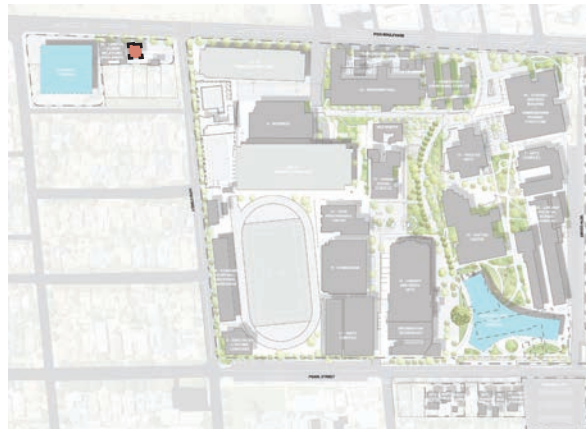
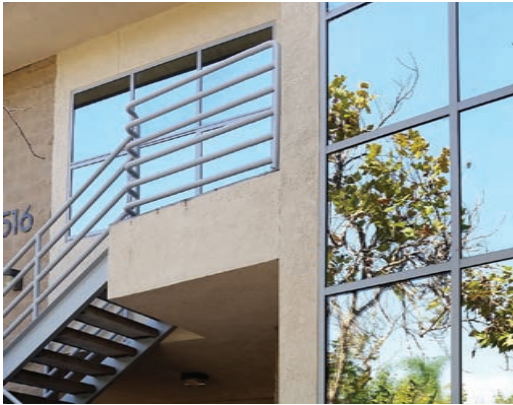
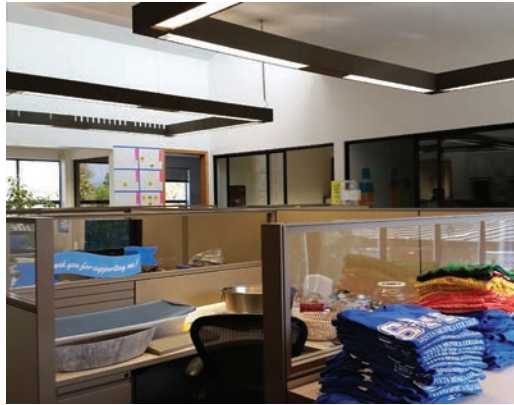
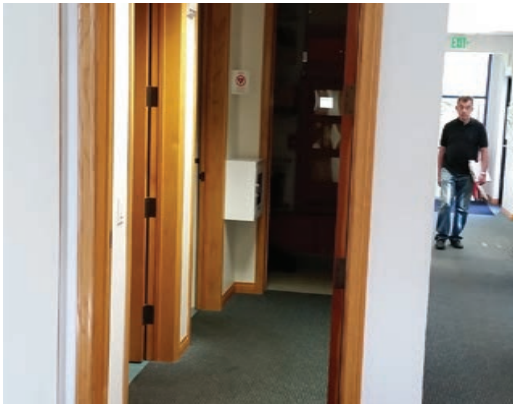
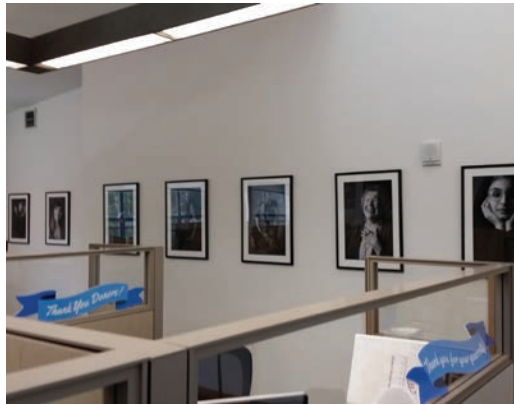
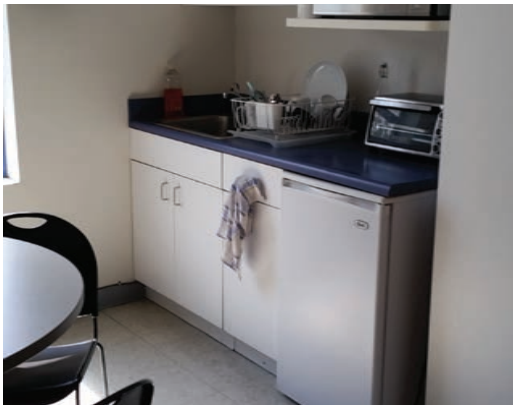
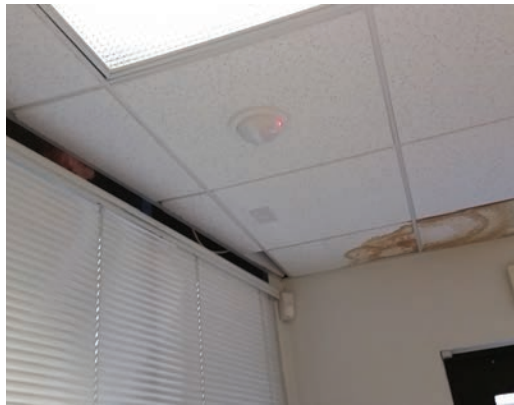
# BUILDING 33 - FOUNDATION

SYSTEM	COMMENTS (CONDITION)	SHORT-TERM RECOMMENDATIONS
<b>ARCHITECTURE/ INTERIORS</b>	<p>This building is a 2 story building that sits on top of an underground parking. Exterior walls are concrete and store front system. Doors and windows are aluminum frame. Interior doors are metal in metal frame. Interior walls are painted drywall. Ceilings are acoustic tiles. In general the building is in good condition. 2 major sewage leaks took place in the last 5 years. Floor and wall damages have been fixed since.</p>	
<b>STRUCTURE</b>	<p>Structural Assessment noted here is data reported on Fusion, 2017.          “The building rest on a concrete slab on and below grade using cast in place concrete walls.”          Further assessment requires more in-depth investigation.</p>	
<b>MECHANICAL</b>	<p>The HVAC systems are well maintained and are in good operating condition. Each floor is served by a dedicated single zone rooftop packaged unit. There is only one thermostat on each floor that may cause poor comfort in other areas of the floor experiencing different cooling peak time. No issues with the HVAC except for not easy roof access.</p>	<p>We recommend the system retrofit with the Variable Volume/Viable Temperature system (VVT). It will allow better temperature control on the individual floors.</p>

<b>PLUMBING</b>	<p>Lavatories and water closet area in good condition and need no replacement. Hot water delivery is acceptable with no issues.</p>	<p>No work needed.</p>

SYSTEM	COMMENTS (CONDITION)	SHORT-TERM RECOMMENDATIONS
<b>ELECTRICAL</b>	<p>We observed this building or structure had been recently remodeled approximately within 10 - 12 years. Electrical distribution equipment was observed to be in good condition. Service for this building was observed to be 600 amps, 120/208 volt, 3 ø, 4W. Lighting in this building were observed to be using fluorescent type luminaries. We observed energy management controls for lighting and energy controls. We also observed presence of fire life safety devices such as smoke detectors, and fire alarm pull stations. We recommend upgrading the light fixtures to more efficient LED type and providing a new lighting control system compliant with the California Title 24 energy code (which would require additional lighting control devices such as dimmers, daylight harvesting sensors. etc.) and other applicable codes, for this building.</p>
