**GEOTECHNICAL INVESTIGATION**

GeoLabs - Westlake Village  
Geo-Hazard Review, Proposed Art Complex Building  
1410 Pico Boulevard, Santa Monica College,  
City of Santa Monica, California  
March 13, 2020.

Geo-Hazard Review,  
Proposed Art Complex Building,  
1410 Pico Boulevard, Santa Monica College,  
City of Santa Monica, California

March 13, 2020  
W.O. 8266

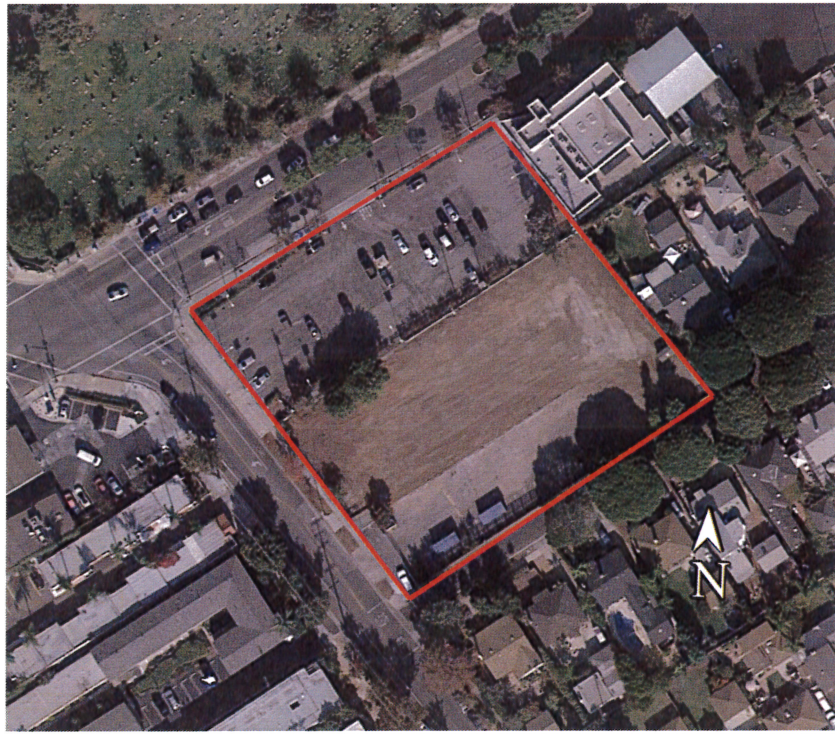
Figure 1 Project site outlined in red. Source: Google satellite imagery November, 2018.

approximately 350 feet west of the main Santa Monica College campus, at the corner of Pico Boulevard and 14<sup>th</sup> street (Plate 1.1, Site Location Map). The site is rectangular in shape and consists of three parcels. APN 4284-034-900 is 0.65 acres at 1410 Pico Boulevard, and contains a paved parking lot with lighting and a habitable kiosk. APN 4284-034-904 is 0.87 acres at 2019 14<sup>th</sup> Street. It is separated from parcel 900 by a chain link fence and four foot masonry wall. Historically it has been developed and contained buildings since 1925. The most recent structure was demolished in October of 2018 and the parcel is currently vacant. The northwestern half is primarily dirt with occasional weeds and grass. The southeastern half consists of a paved parking lot. The northeastern corner of the parcel contains a few yards of ground concrete in stockpiles. The third parcel, APN 4284-034-903 is 0.13 acres adjacent to 14<sup>th</sup> street. It makes up the southeastern corner of the parking lot in parcel 904.

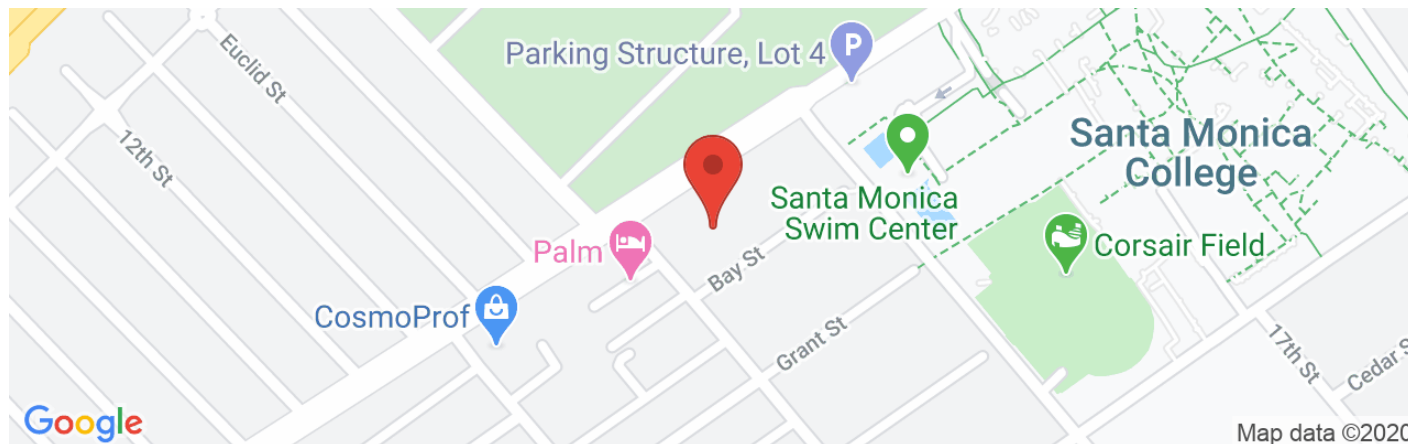
Latitude, Longitude: 34.015934, -118.475062

<b>Date</b>	3/9/2020, 2:54:52 PM
<b>Design Code Reference Document</b>	ASCE7-16
<b>Risk Category</b>	II
<b>Site Class</b>	D - Stiff Soil

Type	Value	Description
S <sub>S</sub>	1.924	MCE <sub>R</sub> ground motion. (for 0.2 second period)
S <sub>1</sub>	0.686	MCE <sub>R</sub> ground motion. (for 1.0s period)
S <sub>MS</sub>	1.924	Site-modified spectral acceleration value
S <sub>M1</sub>	null -See Section 11.4.8	Site-modified spectral acceleration value
S <sub>DS</sub>	1.282	Numeric seismic design value at 0.2 second SA
S <sub>D1</sub>	null -See Section 11.4.8	Numeric seismic design value at 1.0 second SA
