4. ENVIRONMENTAL IMPACT ANALYSIS

4. GEOLOGY/SOILS

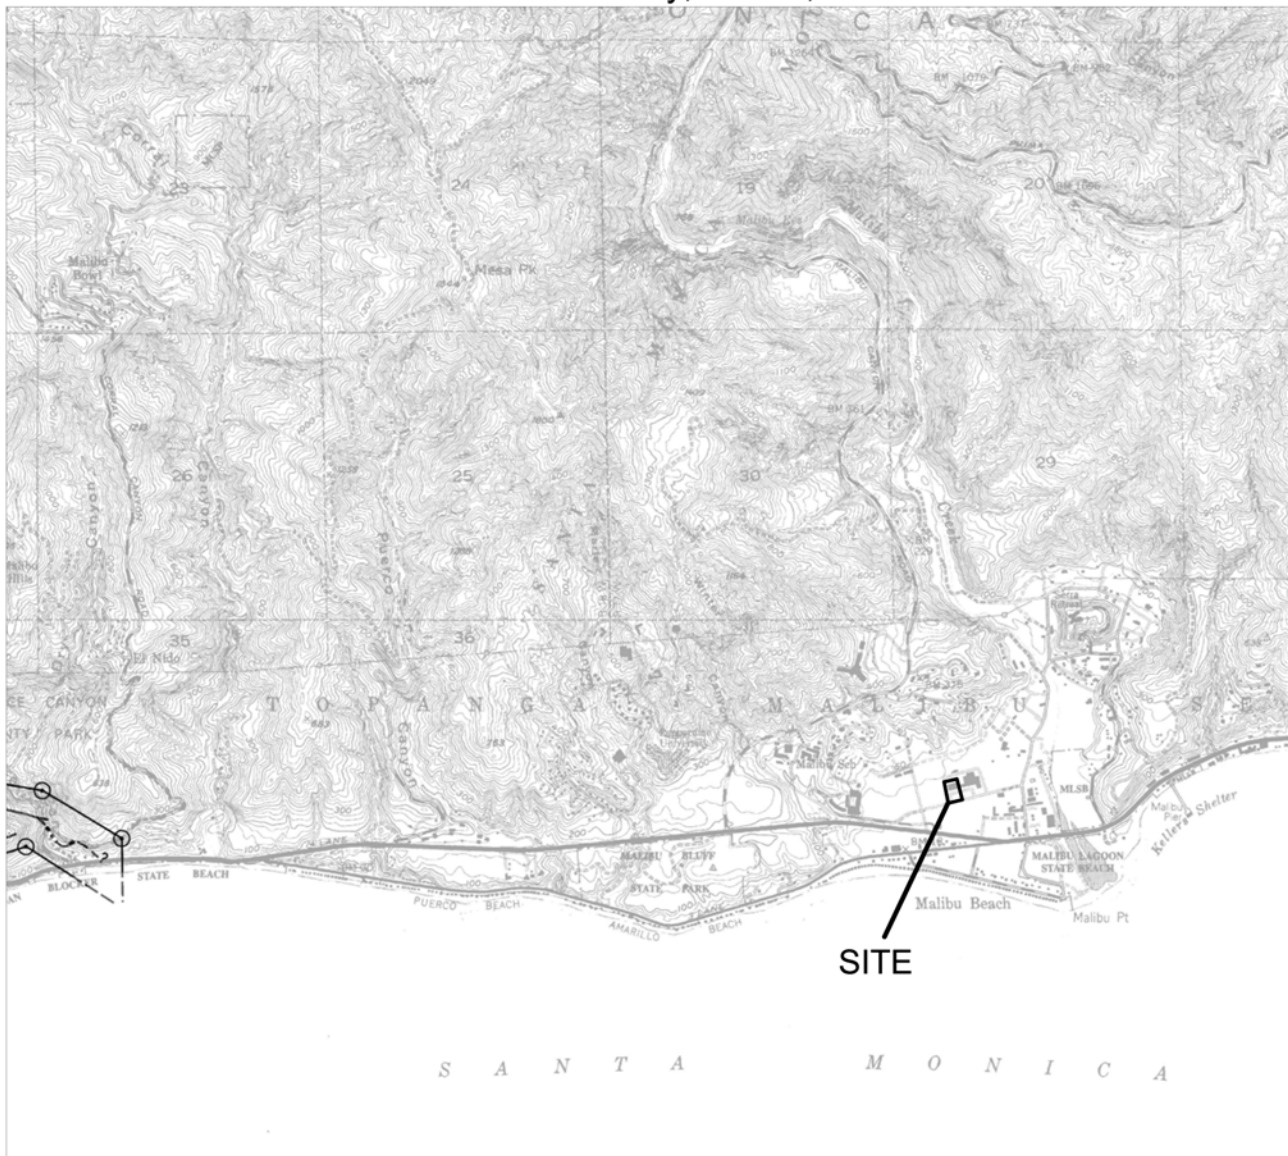
ALQUIST-PRIOLO MAP

23555 Civic Center Way, Malibu, California

MAP EXPLANATION

Active Faults

Faults considered to have been active during Holocene time and to have potential for surface rupture: solid line where accurately located, long dash where approximately located, short dash where inferred, dotted where concealed; query (?) indicates additional uncertainty. Evidence of historic offset indicated by year of earthquake-associated event or C for displacement caused by fault creep.

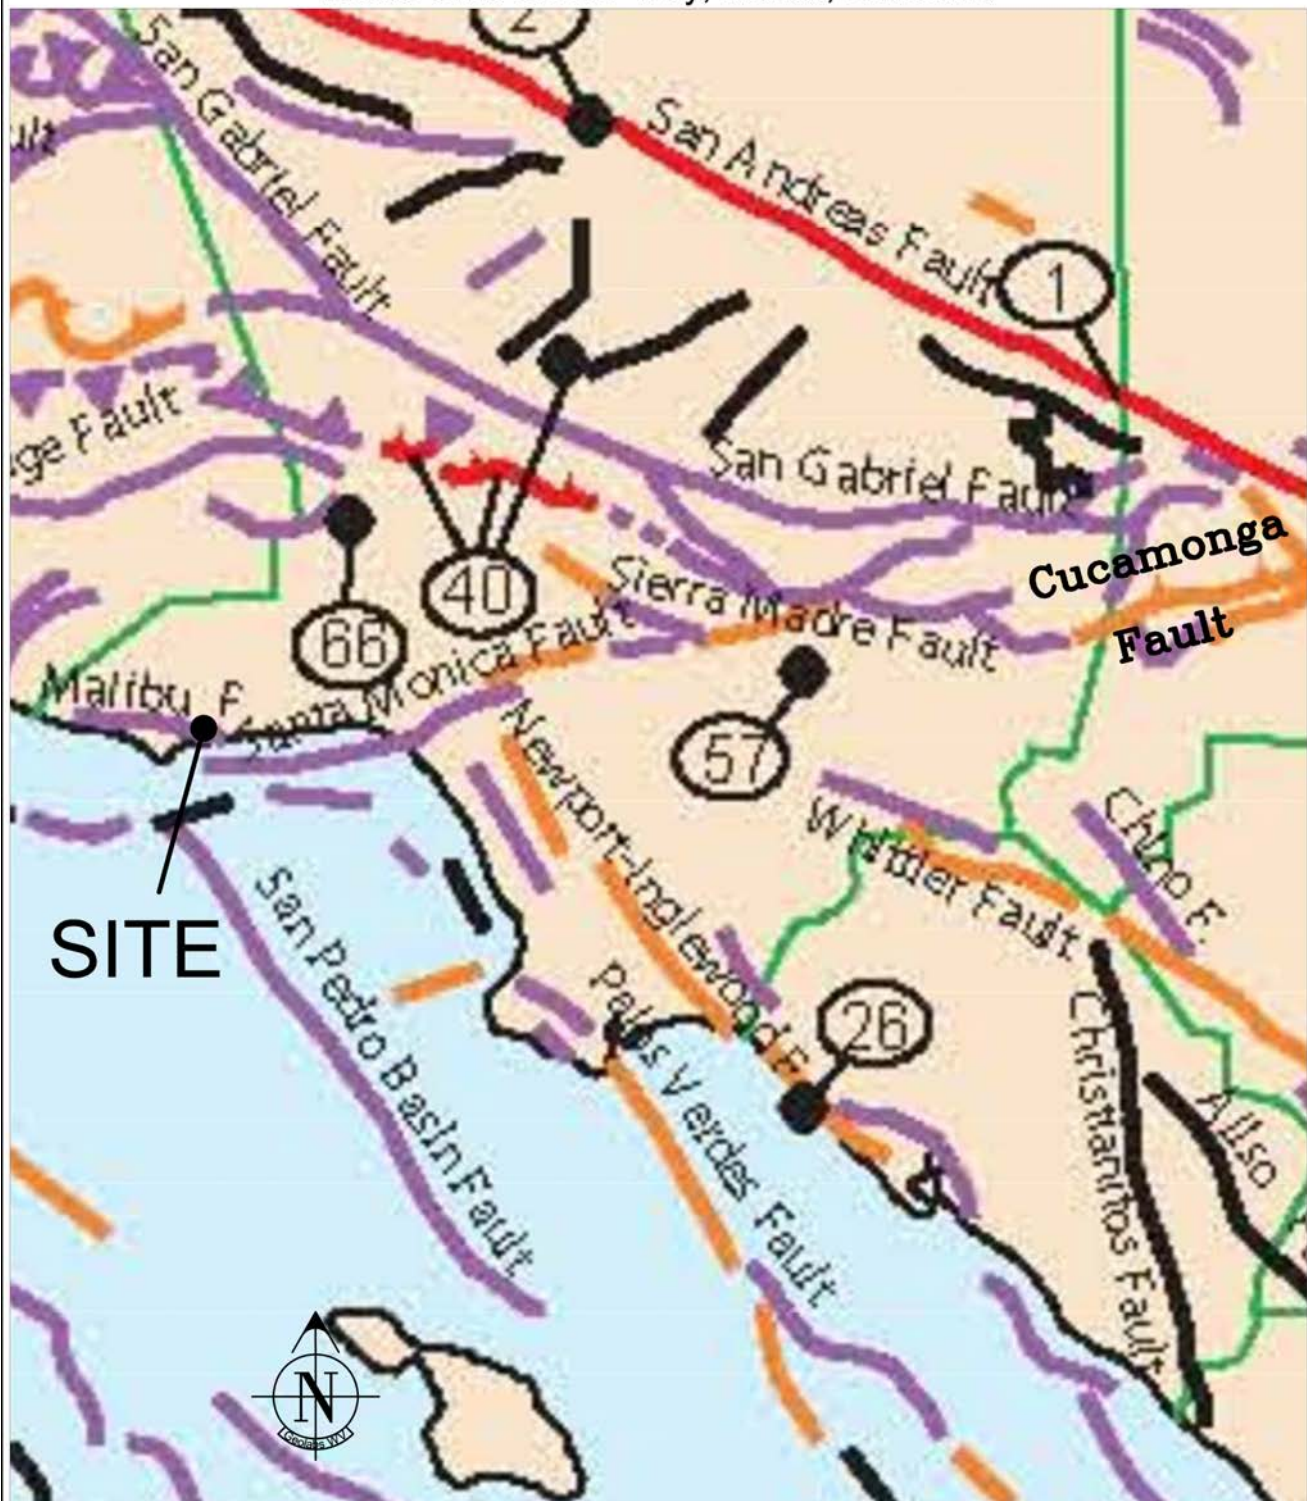
REGIONAL FAULT MAP

23555 Civic Center Way, Malibu, California

Base Map: CGS, 1999, Simplified Fault Activity Map of California, Compiled by C.W. Jennings and George J. Saucedo (Revised 2002 by Tousson Topozada and David Branum)

The entire Southern California area is considered to be a seismically active region. A significant active fault is defined by a fault's capability of generating a magnitude 7.0 or greater earthquake and has a slip rate exceeding 5mm/year. Although significant earthquakes may occur on faults, the San Andreas and Cucamonga faults (Sierra Madre Fault Zone) are most likely to cause damage to the Project Site. Figure 4.4.3, Alquist-Priolo Map, and Figure 4.4.4, Regional Fault Map, show the active faults around the Project Site.
